## Examples of Stress Corrosion Cracking in Copper Piping for Heating and Cooling Systems

M. A. Hineman, M. J. Danko, and F. E. Schmidt

Engineering Systems Inc., Aurora, IL 60504

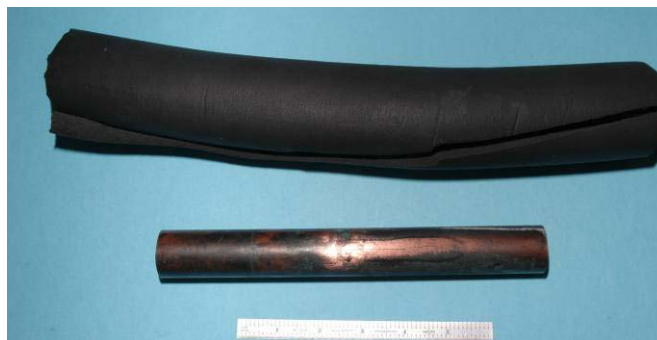
Within the first 2 years of operation, a high rise building had reported 3 incidents of leaking copper pipes in the fan coil system. These 1" diameter copper pipes were insulated with a black foam. In several areas, nylon wire wraps (or zip-ties) were found. Some of those areas contained water which was apparently dammed in the annular space between the insulation and the copper tube. In the areas of the leaks, the pipe had a black appearance in contrast to the typical clean copper color. There were also isolated areas of greenish deposits, but these green deposits did not appear to be directly related to the failures. The observed cracks were predominantly longitudinal with only short isolated transverse cracks connecting adjacent longitudinal cracks. Visual and low power microscopy indicated only short cracks on the inside of tubes where longer cracks were found on the outside.

Figure 1 – To the right is a sample of cracked copper tubing and the black foam insulation which had been on the outside.

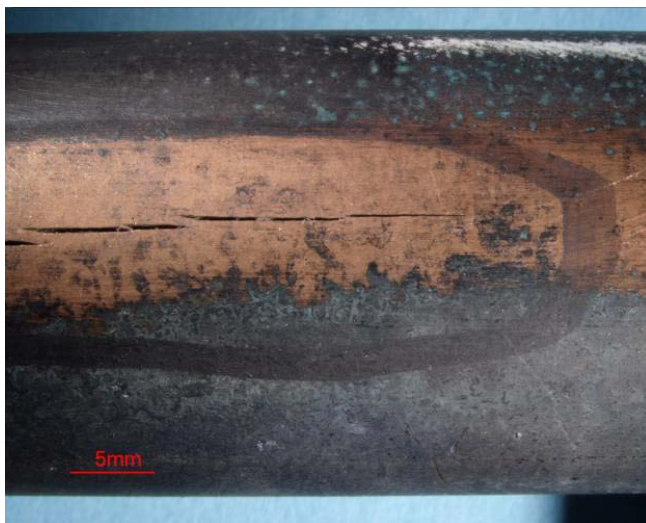
Based on the testing of the fractured and other samples of the copper piping samples, it appears that the cracking was due to SCC of the copper tube due to the combination of high residual stress in the copper tubes and the release of ammonia from the insulation. The presence of water in the annular space between the tube and insulation significantly contributed to the failure in that the water promoted release of ammonia and corrosion of the copper. The water may have been introduced by rain or snow events during construction when the piping system was being built. Heat from brazing operations was also a potential contributor to the release of ammonia.

Figure 2- An illustration of the cracks observed on the outside of the tubing is shown in the photograph to the right.

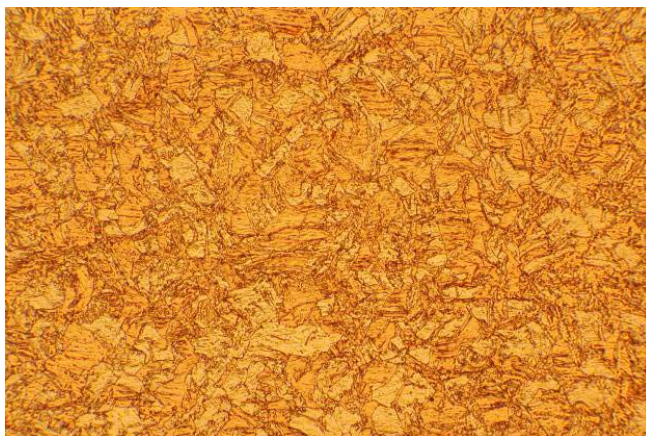
Figure 3 - the image at the right shows the typical microstructure of cold worked alpha grains. Original magnification was 100X, etch ammonium hydroxide and hydrogen peroxide.

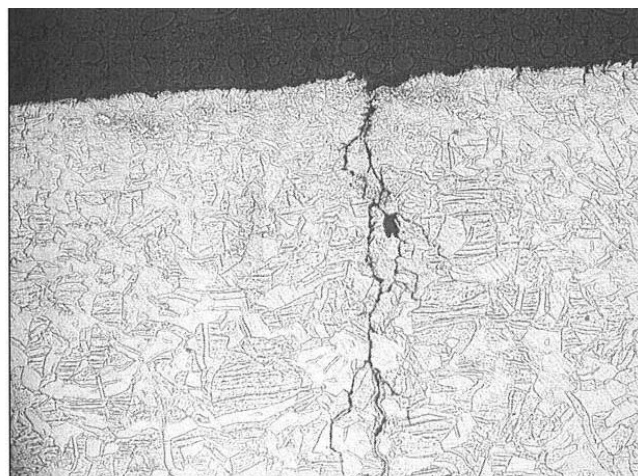
The copper tube material was specified as ASTM B88 grade C12200, type L. The chemical properties and hardness values (66 HR30T) were typical of C12200. The hardness was relatively high, though no maximum hardness was specified. Residual stress measurements indicated values in the 20,000 to 25,000 psi range in the circumferential direction. The microstructure consisted of alpha grains which were elongated typical of a cold worked product. In the cracked areas, brittle intergranular cracks were observed with branching characteristic of Stress Corrosion Cracking.

Figure 4 – A typical example of the cracking observed in a section from the copper tube. Original magnification was 100X, etch ammonium hydroxide and hydrogen peroxide.
