Studying the topographic changes in ProTaper Next endodontic rotary file by Scanning Electron Microscopy (SEM)

Ranya Eleman¹, José A. Capelas¹ and Manuel F. Vieira²

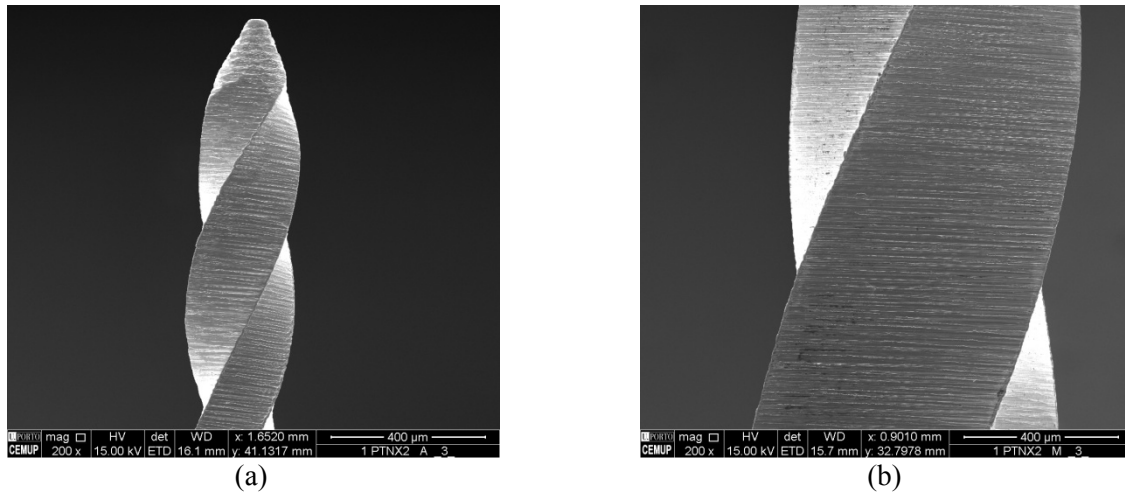
All the PTN files were observed in the same position before and after three canals preparation using high resolution scanning electron microscope (FEI Quanta 400FEG ESEM / EDAX Genesis X4M). Figure 1 shows lateral views of a PTN file before use. In five of the instruments no obvious topographic changes, like instrument's spiral distortion or surface wear, were detected. Figure 2 shows the file of Figure 1 after the preparation of three simulated root canals. However, one PTN file fractured during the third use (Figure 3). The strong plastic deformation of the file near the fracture, indicates the fracture occurred by torsional stresses and not by fatigue. This fracture occurs when the tip or other parts of the file is locked in the root canal during the preparation, but the shaft remains rotating [3]. Although the tested files are small in number, this study show that each file can prepare three canals without fracturing by cyclic fatigue.

Figure 2. SEM images of the PTN file shown in Figure 1 after three uses.

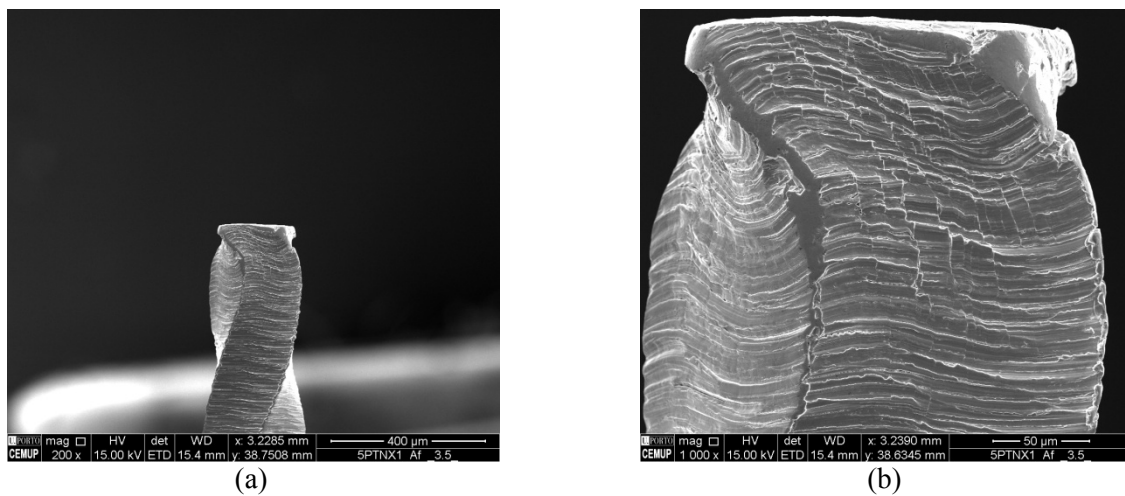
Figure 3. SEM images of the fractured PTN file (a) showing in detail the plastically deformed region (b).
