The Use of Mechanical Testing, Photomicrography, and Electron Microscopy to Characterize an Insulating Fiberglass Composite Post-Electrical Arc Failure.

Robert J. Pieper¹

¹ Element Materials Technology, New Berlin, WI, USA

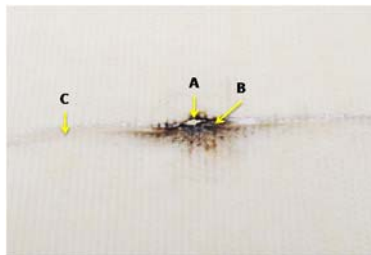
The failed fiberglass composite liner was visually inspected and the hole in the liner from the arc was evident with the crack parallel to the length of the liner. On the bottom side of the liner was the residue from an adhesive used in the manufacturing process that ran parallel across the entire length. The presence of the adhesive resulted in only a small portion of the slot liner being mechanically secured, which allowed for the unsecured portion of the slot liner to flex at the point where the adhesive stopped. Any flexing could result in the formation of micro-fractures on the surface between the immovable/movable interfaces, which in turn can facilitate crack formation and extension.

Figure 1. Locations chosen for SEM analysis.

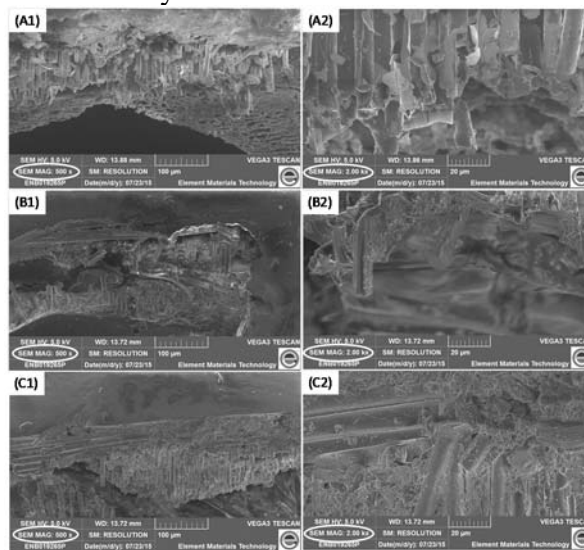
The fracture and electrical arc sites labeled A, B, and C in Figure 1 was examined with the aid of a scanning electron microscope (SEM). Figure 2 shows locations A, B, and C, where individual fibers showed evidence of smooth fractured surfaces, which is a distinct characteristic of compressive force [1]. In addition, some individual fibers in location B showed two distinct areas of smooth compressive and rough tensile areas separated by a neutral axis, a typical feature of compressive failure. In the final fracture region, represented by Location C, fiber fracture by micro-buckling is observed. This feature is characteristic of axial compression, and is typically revealed as stepped structures. Local fiber buckling and fiber fractures lead to an irregular, stepped fracture surface, which is a characteristic feature of compression failure [2]. Location C showed evidence of matrix and fiber debris, which are also characteristic of compression failed samples. Additional SEM images were taken of the lab samples after completion of the mechanical compression tests. The lab samples were compressed and the images were scanned from the top down on the failed specimen. Figure 3 shows the lab sample in increasing magnification. The scans clearly showed individual fibers with smooth fractured surfaces, similar to the failed sample depicted in Figure 2. The lab specimen had characteristics similar to the original failed sample, such as smooth fractured surfaces of the individual fibers and matrix/fiber debris scattered along the scanned area. Also similar is the lack of adhesion of the matrix/fibers.

In conclusion, microscopic examination of the failed composite liner indicated potential failure via mechanical overload due to cyclic compression resulting in cracking from the area not mechanically adhered. To prove this, SEM images of the lab samples that were mechanically compressed to simulate compressive failure revealed similar fiber break features when compared to the failed samples. This indicates that one could simulate and characterize failure modes when the failed sample has limited evidence due post-failure destruction from heat, flame, or other contamination.

Figure 2. Locations A, B, and C shown in increasing magnification. Individual fibers show evidence of smooth compressive fractured surfaces, micro-buckling; with poor matrix/fiber adhesion.

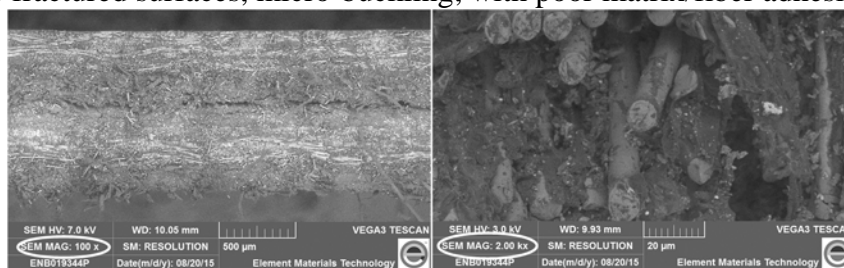
Figure 3. Lab simulated compression test shown in increasing magnification; with evidence of smooth surface fracture and good matrix/fiber adhesion.
