Post-Irradiation Examinations of Irradiation Creep Tested Zircaloy-2

Wade Karlsen¹, Mykola Ivanchenko¹, Ulla Ehrnstén¹ and Ken R. Anderson²

¹ VTT Technical Research Centre, Espoo, Finland.

² Bechtel Marine Propulsion Corp., Bettis Laboratory, West Mifflin, PA, USA

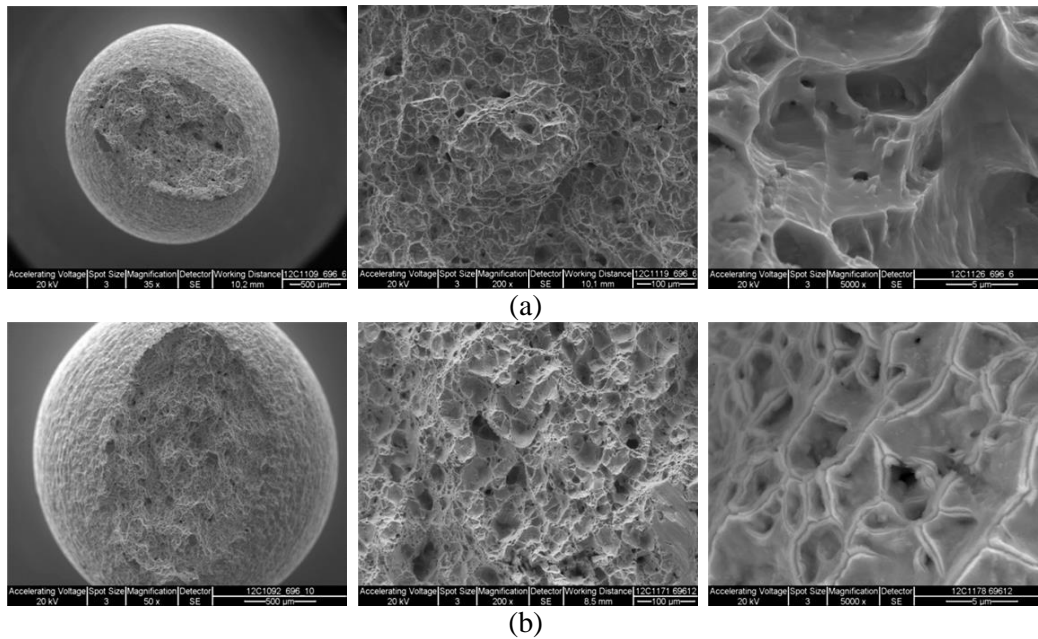
Scanning electron microscopy fractography was carried out using a Philips/FEI™ XL30 ESEM with a LaB₆ electron source. The fractured specimens showed asymmetrical necking, but the fractures were ductile and similar in appearance (Fig. 1). One of the specimens showed ductile dimple features, but with dimple walls exhibiting split fracture edges, rather than single, sharp edges (e.g., the higher magnification image in Fig. 1b). Dimensional measurements showed that in all cases there was significant localization of deformation, manifested by marked necking of the specimen, while the gauge diameter even 5 mm away from the fracture surface was still quite close to the specified original diameter.

Figure 1. SEM fractography of two irradiation creep tested Zircaloy-2 specimens; (b) shows dimple walls exhibiting split fracture edges.

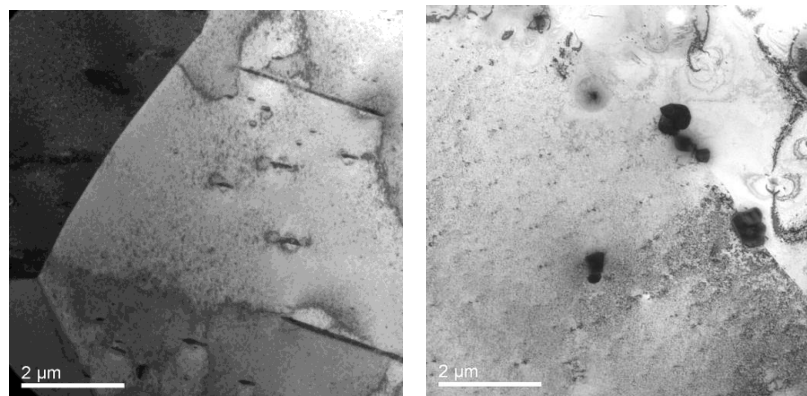
Figure 2. Low-magnification bright-field TEM images of irradiation-creep tested Zircaloy-2 – showing overall microstructures, including second-phase precipitates (mainly Zr-Fe-Cr Laves).

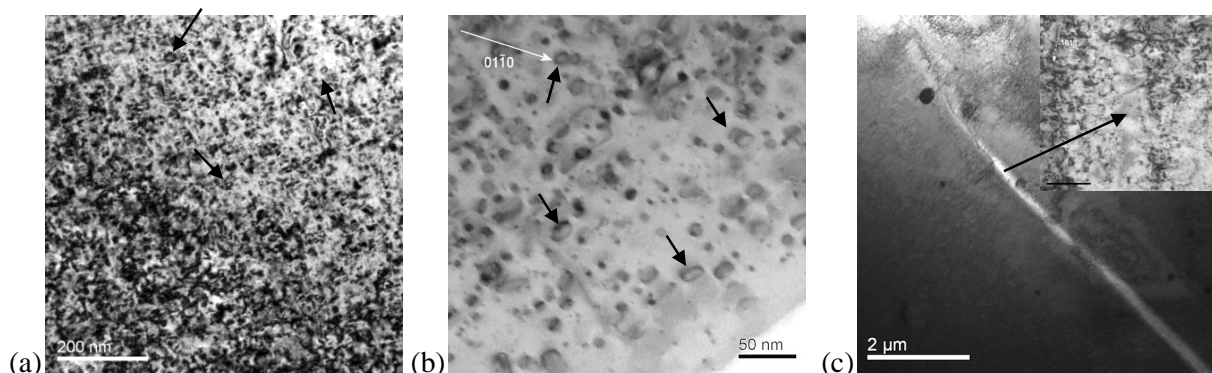
Bright-field TEM images of the general microstructure of irradiation-creep tested Zircaloy-2 specimens are shown in Fig. 2. Figure 3 shows higher-magnification bright-field TEM images of the primary irradiation-induced defects, <a>-type dislocation loops. The measured irradiation produced <a>-type dislocation loop populations were similar in all of the materials, with mean diameters ranging from 6 to 9 nm, and number density from 1.8 to $2.9 \times 10^{22}/\text{m}^3$ (dislocation density 4.5 to $7.3 \times 10^{14}/\text{m}^2$). Figure 3 also shows evidence of dislocation channeling. More details of the analysis will be given in the presentation. The results of this recent work presented here augment the work reported by Cockeram, *et al.* [1] and are directly related to and support the work reported by Kozar, *et al.* [2].

Figure 3. Higher-magnification bright-field TEM images of the primary irradiation-induced defects observed in the examined specimens: $\langle a \rangle$ -type dislocation loops formed on prism planes of the hexagonal crystal structure, (a) and (b); and an example of a clear band indicating evidence of dislocation channeling in regions close to fracture surface of the deformed gauge region (c).
