## Failure Analysis Problem Solving Using Metallography

F. Hogue

Hogue Metallography, 15201 DePauw Street, Pacific Palisades, CA 90272

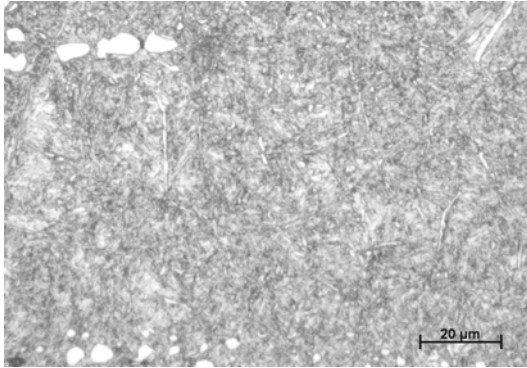
Etching with Kalling's reagent revealed a martensitic matrix and globular carbides that remained white after etching. In the failed part faint linear indications were visible in the microscope, but difficult to document (Fig. 1 & 2).

Fig. 1 Failed Kalling's Etch 1000x

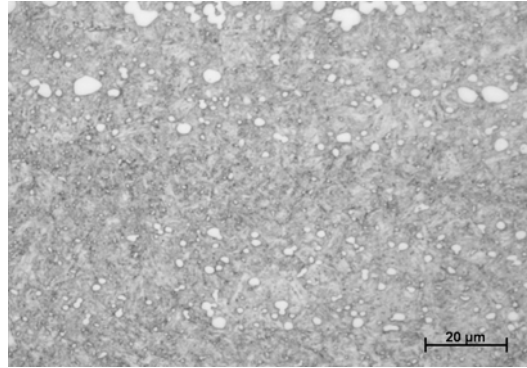
Fig. 2 Good Kalling's Etch 1000x

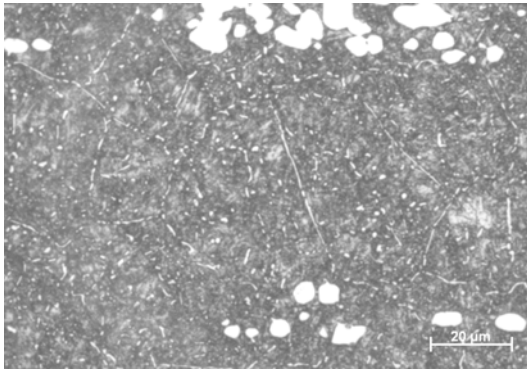
Fry's etch darkens the martensitic matrix, but the primary carbides and cementite remain light, providing good contrast (Fig. 3 & 4). Long platelets of carbides can easily be distinguished in the failed sample (Fig. 3). These platelets could be removed by re-heat treating the sample, which indicates that they were cementite plates precipitated along prior austenite grain-boundaries during improper heat treatment.

Fig. 3 Failed Fry's Etch 1000x

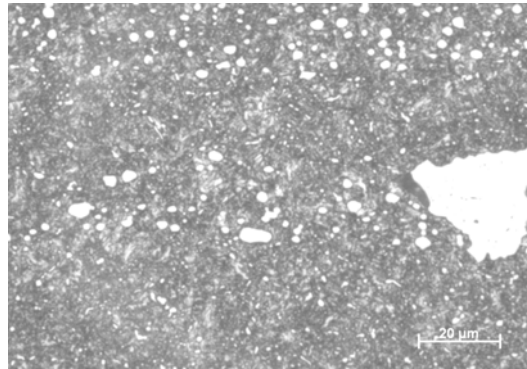
Fig. 4 Good Fry's Etch 1000x

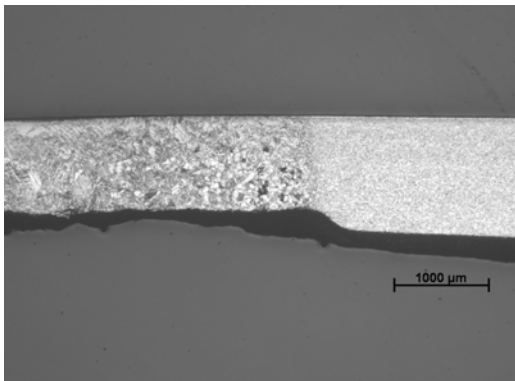
Considerable thinning on the I. D. is evident in the weld zone (Fig.5). The I.D. of the tubing shows a very thick, dark layer of Ti-hydride (Fig. 6). Hydrogen in titanium migrates preferentially to irregularities in the structure, such as the weld. The Hydride is very brittle and spalls off easily if enough thickness is achieved. Fig. 7 shows black hydride needles in the weld close to the outside. Even in the non exposed areas a high amount of hydrogen is present in the form of black needles that are only visible in the etched condition (Fig. 8).

Fig. 5 Weld Kroll's Etch 25x

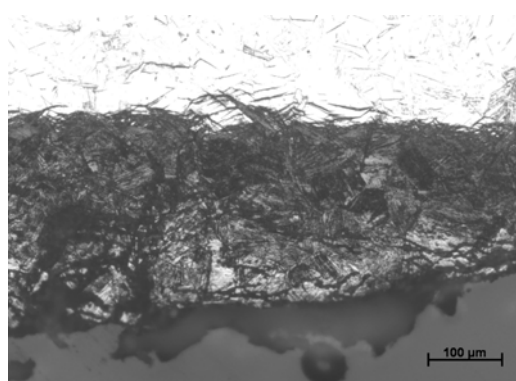
Fig. 6 Hydride Needles Kroll 200x

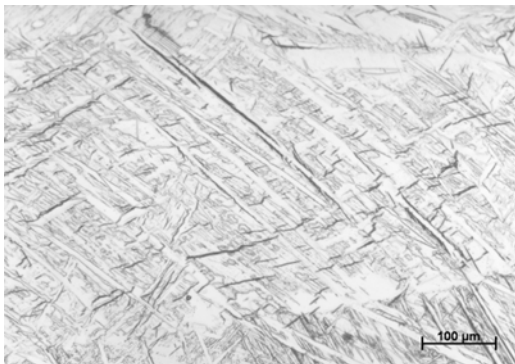
Fig. 7 Hydride Needles in Weld 200x

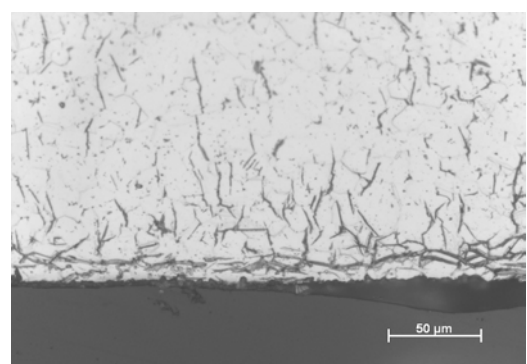
Fig. 8 Hydride in Unexposed Material
