Mediation of Electrostatic Discharge Induced Morphological Damage in Atomically Precise Tips

B. P. Gorman*, J. Ballard**, M. Romanes ***, D. Jaeger ***, R. F. Reidy ***, J. N. Randall**

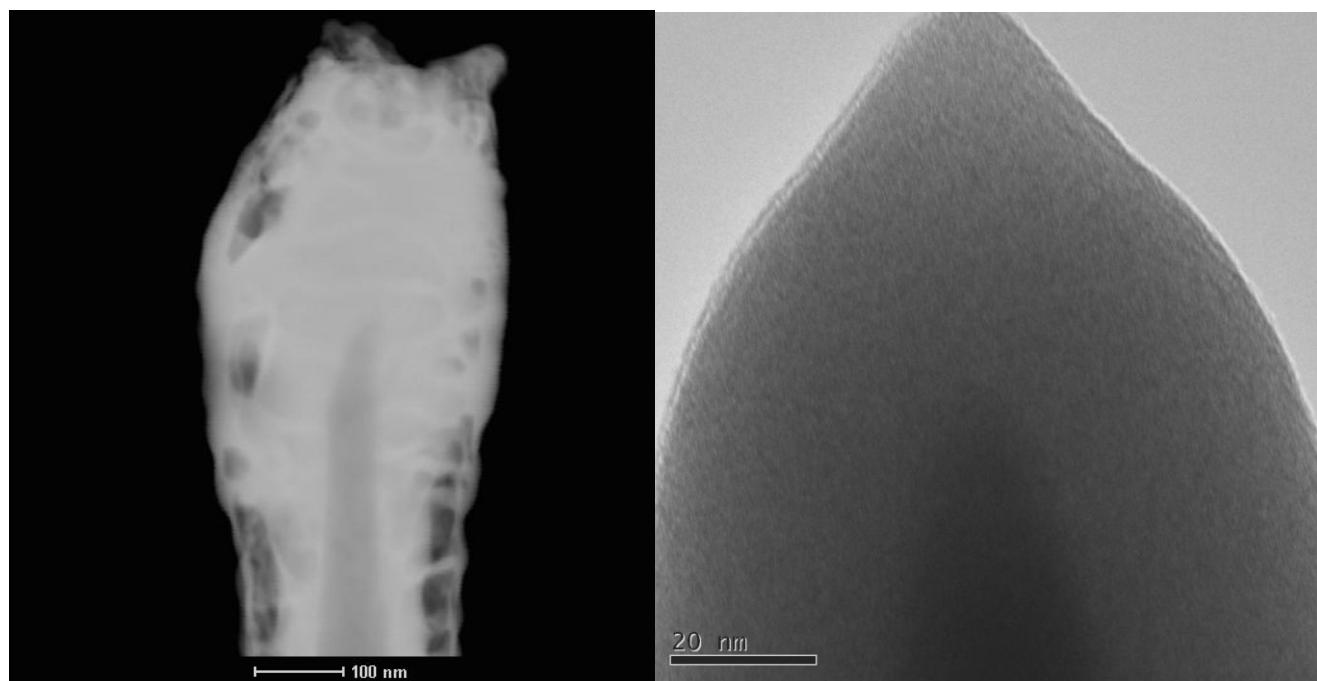
During development of tips for APM, several processing techniques for extremely low radius of curvature W tips were developed. In order to fully characterize the tip geometry, hardware was developed that allows for cross sectional tomographic imaging of W wire shaped tips in a modern TEM or STEM, along with FIM, Atom Probe Tomography, and imaging in a UHV STM [4]. During characterization of the tip geometries using SEM, TEM, FIM, and atom probe, it was found that the tip radius was several orders of magnitude larger than expected (Fig 1). Characterization of the tips using STEM-EELS, -EDS and atom probe tomography revealed the presence of a thick (>50 nm), low density WO_x . The sub-oxide layer was significantly thicker and less dense than expected for simple reactions with air.

Subsequent changes in the experimental methods for cross-examination with all of the above techniques revealed that the oxide formation was actually due to electrostatic discharge (ESD). It is worth noting that most ESD events that result in tip morphology changes are not observable visually or via human touch. Using good ESD tip handling protocol such as continuous grounding of specimen holders and tweezers during transfer had a profound effect on the ability to image in STM mode with nearly atomically sharp tips (Fig 2). Correlating the tip geometry with STM operation has also been illustrated in this work.

FIG. 1. Representative (a) STEM-HAADF and (b) bright field TEM images of improperly handled W tips. The layer surrounding the W core consists of an amorphous, porous WO_x material deposited through an electrostatic discharge.

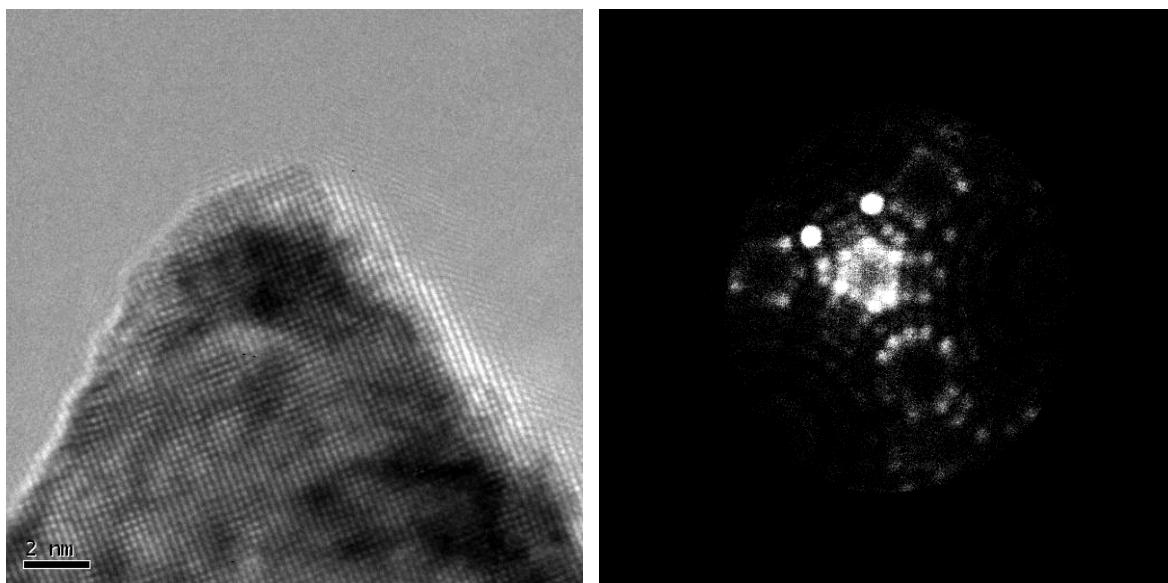
FIG. 2. (a) HRTEM image of a properly handled W tip showing no evidence of oxide formation. (b) Representative field ion microscopy image of a properly handled W tip showing excellent crystallinity, a strong $<111>$ orientation, and small radius of curvature.
