Towards Understanding Tribocorrosion in Hip Replacements

Emily Hoffman, Yifeng Liao, and Laurence D. Marks

Department of Materials Science and Engineering, Northwestern University, Evanston, IL

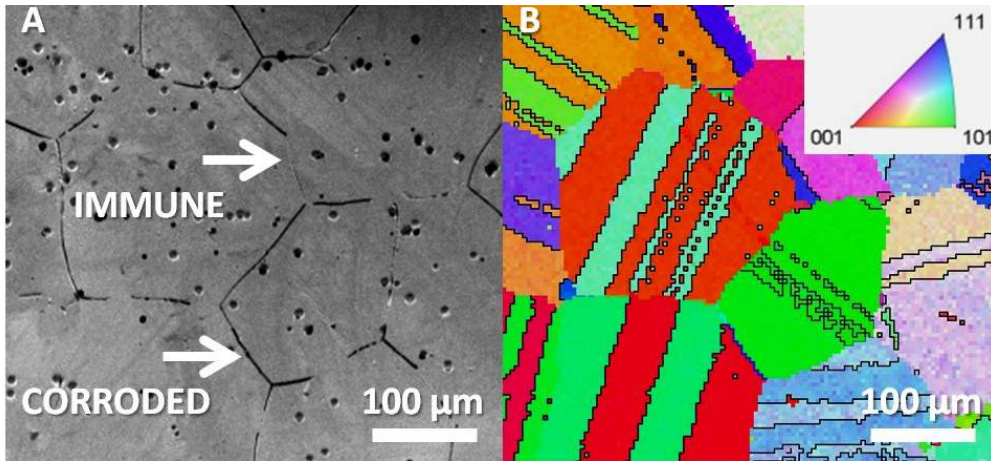
The misorientation of the grain boundaries was determined through electron backscattered diffraction (EBSD) and was quantified using coincident site lattice geometries ($\Sigma 3 - \Sigma 35$) using the tolerance as defined by the Brandon Criterion, $\Delta\theta \leq 15^\circ(\Sigma^{-1/2})$ [2]. An SEM in Figure 1 (A) shows the visual difference between corroded and immune grain boundaries, while (B) shows the EBSD mapped crystallographic orientations. Previous work on the crystallographic misorientation for 102 corroded and immune grain boundaries showed that 100% low-energy grain boundaries did not corrode, whereas only 30.4% of general high-angle grain boundaries did not corrode [3]. This indicates that the crystallographic orientation affects corrosion susceptibility in CoCrMo. Using this knowledge of grain boundary orientation, focused ion beam (FIB) was used to make TEM samples of specifically selected, high-energy grain boundaries to evaluate the composition across the boundary.

Figure 1. (A) A SEM image showing the corroded and immune grain boundaries in a CoCrMo sample, along with the EBSD crystallographic mapping to determine the grain boundary energy in (B).

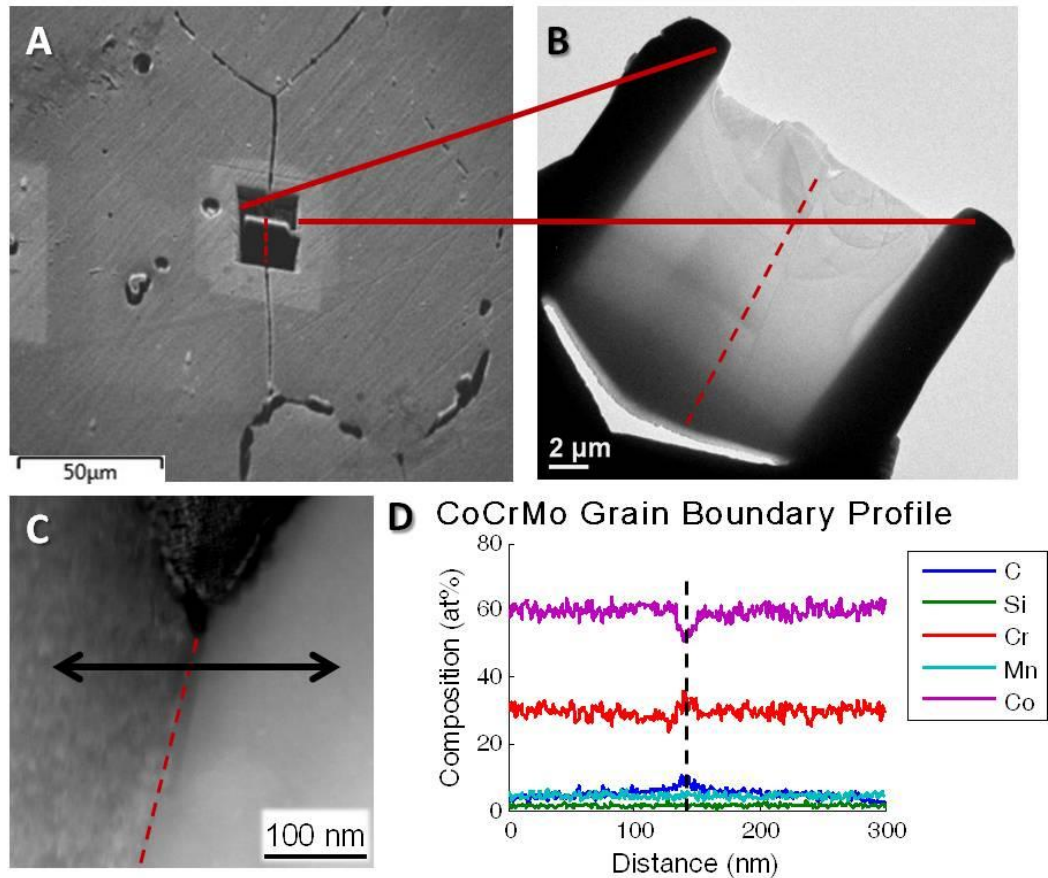
EDS was employed to scan line profiles across the high-energy grain boundaries of the CoCrMo TEM samples. Figure 2 (A) and (B) show an example TEM sample FIB'ed from a corroded grain boundary. Figure 2 (C) shows the EDS scan area, with (D) depicting the alloy element compositions across the scan. EDS results indicate that, at the corroded boundary, there is a depletion of cobalt and an enrichment of both carbon and chromium around approximately 10 nm on either side of the boundary. This trend of Co depletion and Cr enhancement is seen in three out of four samples initially evaluated, to various degrees. Our preliminary results showed composition along the depth of the grain boundary changes, necessitating further TEM analysis to determine the segregation levels and atomic structure of corrosion susceptible grain boundaries.

Figure 2. (A) FIB/SEM image showing a single grain boundary being cut from the sample, viewed in a TEM in (B) and (C) and EDS spectra indicating Co depletion (purple) and Cr increase (red) near the boundary marked with the dashed line in (D).
