Correlative Characterization of Defect Clusters in GaAs Solar Cells by High-Resolution TEM and Spatially Resolved Optical Techniques

B.S. McKeon¹, Q. Chen², S. Zhang², C.-K. Hu^{2,3}, T.H. Gfroerer⁴, M.W. Wanlass⁵, Y. Zhang², and David J. Smith¹

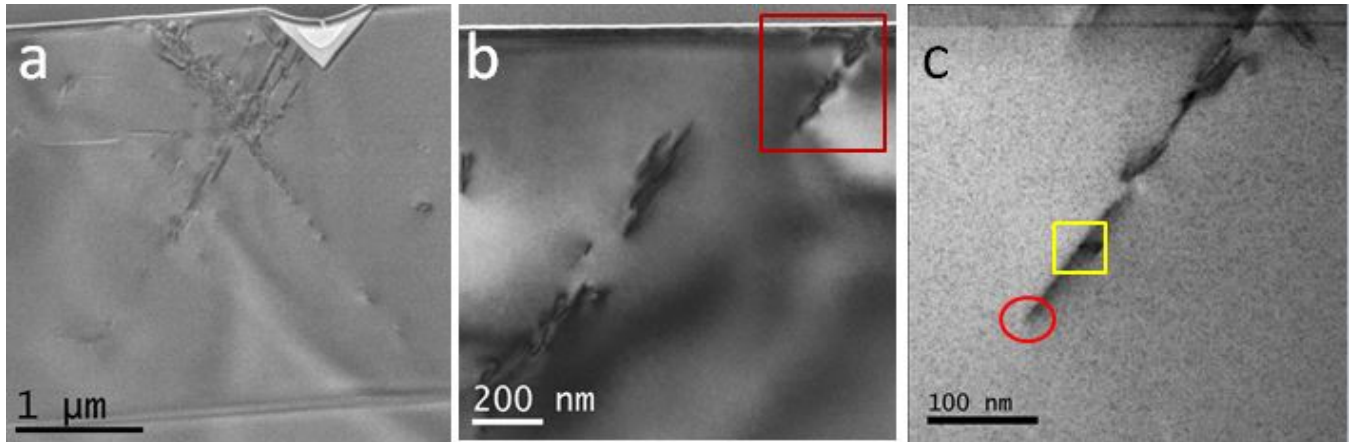
Figures 1 (a) and (b) are TEM images of defect clusters identified by EL. The dark contrast indicates a cluster of defects extending downwards from the surface of the solar cell into the GaAs absorber layer. These defects do not reach all the way to the back-surface confinement layer. Figure 1 (c) is a bright field STEM image taken at higher magnification showing the area indicated by the red rectangle in (b). Figures 2 (a) and (b) are high-angle annular dark field (HAADF) STEM images taken at higher magnification of the areas indicated in figure 1 (c) by a red circle, and a yellow square, respectively. Figure 2 (a) shows 30° and 90° partial dislocations with an intrinsic stacking fault. A yellow Burgers circuit is included for each dislocation, and the general Burgers circuit drawn in red shows the resulting total Burgers vector. An extra plane of atomic columns associated with the 30° partial dislocation is indicated with a blue line. There are three dislocations in figure 2 (b), and each corresponds to an extra plane of atomic columns marked in the figure with a blue line. The two Burgers circuits drawn in yellow surround 30° partial dislocations connected by an intrinsic stacking fault. The general Burgers circuit in red shows that the net Burgers vector in this projection is a null vector. Thus, it is likely that a perfect screw dislocation split to form these two partial dislocations. With further analysis of the types and

Figure 1. (a, b) TEM images of defect clusters identified by EL, (c) Higher magnification STEM image of the area highlighted in (b). The red circle and yellow square indicate the locations where figures 2 (a) and (b) were taken, respectively.

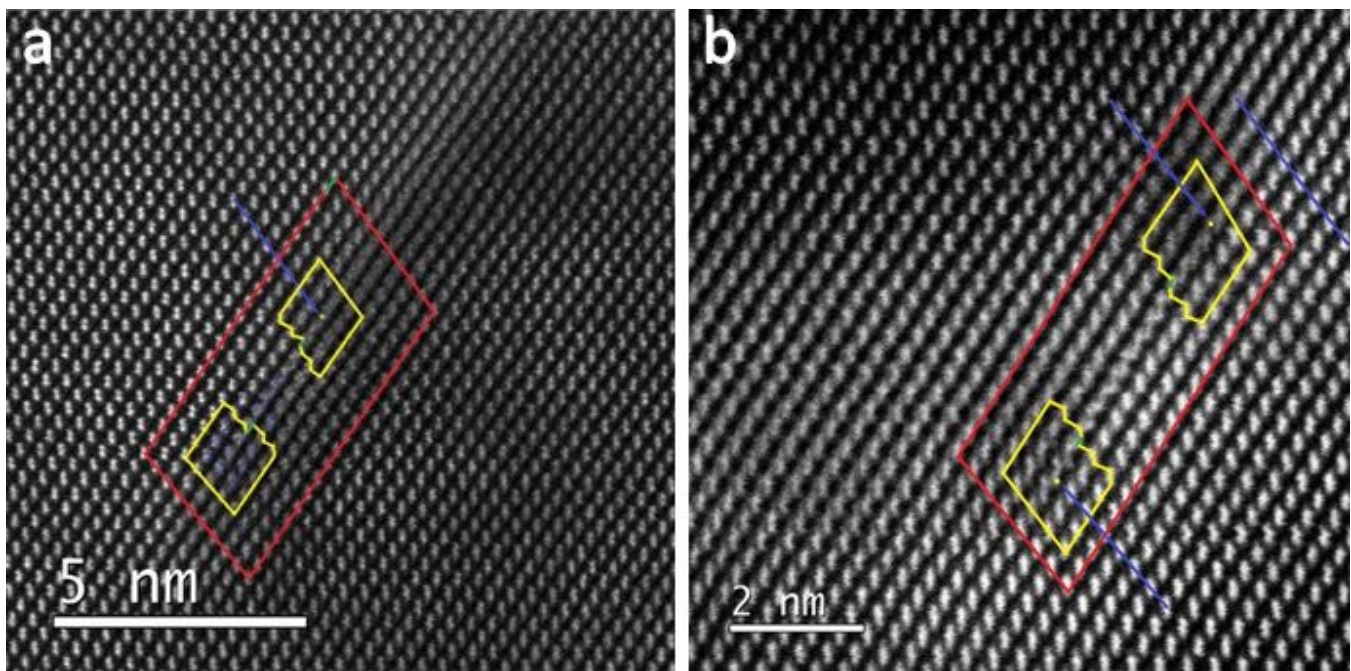
Figure 2. HAADF STEM images of individual defects. (a) 30° and 90° partial dislocations associated with an intrinsic stacking fault. (b) Two 30° partial dislocations associated with an intrinsic stacking fault near another unidentified dislocation.
