## Corrosion Damage of Copper Tubes

Michael Panzenböck, \*

\* Department of Physical Metallurgy and Materials Testing, University of Leoben, Austria

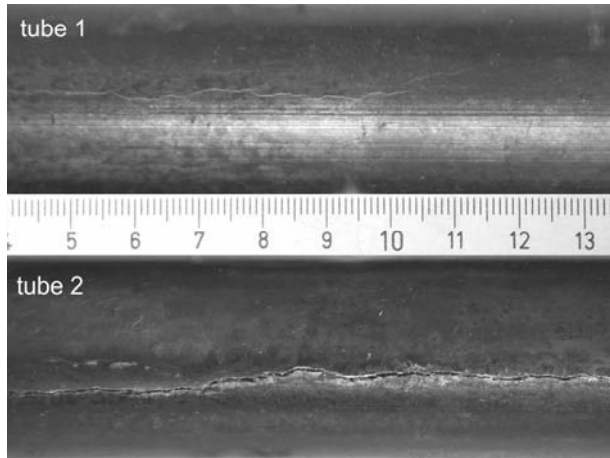
First of all many cracks on the outer surface of copper tubes used for a cold water installation were found in the longitudinal direction (Fig. 1). Careful investigations show that the crack initiation starts at the outside of the tubes. This reveals Fig. 2 where the main crack together with many branched cracks is visible. Crack propagation occurs only along the grain boundaries. A direct view of the main crack (Fig. 3) shows separated grains, secondary cracks and corrosion products. All these facts indicate that the damage is caused by stress corrosion cracking (SCC). Chemical investigations suggest that sodium nitrite and calcium nitrite were responsible for the damage. Nevertheless tension stresses are also necessary for SCC. A simple method allows an estimation of the residual stresses. After cutting tubes in the longitudinal direction the cutting clearance will open in a case when the circumferential tension stresses are present. In other words, the circumference of the tubes will change. Taking all geometry factors into account, a stress level of about 130 MPa was calculated.

FIG. 1. Outer surface of two tubes with cracks in the longitudinal direction

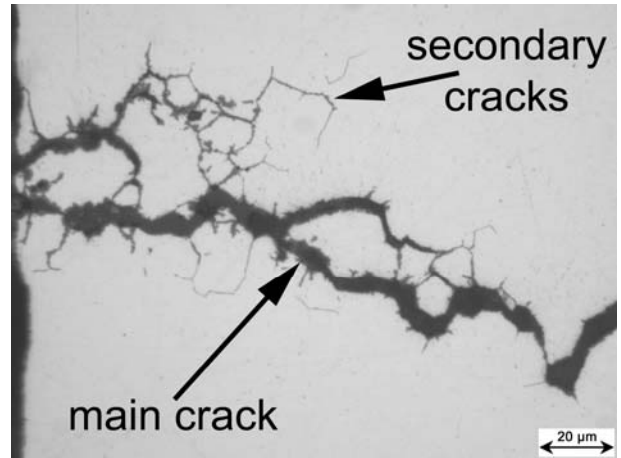
FIG. 2. Microstructure of the copper tube, the main crack starts from the outside

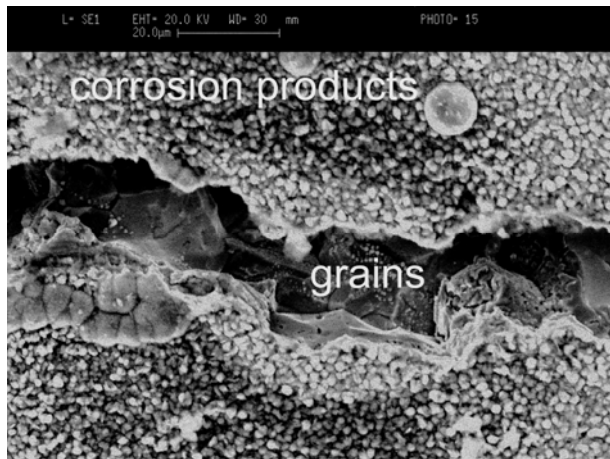
FIG. 3. Overview of the main crack at the outer surface of the tube

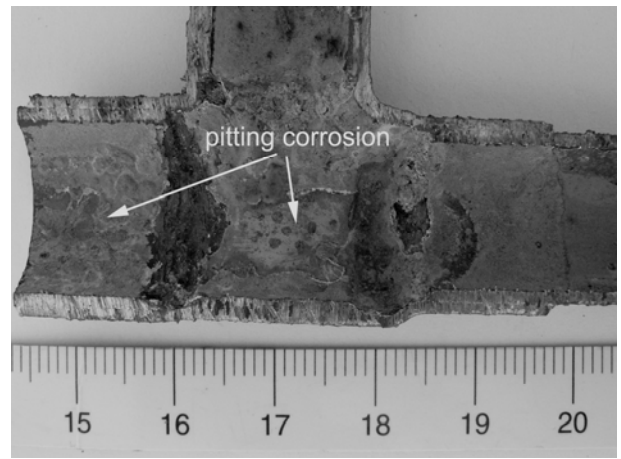
Another predominant failure mechanism of copper tubes is pitting corrosion. After new installation of the water supply in an old building, water patches on the wall were observed within one year. The damaged parts (Fig. 4) of the water pipe were cut out and replaced with new tubes. Soft-soldering techniques were used for connecting the pipes and fittings. Subsequently the pipes were flushed with citric acid. Such a procedure has to be repeated two or three times a year. The house seems to be an everlasting construction site. Many local attacks are predominant in the vicinity of the pipe connection (Fig. 5, 6). Cuprite and malachite are detectable within these pits. In addition, residues of soldering flux were found at the inner surface of the tubes. Thin films of carbon layers and chloride containing soldering facilities were responsible for the disastrous failure of the pipes.

FIG. 4. Overview of the inside of the copper tube, in the vicinity of the pipe connection

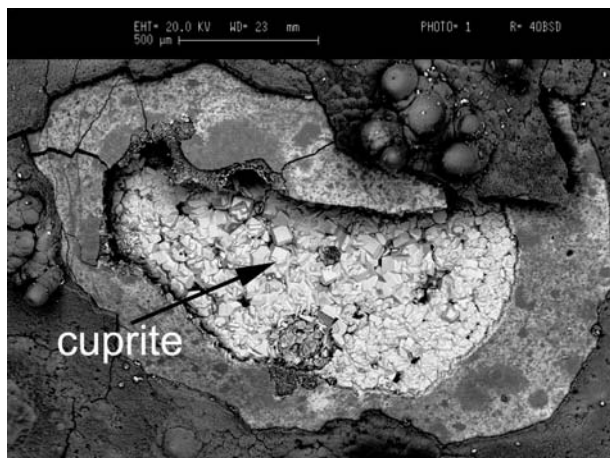
FIG. 5. Local attack at the inner surface of the copper tube

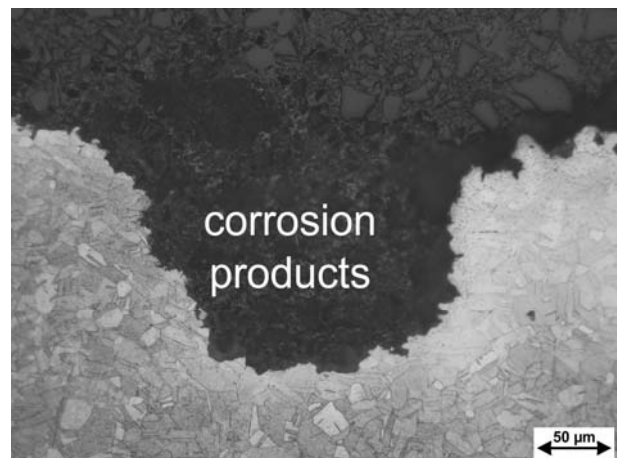
FIG. 6. Cross section of a local attack at the inner surface
