## Application of microscopy techniques for forensic analysis of a failed aircraft crankshaft

Silva J.M.\*, Silvestre M.A.\*, Infante V.\*\*

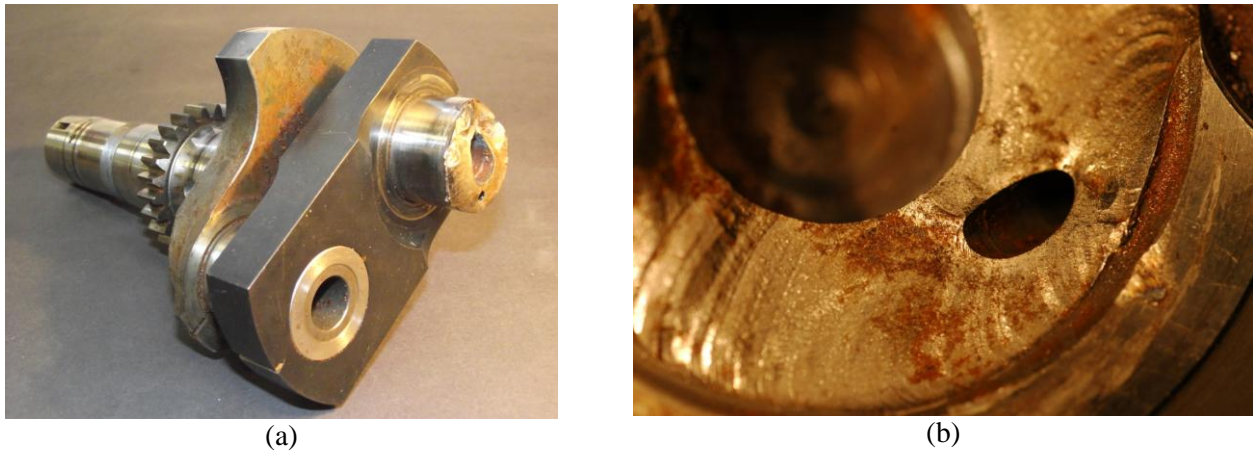
This work presents a microscopy analysis of the fracture surface of a failed crankshaft from an aeronautical internal combustion engine which culminated in the crash of an ultralight aircraft. The crankshaft's catastrophic failure occurred in the interface region between cylinder #2 connecting rod journal and the adjacent web (Fig. 1(a)). At an initial stage, efforts were directed towards the microscopy observation of this region of interest to characterize the fracture surface pattern and other features that could provide significant information about the failure mechanisms. From these observations it was found that the fracture features were compatible with a cyclic load dependent crack front propagation related to a mechanical fatigue process (Fig. 1(b)). A particular attention was addressed to the identification of the crack initiation site in order to determine likely contributing factors in the base of the cyclic damage mechanism, such as stress raisers and imperfections. By resorting to SEM analysis, striation marks were found (Fig. 2(a)) along the crack propagation path which besides confirming the cyclic plastic process also provide meaningful information regarding the crack propagation rate and consequently the number of cycles to failure [4]. Additionally, SEM observations focused in the crack initiation site allowed the detection of a possible forging defect concomitant to the onset of the fatigue process (Fig. 2(b)). The characterization of this defect was attained by using an energy dispersive spectrometer (coupled to the SEM equipment) in order to undertake a chemical composition analysis of the neighbouring region and confirmed possible segregation mechanisms resulting from the forging process in the course of the crankshaft's fabrication. Finally, the fractured component was chemically etched to confirm the existence of a case-hardened surface region which was then visualized by means of an optical microscope to determine its depth. The dimension of the surface layer was not perfectly uniform along all the perimeter of the section and the nominal case depth was found to be around 0.2 mm.

Fig.1 – Failed crankshaft; (a): failure occurred in the interface region between cylinder #2 connecting rod journal and the adjacent web; (b): fracture surface.

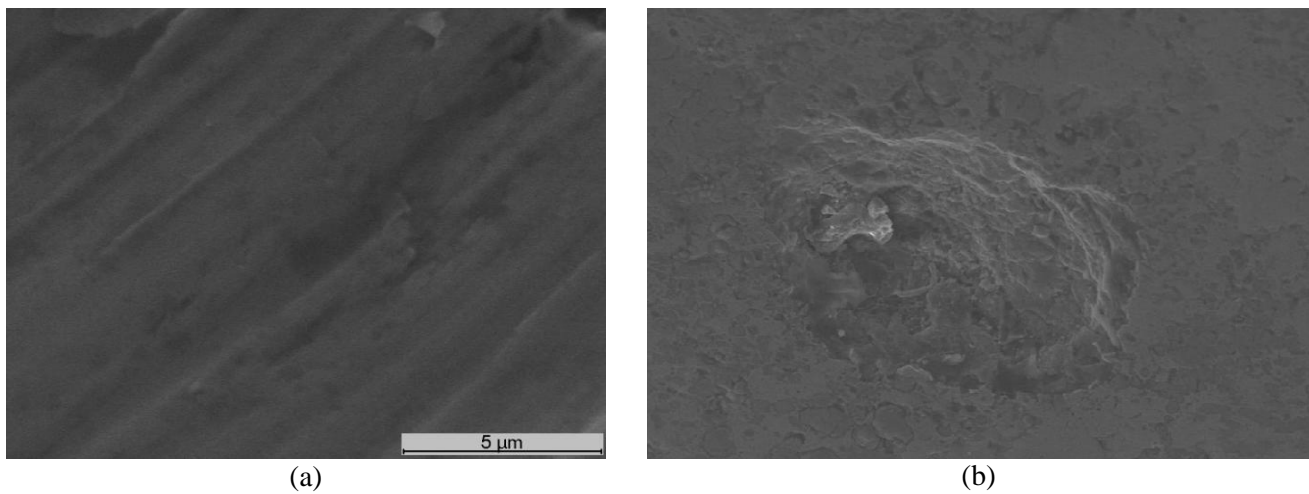
The visual and microscopic inspection of the fracture surface permitted to conclude that the crankshaft failed as a result of a high cycle fatigue process with the crack initiation region in the interface of the crankpin journal and the adjacent web. As a result of the combined contribution of the adjacent undercut fillet and lubrication hole as stress raisers and the possible forging defect. The stress concentration in the adjacent of the fillet region should be stressed out has the major likely root cause for the failure of this component.

Fig.2 – SEM analysis of the fracture surface of an aircraft crankshaft; (a): striations due to cyclic plastic deformations related with fatigue mechanisms; (b): possible forging defect close to the crack initiation region.
