## Quantitative Metallography And Microanalytical Analysis Of Particles In Iron Rivets Recovered From The Wreck Of The RMS Titanic

T. Foecke,\* and J.J. Hooper-McCarty\*\*

\* Metallurgy Division, National Institute of Standards and Technology, Gaithersburg, MD, 20899-8553

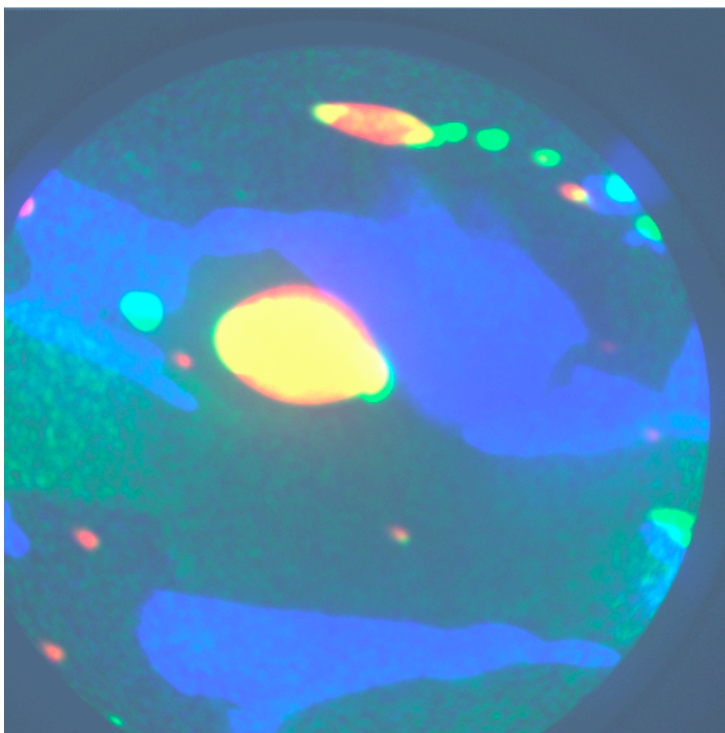
Figure 1: Composite SIMS image showing sulfur (yellow), oxygen (green) and carbon (blue) distribution in iron.

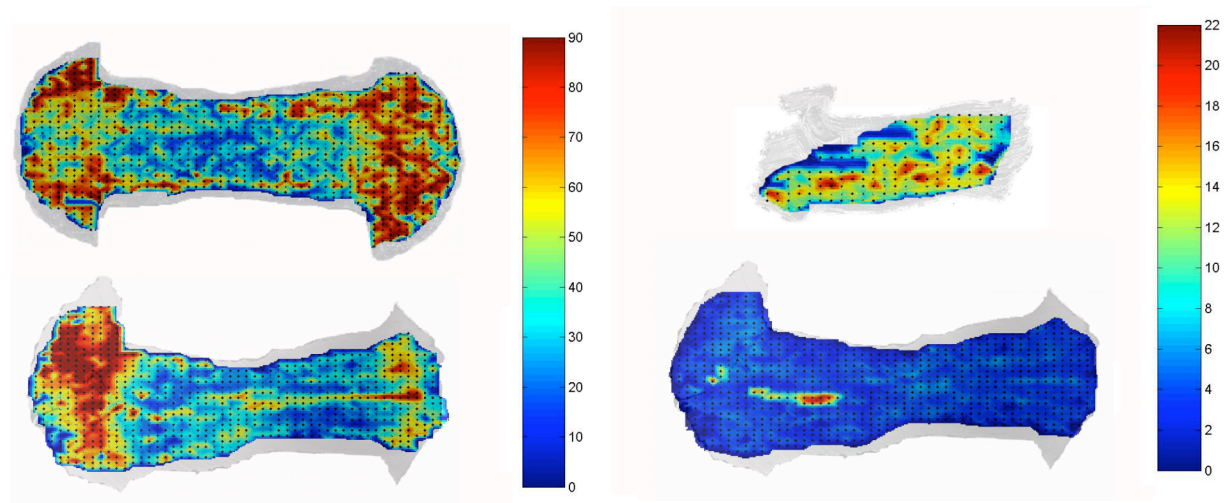
Large slag particles compromise the strength of the iron when used as a rivet, as upsetting the shaft into a second head during installation re-orientes the large particles from along the shaft to a transverse orientation within the head and at the head-shaft interface, weakening this interface. A thorough analysis of construction records of Harland and Wolff revealed that, under immense production pressures, the company purchased sub-standard wrought iron rivets from many suppliers other than those with whom they normally did business, in agreement with our metallographic observations.

Figure 2: Montage of data from thousands of micrographs, showing particle orientation with respect to tensile axis of rivet (left) and area fraction of particles (right).
