Failure Analyses of Three 6061-T6 Aluminum alloy Turbo-Expander Wheels Exposed to Natural Gas Environments,

Behzad Bavarian, PhD

Dept. of Manufacturing System Engineering and Management
California State University, Northridge 91330-8332

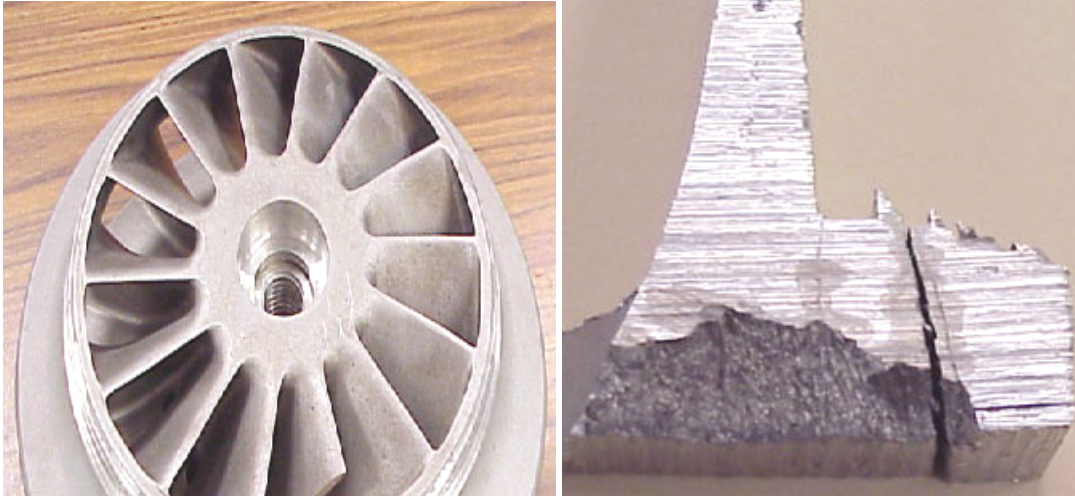
Figure 1: Optical images of the fractured wheel showing a few of secondary cracks that were fractured to analyze their failure mode, Fracture surfaces were covered with Hg and corrosion attacks.

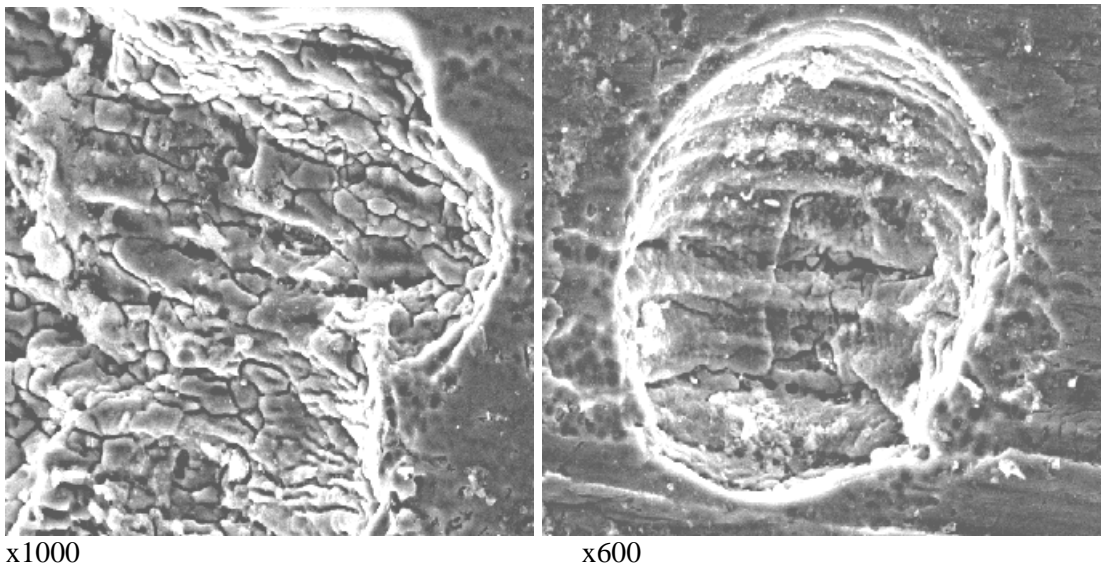
Figure 2: SEM images of the fractured wheel, showing corrosion attacks inside a pit caused by Hg-attack.
