Quantitative image analysis of white etching areas in SAE52100 bearing steel

Philippe T. Pinard¹, Mehmet Özel², Moritz Ploß³ and Silvia Richter¹

¹ Central Facility for Electron Microscopy, RWTH Aachen University, Aachen, Germany

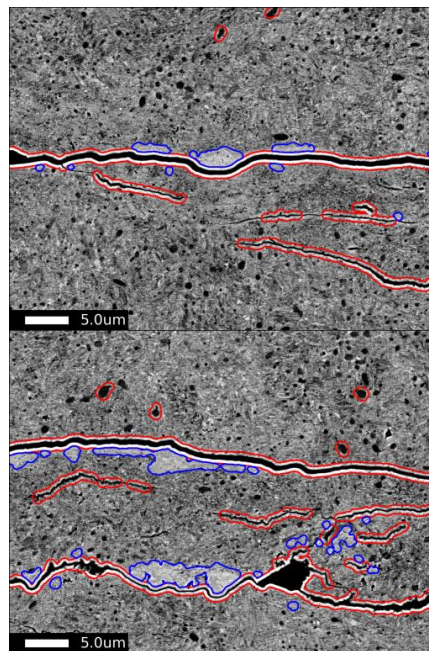
The next step was to identify the WEAs from the surrounding matrix and cracks using an image analysis routine. The goal is to statistically compare the WEAs found in different cross-sections based on potential criteria such as their size, shape, quantity, distance from the surface, etc. The developed image analysis routine utilized the fact that WEAs contain very small grains [2] and therefore appear brighter in a backscattered electron image due to lower electron channelling. The image analysis methodology goes as follows (Figure 2): thresholding to identify the cracks (low intensity pixels), morphological dilation of the identified cracks to remove edge effects (topographical effects), removal of the cracks from the original image, median filter to remove noise, smoothing to remove intensity fluctuations in the matrix, thresholding of WEAs using a random-walk algorithm and finally removal of false positive WEAs based on the criterion that WEAs should be close to a crack. All image processing procedures were written in Python with the scikit-image library [3].

Figure 2: Examples of the image analysis routine used to automatically detect cracks (red) and white etching areas (blue).

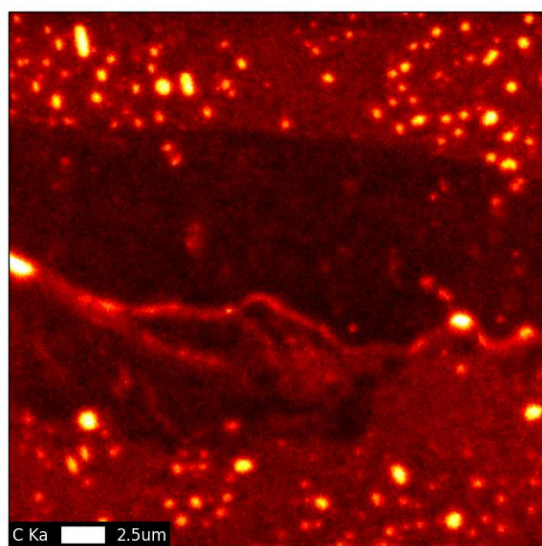
Figure 3: Qualitative carbon (a) and chromium (b) mapping of a white etching area.
