Non-destructive, Multi-scale 3D Fractographic Analysis of a Carbon Fiber Composite Hockey Stick after Compressive Failure

Jeff Gelb, Will Harris, Naomi Kotwal, Wayne Broderick, Leah Lavery, Hrishi Bale, and Arno Merkle

¹ Carl Zeiss X-Ray Microscopy, Inc., Pleasanton, CA, USA

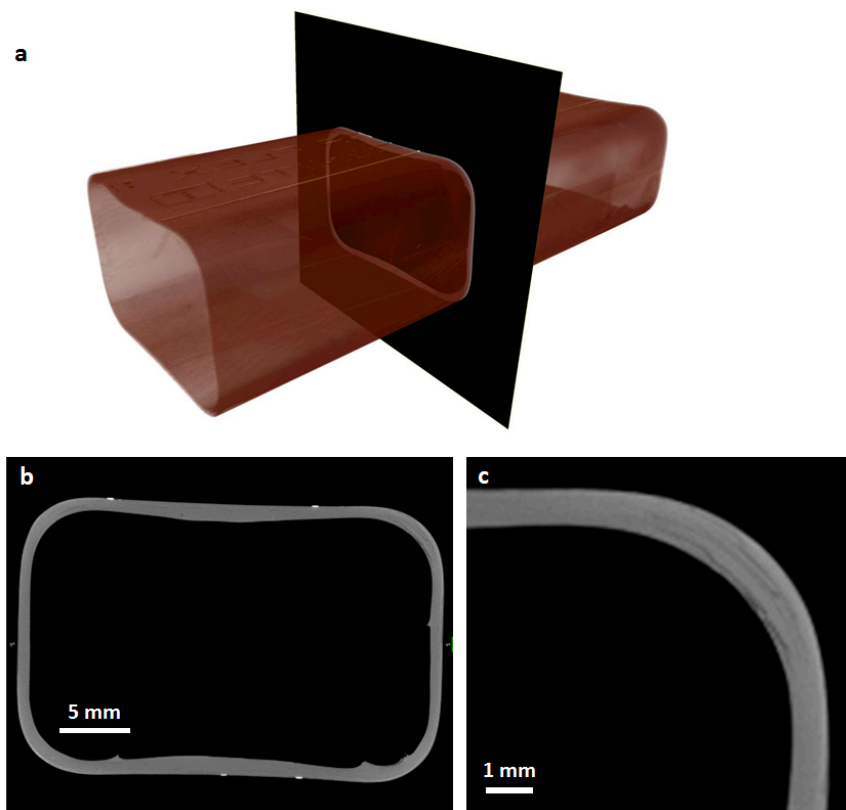
Figure 1. Initial 3D X-ray imaging of the hockey shows indications of defects nucleating in highly localized regions, and not throughout the entire material.

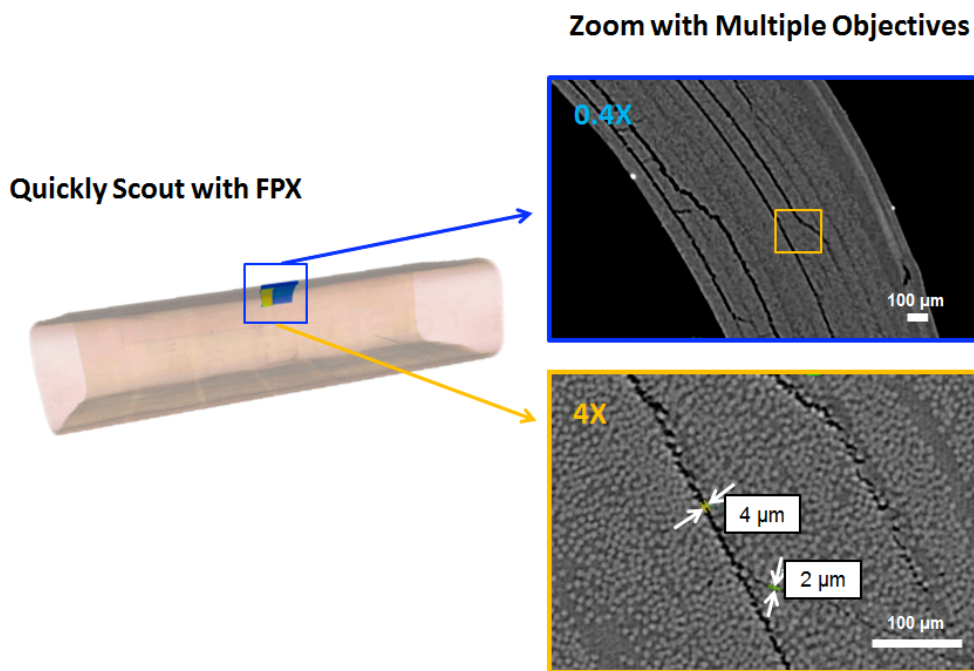
Failures in fiber-reinforced composite materials are often the result of delaminations occurring at the interface of fiber-rich and resin-rich regions. While these failures are known to occur and are often encountered in computational simulation studies during composite design, visualizing and characterizing the nature of these cracks is extremely challenging using conventional techniques. Traditional characterization with light- and electron-microscopy require 2D polished sections in order to produce high quality images of the failure sites, which require some knowledge about the failure location prior to performing the characterization. The failures are also often complex 3D cracks that wind around the fibers, which require a 3D characterization protocol in order to be properly understood.

Figure 2. Zooming-in with high-resolution 3D X-ray microscopy reveals the precise nature of the defects, between fibers and along fiber domain interfaces.
