## Metallography – A Powerful Instrument for Material Characterisation, Material Development and Failure Analysis

<sup>1</sup> Department of Physical Metallurgy and Materials Testing, Montanuniversität Leoben, Austria

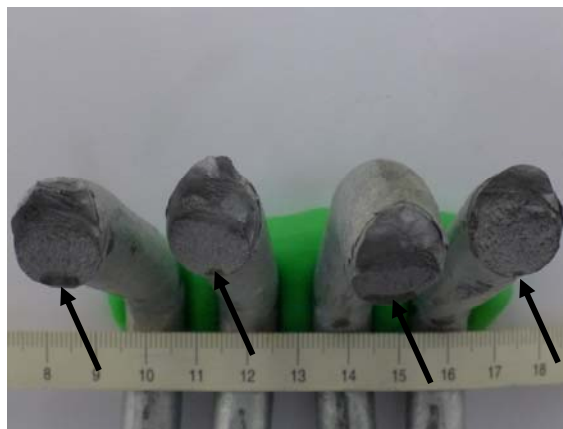
Figure 1 shows an overview of broken supports. Macroscopic investigations reveal dark spots within the crack surface. This indicates that such defects were responsible for the failure of many supports. Further investigations revealed [2] that the area of crack initiation was covered with Zn, which originates from hot dip galvanization. A cut through such broken and unbroken parts in longitudinal direction revealed cracks covered with Zn (Fig. 2). The light-optical micrograph shows the Zn-layer followed by the microstructure of the steel, which consists of ferrite and a small amount of pearlite, as can be seen far away from the Zn-layer. However, it seems that regions near the Zn-layer exhibit a nearly pure ferrite structure. This can be attributed to an effect of decarburisation. The “ferritic” microstructure is caused by the cathodic protection due to zinc during etching with Nital-solution. In this case the cracks can be attributed to a liquid metal embrittlement (LME).

**Figure 1.** Macroscopic overview of the fracture surface. Arrows mark the region of crack initiation (dark spots).

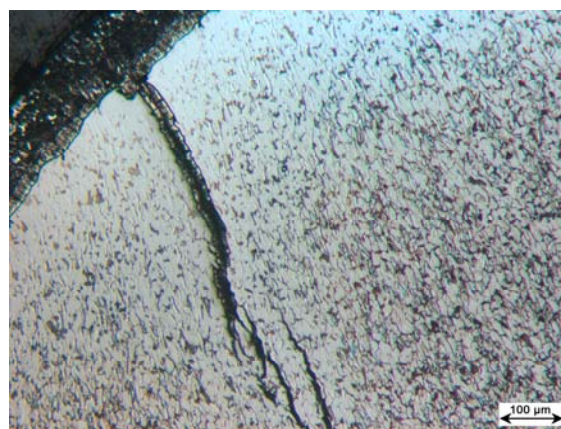
**Figure 2.** Light-optical micrograph of a crack after etching with Nital. The crack surface is covered with zinc.

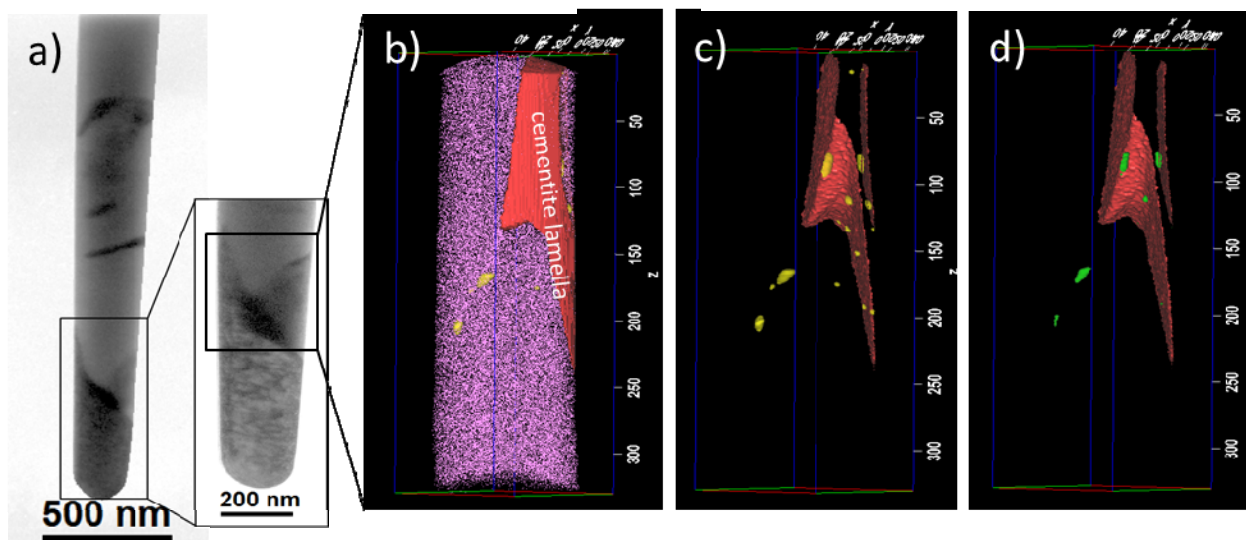
are shown in Fig. 3. The preparation of the tip (Figs. 3a, b) was made by using etching methods and subsequent milling by FIB. The process was controlled by electron back-scatter channelling diffraction (EBSD) to ensure that a grain boundary is in the investigated region. The grain boundaries are covered with precipitates of Cu and Sn (Figs. 3c, d). Additionally, ternary cementite is visible.

**Figure 3.** TEM images (a) of an atom probe tomography (APT) specimen (prepared by FIB) of a broken support. The results reveal fine Cu- and Sn-rich precipitates at the grain boundaries between a cementite lamella and the iron  $\alpha$ -matrix. Fe atoms are shown in pink (b), Cu isosurfaces in yellow and Sn isosurfaces in green. The grain boundary between the cementite lamella and the iron  $\alpha$ -matrix is indicated in red color in (c) and (d).
