Characterization of the Hydrogen Damage in an API 5L X52 Steel by Scanning Electron Microscopy

R. Réquiz*, S. Camero** and A. L. Rivas*

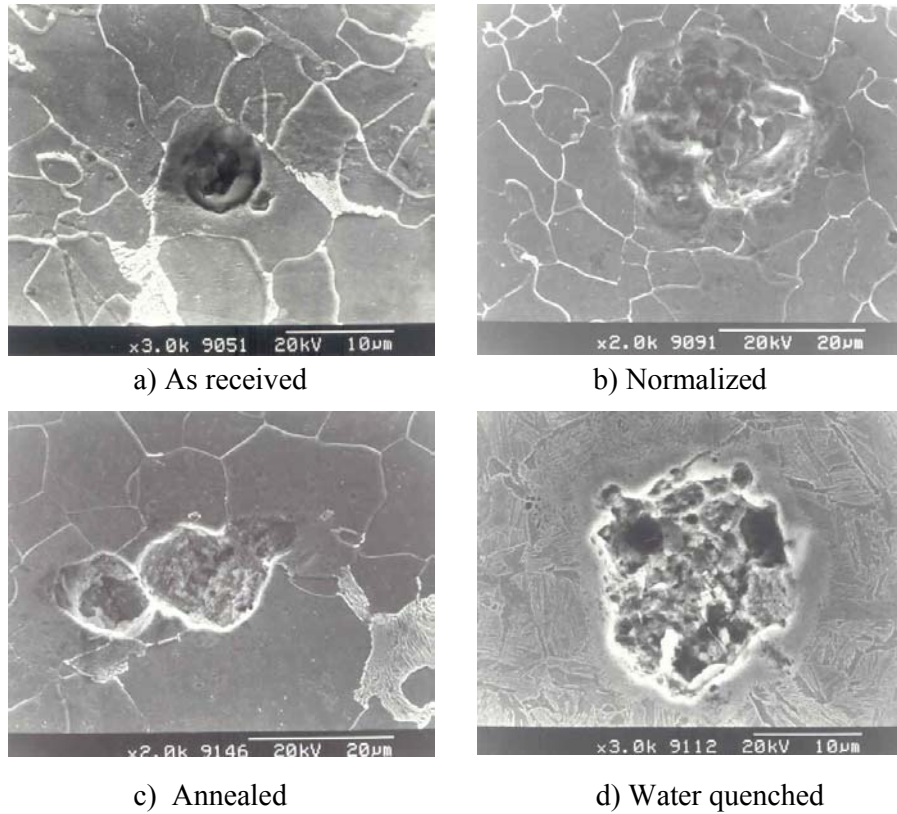
FIG. 1. SEM micrographs showing the blisters present in charged samples.

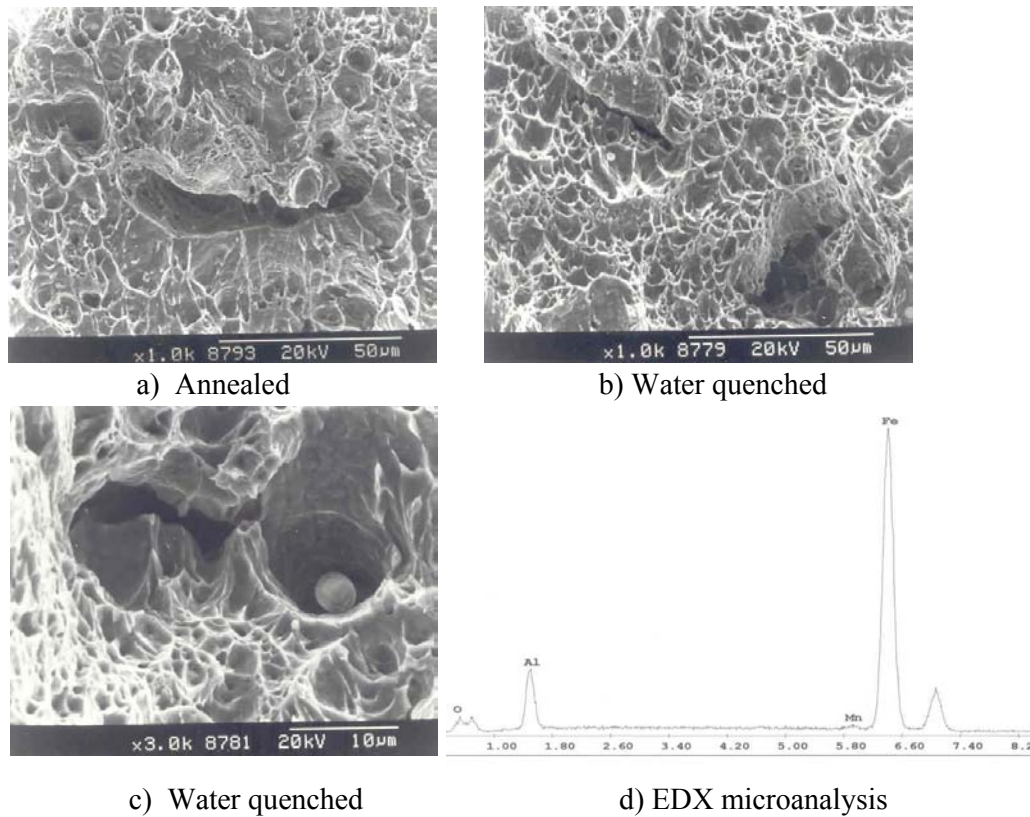
Microstructural characterization and a fractographic study were carried out in the as-received and heat treated samples, previous and after the exposition to the test solution. The samples in the as received, normalized and annealed conditions have the same type of microstructure, comprised mainly by ferrite grains and pearlite, as expected. They only differ in the ferrite grain size and the pearlite amount. The water quenched sample showed a martensite-type of structure. All the tested samples were susceptible to hydrogen damage after 3 hours of exposition in the above mentioned condition. The severity of the hydrogen damage was greater in the quenched and complete annealed samples, followed by the as-received condition and normalized ones. The damage was present in the form of blisters with diameters between 5 and 350 μm related to the presence of aluminum inclusions - fig. 1(a-d). The fracture mode in the samples no subjected to the hydrogen environment, was microvoid coalescence, while for the complete annealed and quenched samples after 3 hours of exposition, the fracture appearance was a mixture of faceted dimples and quasi cleavage – fig 2(a-b). Some inclusions were associated to the dimples as has been shown in the fig. 2c for a water quenched sample. According to the chemical composition reported in the EDS microanalysis, the inclusions are rich in aluminum (fig. 2d).

FIG. 2. SEM fractographs showing cracks, faceted dimples, quasi cleavage and aluminum inclusion associated to the dimple in charged samples.
