Failure Analysis of Trace Elements and Surfaces Using Hitachi Dedicated STEM

C. Vartuli^{1*} and B. Tracy² and Jitty Gu²

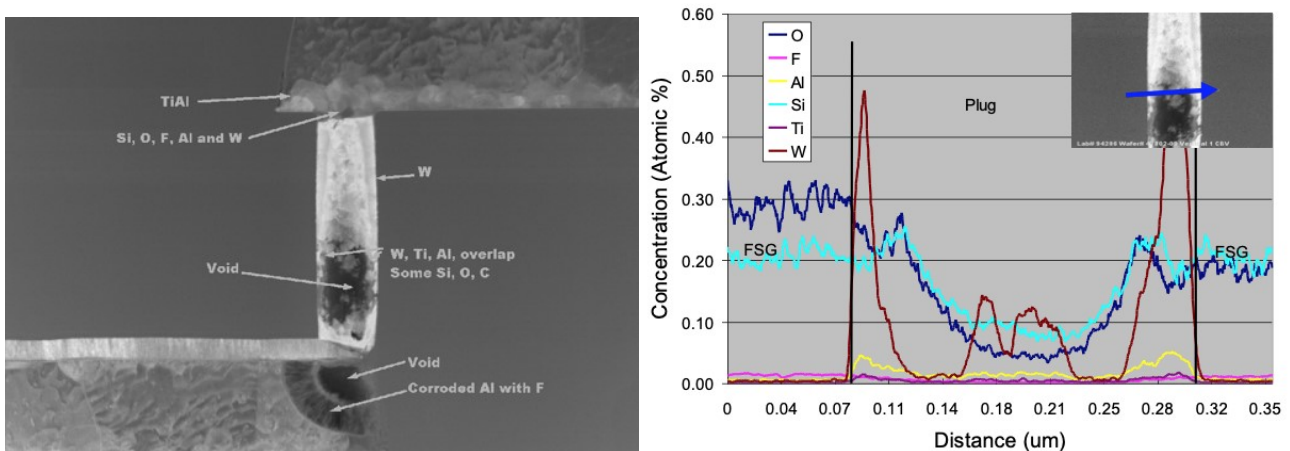
Determining the root cause of corrosion or contaminant defects quickly and accurately is routinely done by Energy Dispersive X-ray (EDX) in SEM or STEM. In some cases, the concentration of the element causing the failure may be very low. In the case of corrosion caused by F, for example, the mobility of the F ions under the beam during preparation and examination can quickly reduce the concentration below detectable levels. In Figure 2a the STEM image of a corroded via is shown with the corresponding elemental analysis. Only trace F contamination remains due to the mobility of the ions, and special care is needed to optimize preparation and analysis of the site to preserve the evidence.

Figure 2. Corroded via and 2b. corresponding elemental analysis to identify the root cause.
