## FLOOD AND LANDSLIDE EVENTS, PEYTO GLACIER TERMINUS, ALBERTA, CANADA, 11–14 JULY 1983

By P. G. JOHNSON

and J. M. POWER

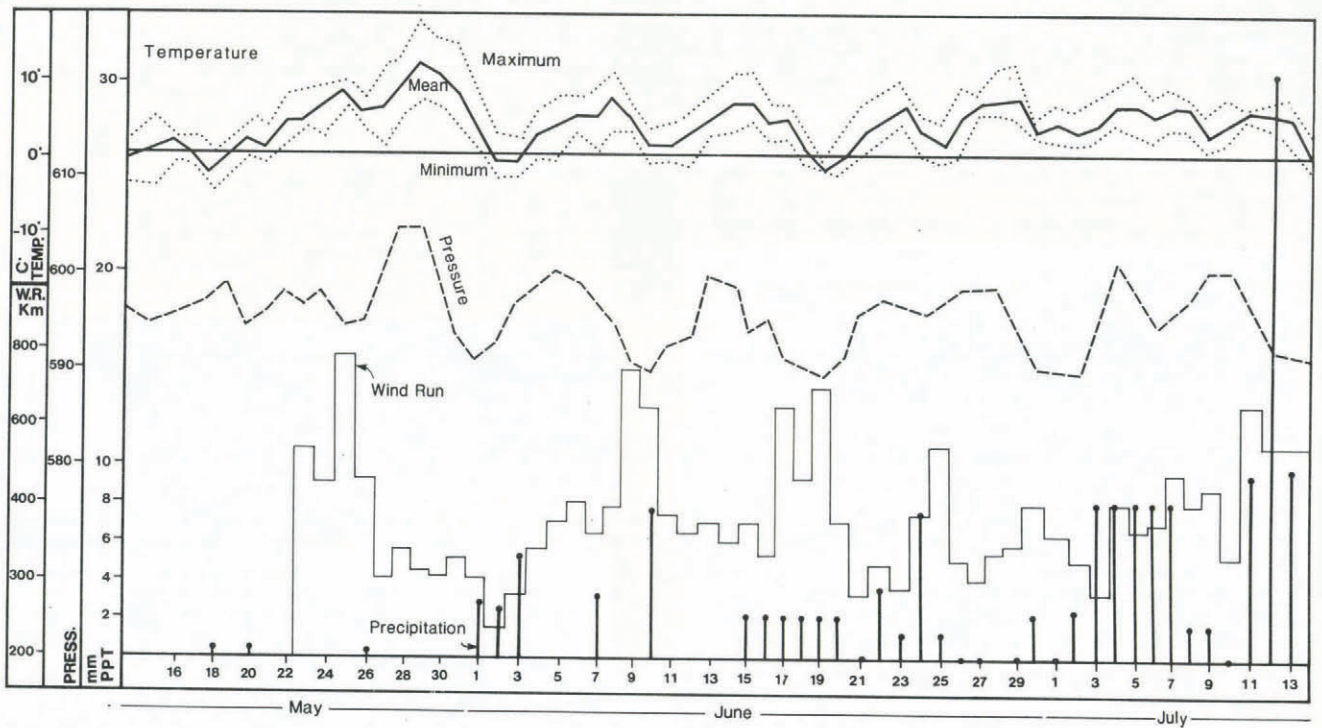
Fig. 2. Summary of the climatic conditions of summer 1983 leading up to the floods and landslide of 11-14 July.

During the 1983 season records were maintained at the glacier between 14 May and 13 September. From 19 May to 30 June the climatic conditions reflected the typical patterns which occur in the high basins of the Rocky Mountains. A series of low-pressure systems crossed the area with associated temperature and precipitation fluctuations (Fig. 2). The only climatic variation of note was the prolonged influence of up-valley winds in early June associated with the rapid drop in pressure between 29 May and 1 June. Total precipitation during the early season can be classed as normal with maxima of 7.6 mm on 10 June and 24 June but with no extreme events. Commencing 2 July there were two weeks of unusual weather conditions which culminated in the events of 11 to 14 July. On 2 July pressure started to rise and stayed relatively high without any rapid changes. Temperature in this period was unusually constant with mean daily values between 6°C and 3°C. Average humidity was about 60% through the period. The precipitations pattern, however, was exceptional. Steady precipitation between 2 and 8 July resulted in a total of 44 mm. During 11 and 12 July the area was on the edge of a major storm to the west which contributed 30 mm (measured) with wind speeds between 30 km h<sup>-1</sup> and 40 km h<sup>-1</sup>. This precipitation caused rapid run-off from the glacier surface and from the adjoining basin already saturated from the 2 to 8 July rainfall. During 12 and 13 July the rainfall abated slightly but the area still received a further 9.7 mm. During the night of 13 to 14 July an intense thunderstorm contributed an additional 15.5 mm of rain concentrated into a 2 h period. The total precipitation for the first two weeks of July was in excess of 100 mm.

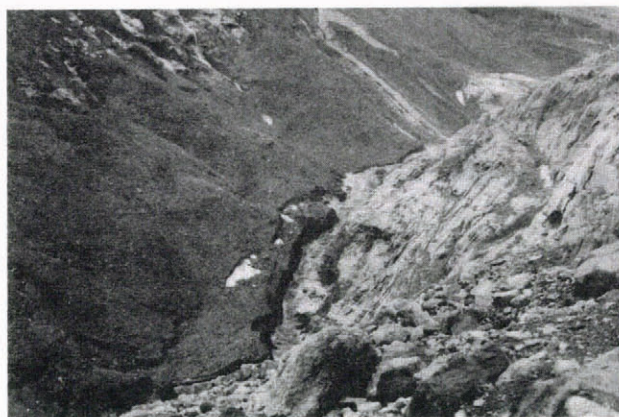
Fig. 3. The ice-cored moraine after the flood of 11-12 July. Note the flood plain surface in the lower left quadrant, the incision of the stream into the ice core, and the mud-flow activity on the moraine in the upper right quadrant.

tunnel was unable to accommodate the increasing discharge and the water backed up above the entrance. The resultant pond in the gorge attained a depth of about 30 m before overflowing across the ice-cored moraine surface. The overflow rapidly developed into a flood wave removing the till cover of the moraine and initiating erosion of its ice core (Fig. 3). The flood wave cascaded over the end of the ice-cored moraine, through the gorge waterfall sections of the channel and across the National Hydrology Research Institute (N.H.R.I) stream-gauging site. The flood wave destroyed most of the gauge site, removing all instrumentation and leaving standing only the stilling well. The stream course also changed, migrating towards the east side of the valley. Figure 4 shows the gauging site at midday on 12 July. The large, white-painted, survey boulder in the left-centre of the photograph was sited 30 m away from the pre-flood stream course. The pond in the upper gorge remained full and discharged over the moraine throughout the 12 and 13 July. Run-off from the east side of the valley started the degradation of the ice-cored moraine at the higher moraine trim-line. Debris from collapse of this moraine and from small mudflows initiated across the ice core were gradually infilling the pond (Fig. 5). During 12 July this infilling totally sealed off the old entrance to the stream tunnel channel. The new surface stream was rapidly incising into the ice core and inducing slumping of till off the rest of the moraine.

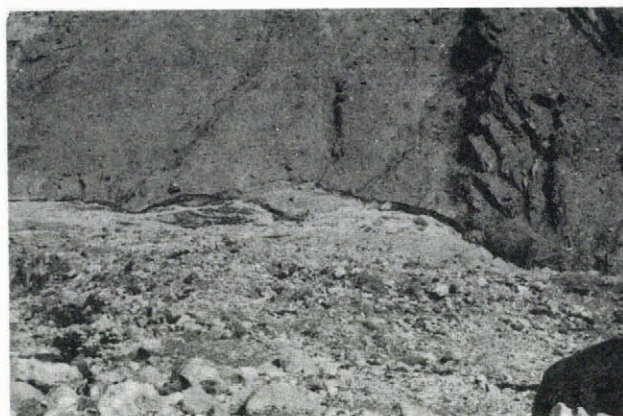
Fig. 4. The gauging site after the initial flood event. Note the position of the white-painted survey boulder. (Two figures on the point of the gravel bar in the centre of the photograph provide scale).

These changes can be illustrated by reference to Figures 4 and 9 and using the white painted survey boulder as the point of reference. Prior to the flood of 11-12 July the boulder was 30 m from the stream which had a course against the west side of the valley (nearest

the camera in the Figures). After the flood the stream course had migrated to the east side of the valley, some deposition had occurred at the site but the stilling well was in place. The flood wave had eroded close to the position of the survey boulder. The flood of 13-14 July after the landslide deposited 2-3 m of gravel and boulders over the whole site ripping apart the stilling well and undermining the surveying rock which subsequently rolled 2 m down-slope. One section of the stilling well was found 600 m down-valley. Fresh deposition or reworking of the river gravels occurred for up to 800 m down-valley and the remains of the equipment from the gauging site were distributed down to the shore of Peyto Lake. Pieces of the steel cable which had been used to anchor the stream gauge had cleanly cut ends and remains of the wire gabions used to protect the stilling well were transported 1 km from the site.

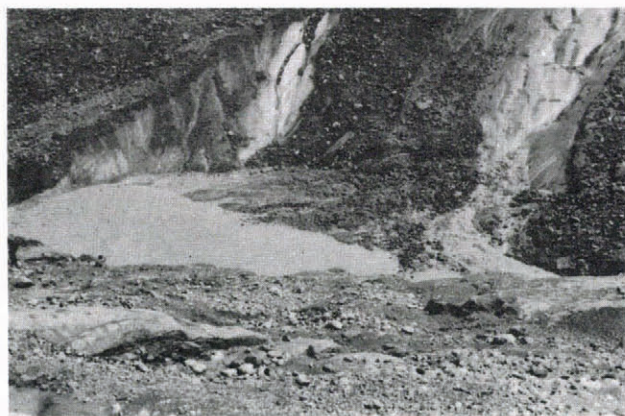
Fig. 5. The pond in the gorge above the ice tunnel infilling with mudflow debris on 12 July.

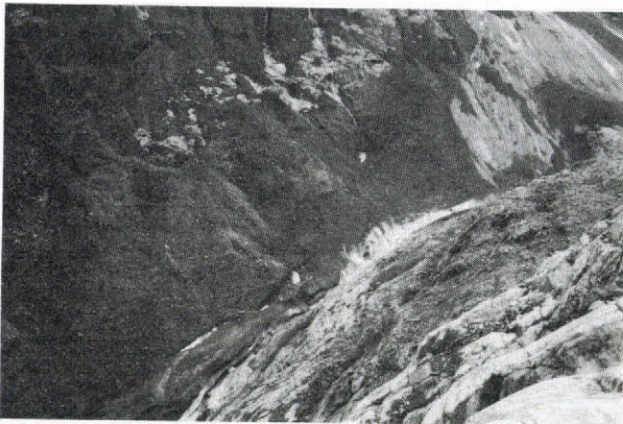
Fig. 6. The ice-cored moraine after the landslide and the flood. Note the meandering track of the landslide across the moraine, re-incision of the stream into the ice core, and the total exposure of the ice in the upper right quadrant of the photograph. Comparison with Figure 3 demonstrates the magnitude of the ice exposure.

moved down-slope (upper right Fig. 6). At the base of the slope the slide divided about a rock bar into two sections, one moving across the outwash at the glacier terminus and partially up on to the terminus (Fig. 7). The second diverted down-valley (Fig. 6) filling the pond site (Fig. 8) and flowing across the ice-cored moraine as far as its terminus (Fig. 6). The result was the damming of the discharge at the glacier terminus and above the ice-cored moraine. The release of these dams, occurring during the night but inferred to be a release at the glacier followed rapidly by a release down-valley, produced a flood wave of rock and mud down the valley and across the old gauging site, totally obliterating the remaining equipment. Material was initially deposited up to 5 m deep in the gorge above the gauge but this was subsequently swept away. Roughly 2–3 m of rock were deposited over the gauging site for a distance of 100 m and thinning down-valley for a further 300 m. The total estimated deposit was 6000 m<sup>3</sup> of gravel. The configuration of the gauging site on the morning of 14 July is illustrated by Figure 9 with the bulk of the gravel in the lower centre of the photograph. For comparison with Figure 4 the position of the survey boulder should be noted. In Figure 9 the boulder has been displaced 2 m down-slope.

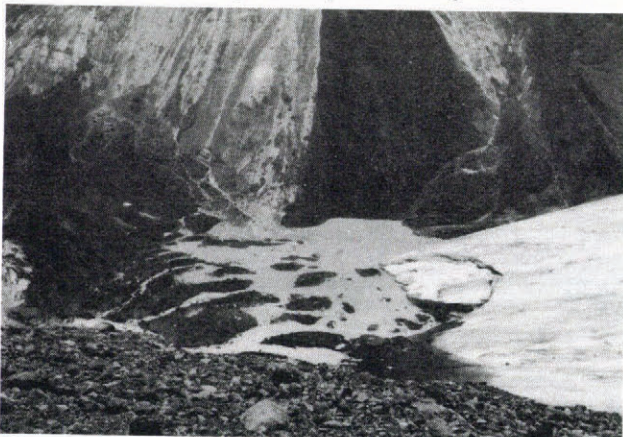
Fig. 7. The landslide debris across the terminus of the glacier.

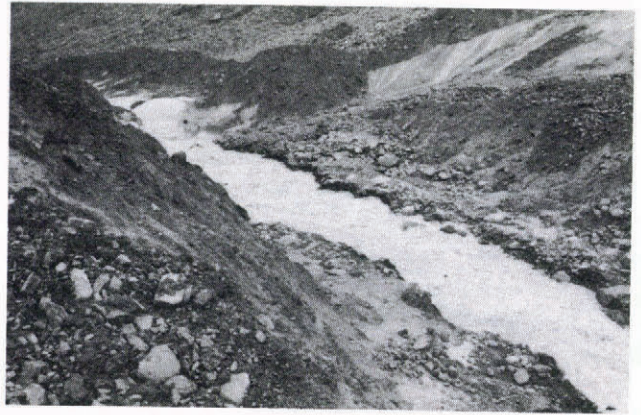
Fig. 8. The pond site in the gorge infilled by landslide material on 14 July. The stream has established a course across the landslide debris.

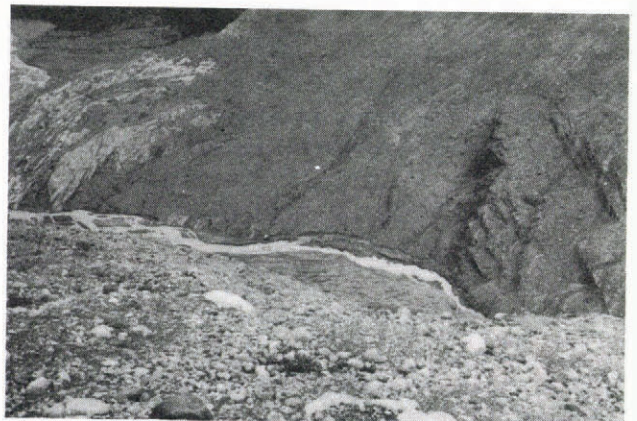
Fig. 9. The gauging site after the landslide and flood event Note the change in position of the survey boulder and the changes in the stream channel.

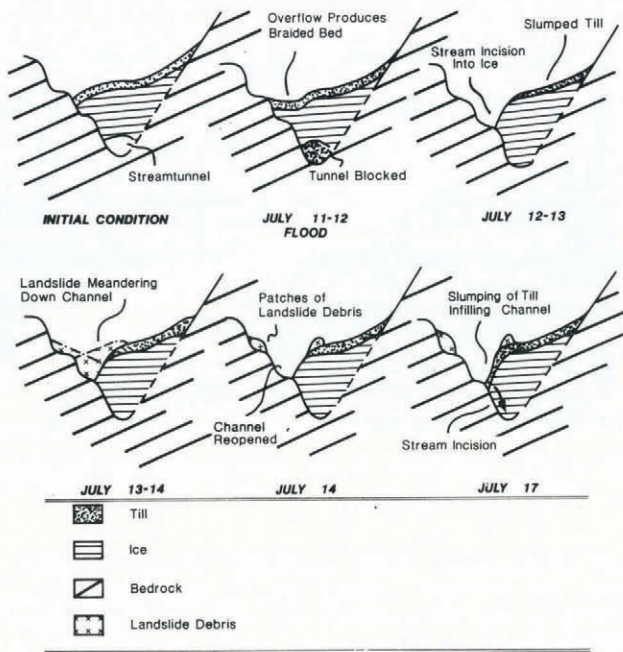
Fig. 10. Diagram of the changes at the ice-cored moraine.

**CHANGES AT THE ICE-CORED MORaine (Fig. 10)**

The overflow of the moraine by the first flood, which incised into the ice, was followed by complete blockage of the channel by the landslide moving down-valley. It was finally re-opened as the second flood wave removed the landslide debris and recommenced incision into the ice core. This incision

had progressed sufficiently by 17 July to allow debris slumping off higher portions of the moraine to partially infill the channel.

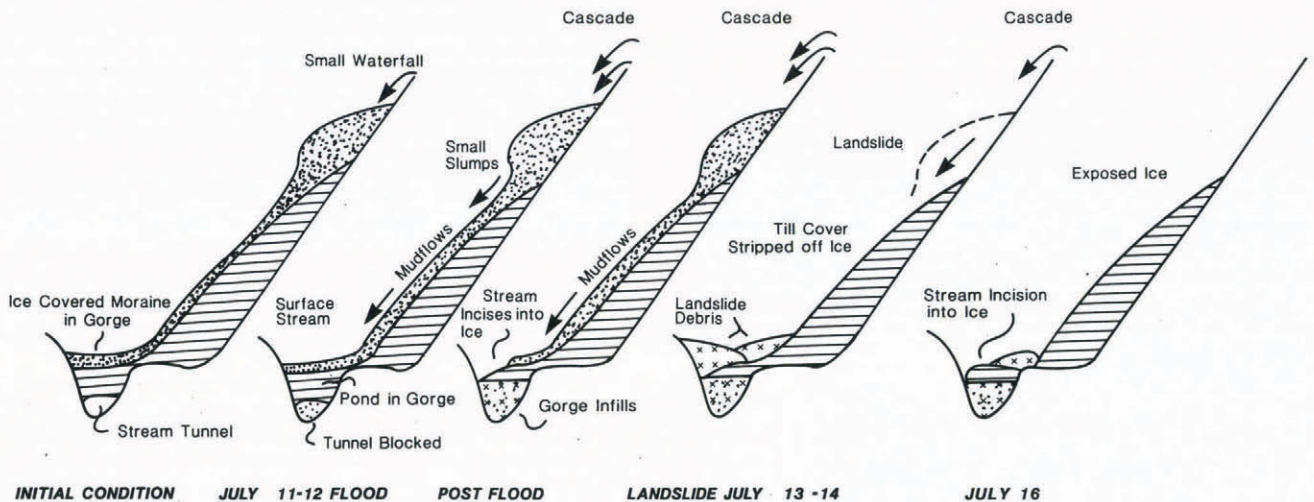
Fig. 11. Diagram of the changes at the glacier terminus.

CHANGES AT THE GLACIER TERMINUS (Fig. 11)

The main changes at the glacier terminus were the exposure of the ice core of the deposits on the east side of the valley, initially on a small scale by the mudflows over the ice core but primarily as a result of the massive landslide of 13-14 July. Landslide debris covered the immediate glacier terminus area to depths of 2 m and this modified the drainage pattern from the glacier. The slide also flowed down-valley and was eventually removed by the flood wave as described above.
