Wire marking reduces bird collisions with a transmission powerline in western Belgium

Research Article

Cite this article: Verbelen D, Bovens W, Dwyer JF, Swinnen K (2024). Wire marking reduces bird collisions with a transmission powerline in western Belgium. *Bird Conservation International*, **34**, e25, 1–10
<https://doi.org/10.1017/S0959270924000169>

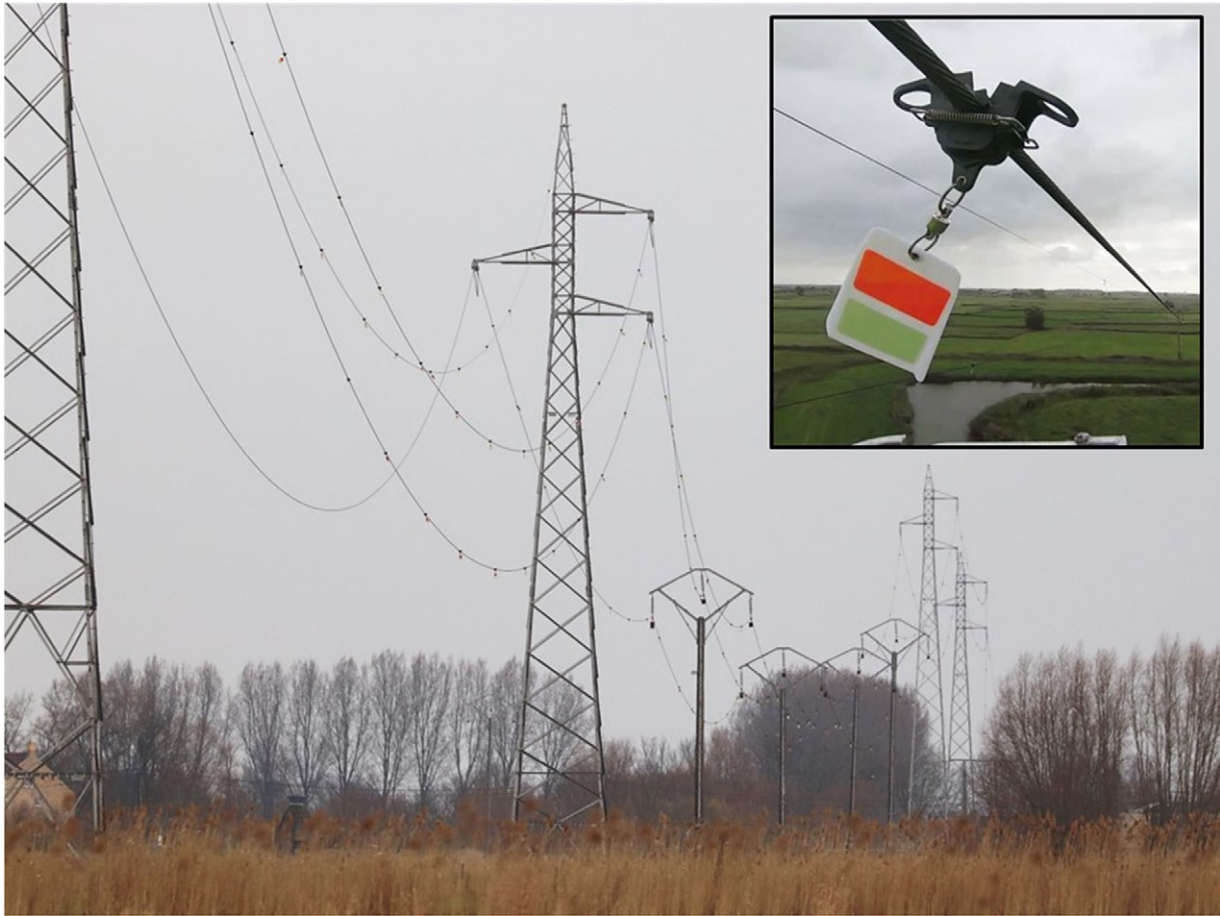
Figure 2. The study area included two pylon configurations. A taller configuration with a shield wire supported five spans at the south end, and a shorter configuration without a shield wire supported five spans at the north end. (Photo credit: James F. Dwyer.)

In October 2019, Elia installed 302 line markers at 30-m spacing on each marked wire, with markers offset by 10 m on each of three marked wires in each span. This created a visual effect of 10-m spacing. Elia installed the FF model of FireFly because the FF was an active (moving) device which spun and fluttered in wind, presumably increasing visibility to birds compared with alternative passive line markers that lacked movement. On the southern five spans (supported by tall pylons), Elia installed line markers on the shield wire and on the upper and lower conductors, i.e. all wires accessible from the west. This left the middle conductor unmarked. On the northern five spans (supported by short pylons), where no shield wire was present, Elia installed line markers on all three conductors.

The spans we studied were of two different configurations: tall spans with shield wires, and short spans without shield wires. Prior to line marking, 97 collisions (68% in 2001 and 2018 combined) occurred on spans supported by tall pylons with shield wires, and 46 collisions (32% in 2001 and 2018 combined) occurred on spans supported by short pylons without shield wires (Table 3). After line marking, six collisions (100% in 2021) occurred on spans supported by tall pylons, and none (0%) occurred on spans supported by short pylons. Thus, in 2021, FireFly line markers correlated with an observed mortality reduction of at least 73% and up to 100%, depending on the configuration.

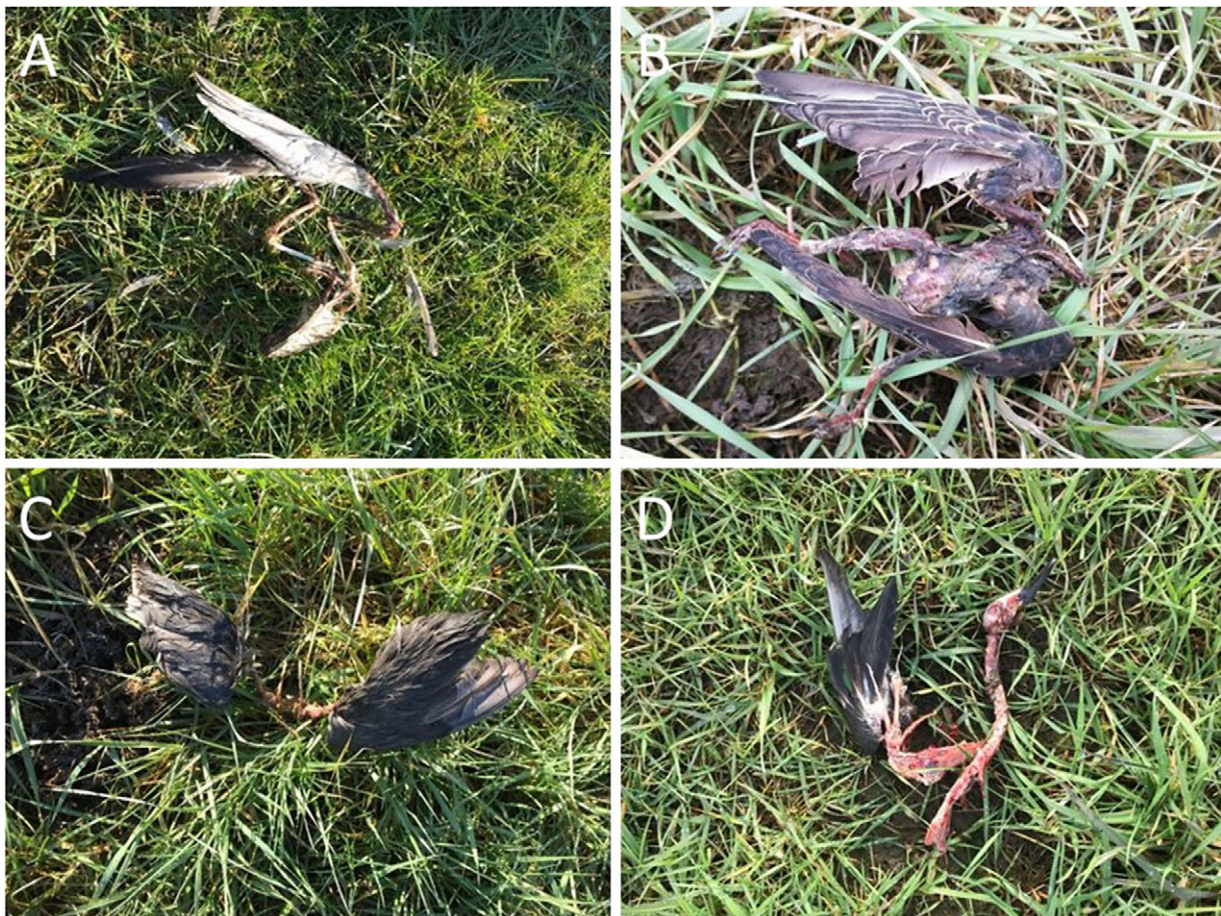
Figure 3. Examples of avian carcasses found in 2021 attributable to Peregrine Falcon predation in which the breastbone and the wings were connected by the shoulder girdle and all muscle had been consumed. (A) Common Pochard *Aythya ferina*; (B) Common Starling *Sturnus vulgaris*; (C) Common Coot *Fulica atra*; (D) Eurasian Teal *Anas crecca*. (Photo credits: Filip Declerck.)

Peregrine Falcons were likely present in the area in 2001 but were not considered as a cause of mortality for the carcasses collected. Presumably some carcasses in 2001 should have been attributed to Peregrine Falcon predation, but because Peregrine Falcons were relatively rare at that time, the biasing factor is likely low. In 2018 and 2021, 23 and 11 carcasses were attributed to Peregrine Falcon predation, respectively (Figure 3), and were removed from the data set to avoid over-counting carcasses attributable to collisions.
