Improvements in long-term output energy performance of Nd:glass regenerative amplifiers

Peng Zhang, Youen Jiang, Jiangfeng Wang, Wei Fan, Xuechun Li, and Jianqiang Zhu

National Laboratory on High Power Laser and Physics, Shanghai Institute of Optics and Fine Mechanics, Chinese Academy of Sciences, Shanghai 201800, China

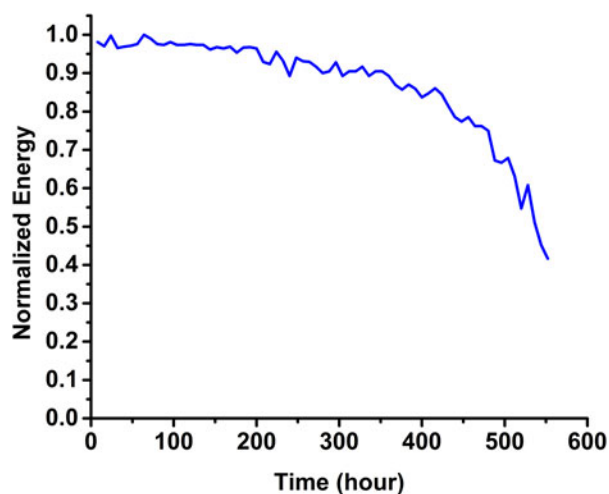
Although the regenerative amplifier has excellent energy stability, its output energy will gradually drop after a long-term operation. And the energy decreases faster as operation time grows. Figure 1 displays the output energy of the regenerative amplifier over a 3.5-month period, which has dropped by almost 60%. To our knowledge, this is a common problem for most high-power solid-state lasers and is the most severe challenge to apply them in large laser systems.

Figure 1. Normalized output energy of the regenerative amplifier as a function of time over a 3.5-month period.

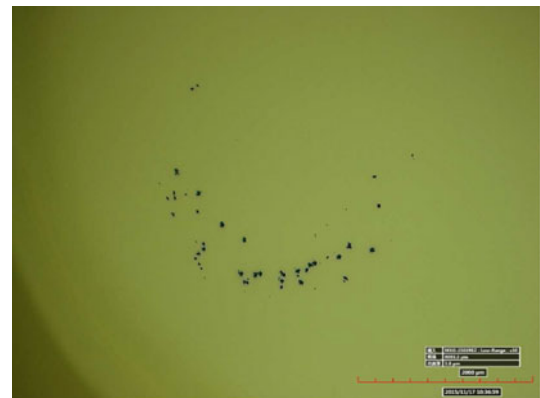
Figure 4. Morphology of the whole damage sites of WG surface of PC in the Regen.

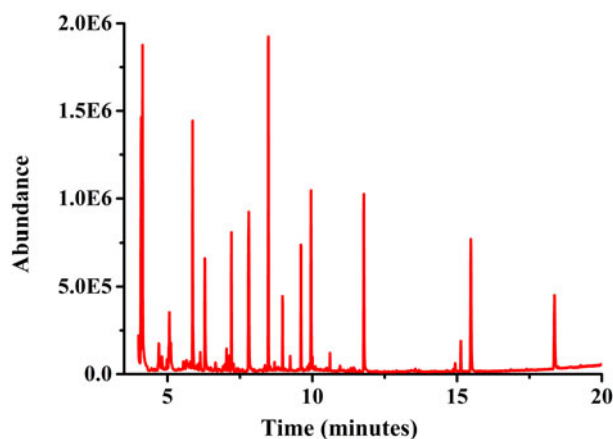
Figure 7. The TIC for the AMC sampling made in the Regen cavity.

The total ion current chromatogram (TIC) is shown in Figure 7. The top ten AMCs in the sample, whose concentrations were highest, are listed in Table 2. Concentration of each AMC is less than 10 ppbv, and the total AMC concentration in the sample is a mere 42 ppbv, almost in the same order of magnitude of that in a general air environment, which indicates that the outgassing of organic materials in the Regen is at a very low level.

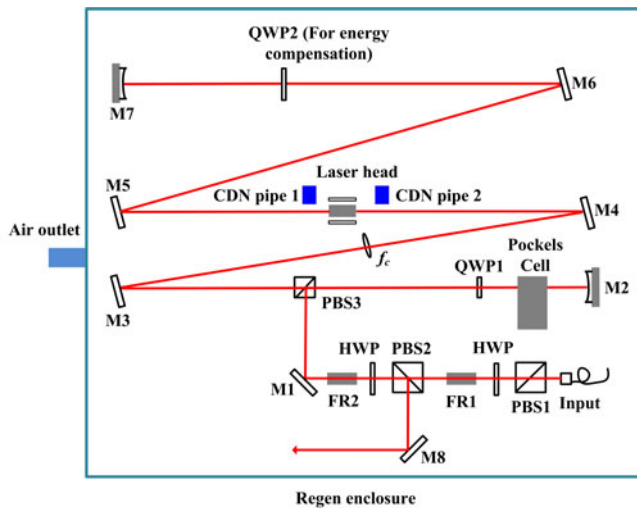
Figure 8. The regenerative amplifier with a CDN purge system, which is installed in the Regen cavity.

The layout of the regenerative amplifier with a CDN purge system is shown in Figure 8. Two clean stainless steel pipes are installed near both ends of the Nd:glass laser head, which suffers from LIC frequently. CDN with the cleanliness level less than Class 10 standard is purged into the Regen cavity by these two pipes. The flow rate of CDN purge system is 3 L/min. However, as is shown in Figure 9, when the Regen worked, its output energy declined more than 10% after 26 h of operation, much faster than it used to. Then the energy was compensated to its initial value by QWP2, which had preattenuated output energy of the Regen, but the energy decreasing rate still remained the same.

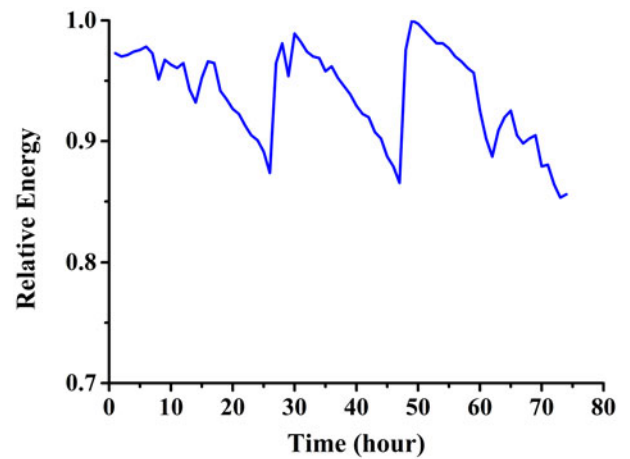
Then we turned off the Regen, and uncovered its enclosure. It was found that almost all the optical components with antireflective (AR) coatings were damaged on surfaces. All these damages had been proved to be organic deposits by the optical microscope and Raman spectrometer. It should be mentioned that no deposits have been discovered in reflecting mirrors. And the reason for this may be that the energy fluence on the surfaces of reflecting mirrors is almost twice as much as that on AR coatings, since energy fluence had been enhanced by incident beam and reflected beam, and the high fluence laser beam cleaned the deposits

Figure 9. The output energy of the Regen with a CDN purge system working versus time.

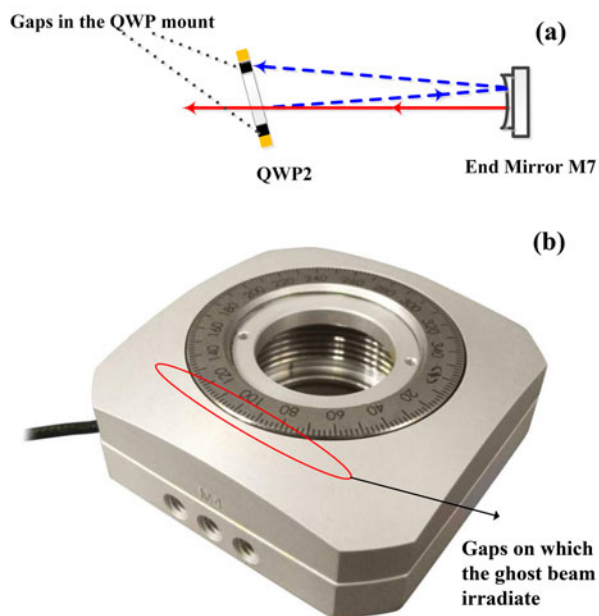
It was observed that a fraction of the laser beam (about 0.5%), which propagated from the second end mirror M7 to QWP2, was reflected by the second surface (S2 surface) of QWP2 with AR coatings, as shown in Figure 10(a). The reflective beam, which reflected from S2 surface of QWP2, is called ghost beam. This ghost beam was first transmitted to M7 and reflected by it. And finally, the ghost beam illuminated on the gap of the rotation stage, in which QWP2

Figure 10. (a) The diagram which describes that the ghost beam irradiates on the gap of the rotation stage of QWP2. The solid red line represents the propagation of the main laser beam, and the dashed blue line represents the propagation of the ghost beam generated by reflection of the main beam from a surface of QWP2. (b) A photo of rotation stage.

was mounted, as shown in Figure 10(b). There was a lot of vacuum compatible grease in the gap. Although the energy of the ghost beam was as low as $50 \mu\text{J}$, its energy fluence was almost on the same level as energy fluence of the main laser beam (1 J/cm^2), since it was focused twice by the concave end mirror M7. This fluence is high enough to generate aerosols.

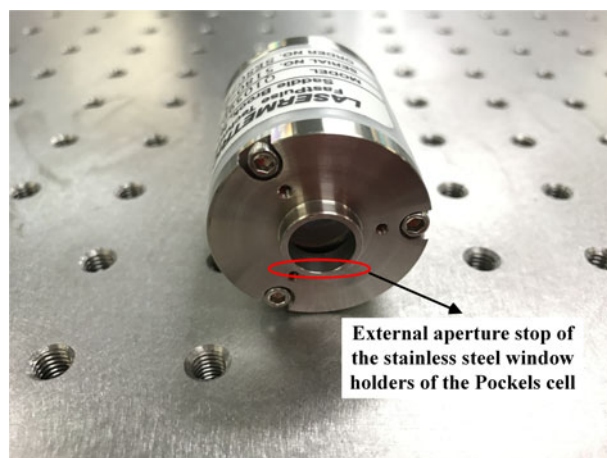
Subsequently, it was discovered that in the vicinity of each damaged optical component, ghost beams can be found illuminating on organic materials. For instance, we found that the external aperture stop of the stainless steel window holders (shown in Figure 11) of the damaged PC (Fastpulse Technology, Inc.) was not clean enough. There was a lot of residual lubricant on the aperture stop. The lubricant, which should have been cleaned away before the PC left the factory, might be introduced by the manufacturer when the PC was produced. And unfortunately, the aperture stop was illuminated by ghost beams from PBS3 and QWP1, which might produce aerosols near the PC which led to LIC on WG surface of PC. The same situation also existed in the Nd:glass laser head.

Figure 11. A photo of the PC used in the Regen. The external aperture stop of the stainless steel window holders was marked with a red circle.

To verify the conclusion of generation process of LIC in Regens, which was illustrated in Section 3.3, several improvements have been made in the regenerative amplifier: (1) all mechanical components in the Regen, including the ones supplied by manufacturers of optical components (PC supplied by Fastpulse Technology, Inc., for instance), were cleaned by ethanol in a supersonic tank; (2) all ghost beams generated by optical components with AR coatings were found, and blocked by beam traps; (3) all nonmetal materials were shielded by clean aluminum foil.

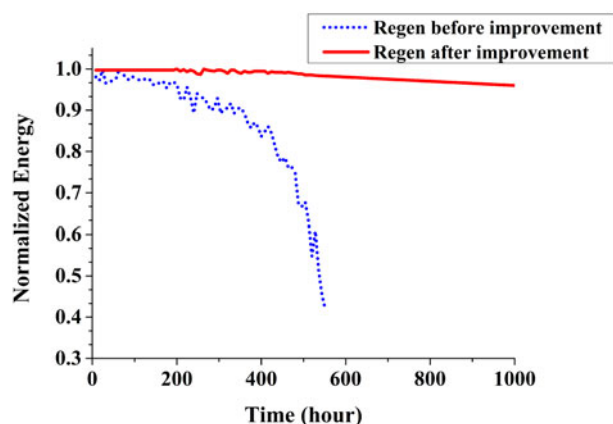
After the regenerative amplifier was modified, it operated for 6 months to examine its long-term output energy performance. The output energy of Regen as a function of time is shown in Figure 12, which illuminates that the decline of Regen output energy after 1000 h of operation is less than 4%, far lower than it used to be. This indicates that laser irradiation on organic materials by ghost beams is the primary cause of energy decrease of the regenerative amplifier in the long-term operation. This operation lifetime meets the requirement for the Nd:glass regenerative amplifier used in high-energy laser facilities.

Figure 12. Normalized output energy of the regenerative amplifier as a function of time before and after improvement.
