Aneurysm Tears Caused by an Aneurysm Clip Springing from the Clip Applier

Can J Neurol Sci. 2017; 44: 326-328

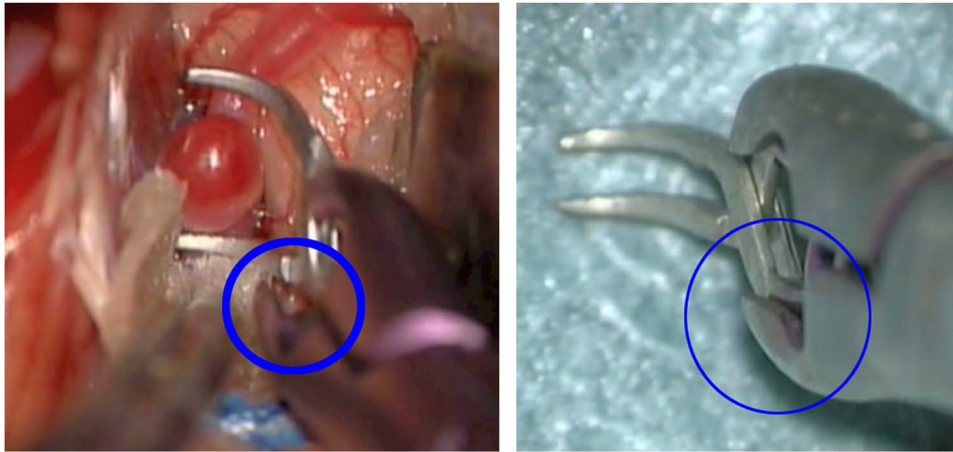
Figure 1: (Left) Intra-operative findings during aneurysm clipping. The proximal right distal anterior cerebral artery (DACA) aneurysm was in the interhemispheric fissure. It was identified, and the aneurysmal neck was dissected. An abnormal space was confirmed between the clip spring and the tip of the applicator (blue circle). (Right) When correctly held, no space should exist between the clip head and applicator (blue circle).

clipped. The unruptured proximal right DACA aneurysm in the interhemispheric fissure was identified, and the aneurysmal neck was dissected. A Yasargil mini-clip applier and an FT 694 T clip were prepared for neck clipping. To confirm the appropriate clip position, a right-handed surgeon opened and closed the clip to place it in the appropriate position (Figure 1, left). When the surgeon had opened the clip sufficiently to position it, the clip suddenly sprang out of the clip applier. The clip abruptly occluded and ruptured the aneurysm. After haemostasis of the ruptured side using three temporary clips for the proximal and distal ACA, the ruptured aneurysm neck was closed with a 10-0 suture. Preservation of blood flow to the distal artery was verified using indocyanine green video angiography (ICGVAG). After the operation, no ischaemic change in the frontal cortex was apparent based on diffusion-weighted imaging on postoperative day 3. Blood flow through the DACA was confirmed using cerebral angiography (Figure 1, right). The patient was discharged without neurological deficit.

In case 1, the incident was caused by an incorrectly held aneurysm clip, as identified during replays of the intra-operative videos (see supplemental video and Figure 1). A space was present between the clip spring and the applicator tip (Figure 1, left). When correctly held, no space should exist between the clip head and the applicator (Figure 1, right).

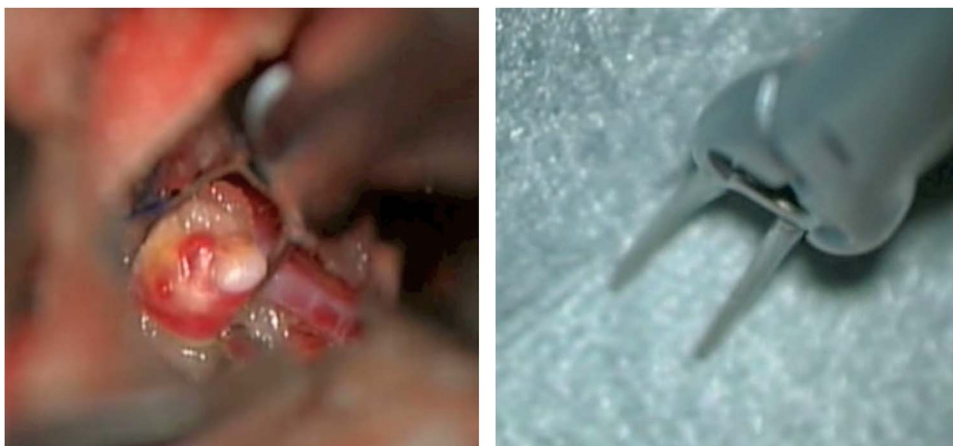
Figure 2: (Left) Intra-operative findings during aneurysm clipping in second case. An anterior communicating artery aneurysm in the interhemispheric fissure was identified. No abnormal space was confirmed between the clip spring and the tip of the applicator. (Right) When correctly held, no space should exist between the clip head and applicator.

In case 2, incorrect gripping was not identified (Figure 2) during review of the intra-operative video, but repeated opening and closing of the aneurysm clip took place during clip placement. Since the surgeon was grasping the clip applicator in a downward manner (Figure 3, left) and repeatedly opening and closing the clip applicator, the clip might have been pulled by gravity until it slipped out of alignment with the applicator tip. This misalignment might be the cause

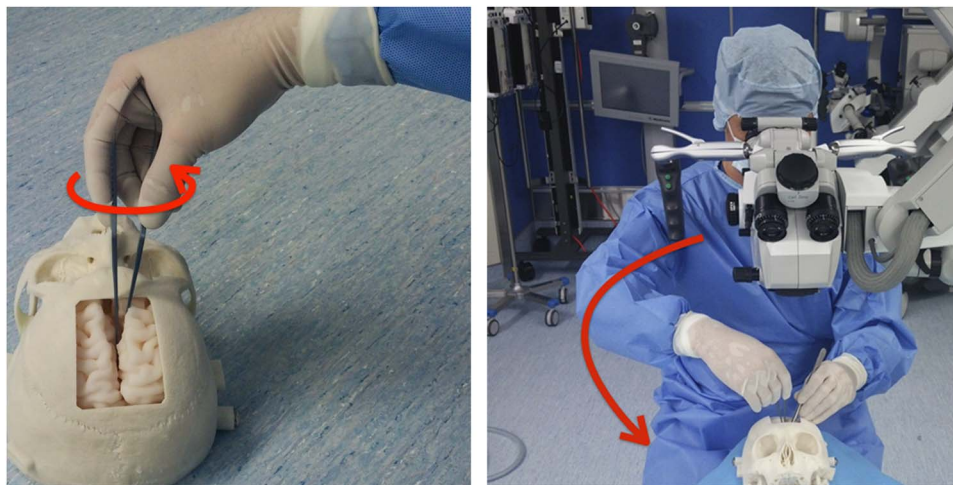
Figure 3: (Left) This picture shows the positional relationship between the surgeon's hand, clip applicator and torque direction (red arrow). (Right) This picture indicates the surgeon's hand posture, the direction of the clip applicator, and the patient's head position. This torque could have been reduced by the surgeon changing position to the right side (red arrow).

of ejection from the applicator. This experience indicates that when the surgeon grasps the clip applicator in a downward manner and repeatedly opens and closes the clip applicator, care is required to ensure that the clip does not slip from the applicator due to contact with surrounding tissues. In addition, some degree of torque in the clockwise direction (Figure 3, right) was placed upon the aneurysm clip applicator as a result of the right-handed neurosurgeon using the applicator. This torque could have been reduced by the surgeon changing position to the right side (Figure 3, right, red arrow). The clip applicator in use was more than 10 years old and had been used in ~700 cases. The influence of wear and tear was also considered, but, according to the survey results of the manufacturer, there was no evidence of deterioration in the body of the clip applicator. In the second case, there was no breakdown in the clip or applicator, and the clip was held correctly, but there is a possibility that the manner of use caused the accident.
