GLACIOLOGICAL PROBLEMS SET BY THE CONTROL OF
DANGEROUS LAKES IN CORDILLERA BLANCA, PERU.
I. HISTORICAL FAILURES OF MORAINIC DAMS,
THEIR CAUSES AND PREVENTION

ABSTRACT. The retreat of glaciers since 1927 in Cordillera Blanca has produced dangerous lakes at the front of many glaciers. All the known data, most of them unpublished, are reviewed. The known *aluviones* are listed, and those of Chavín, Quebrada Los Cedros and Artesoncocha described in full. In these three cases a breach in the front moraine came from big ice falls into the lake. The protective devices made on the outlets are described, as well as the effects of the big earthquake on 31 May 1970. In the case of Laguna Parón, which keeps its level thanks to infiltrations, the fluctuations of the discharge of the springs as related to the level of the lake from 1955 to 1969 are reported. The projects for lowering the level of Laguna Parón and for emptying Safuna Alta are described. The latter partially emptied in fact by piping after the earthquake, allowing a final solution.

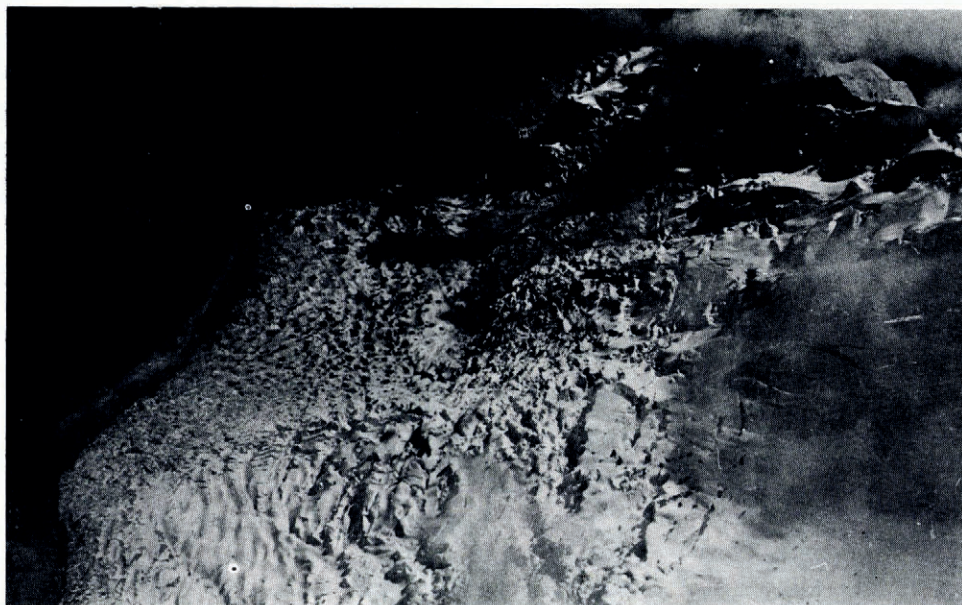
Fig. 3. Glacier Kogan (north-east face of Alpmayo), with many small ponds of water on its tongue. Below (upper left), Laguna Jancarurish. (Picture from helicopter by L. Lliboutry, May 1969.)

Many ponds of water have appeared on Glaciar Kogan, well above Laguna Jancarurish (Fig. 3).

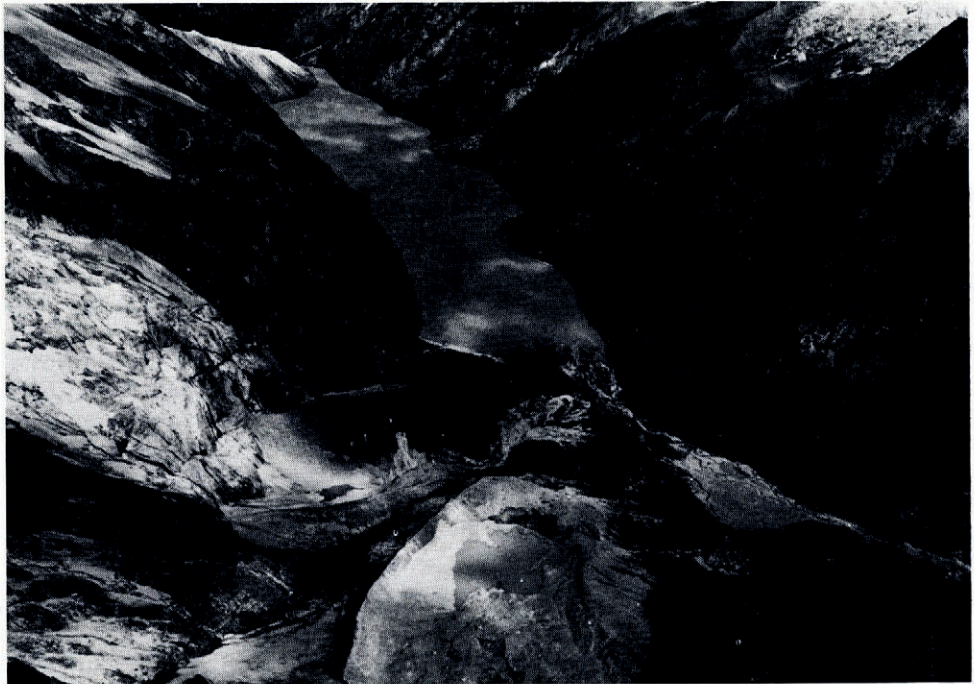
Fig. 4. Laguna Parón from the east. In the foreground, from left to right: Chacrucocha emptied by a breach in the morainic dam, lake 69, and the aluvial fan resulting from the rupture of Artesoncocha. (Picture from helicopter by L. Lliboutry, May 1969.)

Other ruptured lakes may be seen on the aerial photographs of 1948–50: on the eastern glacier of Huascarán (Quebrada Matará, a tributary of Quebrada Ulta), at about 4 450 m; on north-east of Chopicalqui, in Quebrada Shantoc, at about 4 410 m; Allicochoa, on the eastern side of Cordillera Blanca; and behind Laguna Parón, Chacrucocha, which we were able to visit in 1967 (Fig. 4).

With such descriptions in mind, to walk in the break of the frontal moraine through which a lake has emptied, as at Chacrucocha, is an impressive experience. A brooklet now trickles on an avenue of pebbles, 20 to 30 m wide, between two vertical earth cliffs about 50 m high. Down-stream, in the case of a local event such as this one, there is an aluvial fan without sorting, a typical sandur. Many fans in former glacial valleys, previously considered as the result of progressive construction by streams, should in fact be considered as the result of such catastrophic events at the end of the ice age, as proved by the presence of unsorted big boulders embedded at random within them.

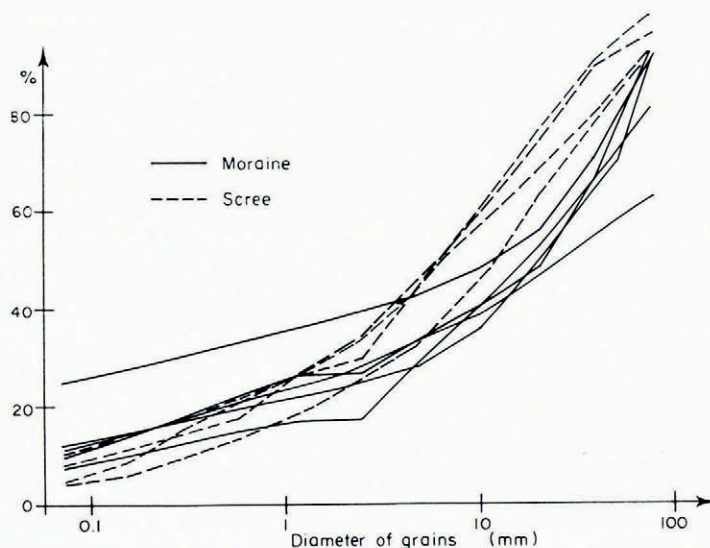
The young morainic dams of Cordillera Blanca, as elsewhere, are formed by a mixture of angular debris of any size, sand and silt, with very little clay. In many parts layers of silty sand and gravel, without any big boulders are found. In Figure 5 the distribution function of the sizes in samples from the moraine surrounding Laguna de Safuna Alta are drawn. There is about 10–15% of fine sand, silt and clay with $\varnothing < 0.2$ mm and 30–50% of pebbles and boulders with $\varnothing > 2$ cm. Thus most moraines are pervious and even when there is an open-air outlet, springs are found at their foot.

Fig. 5. Grain sizes from cores of the moraine of Safuna Alta, and from its veneer of scree.

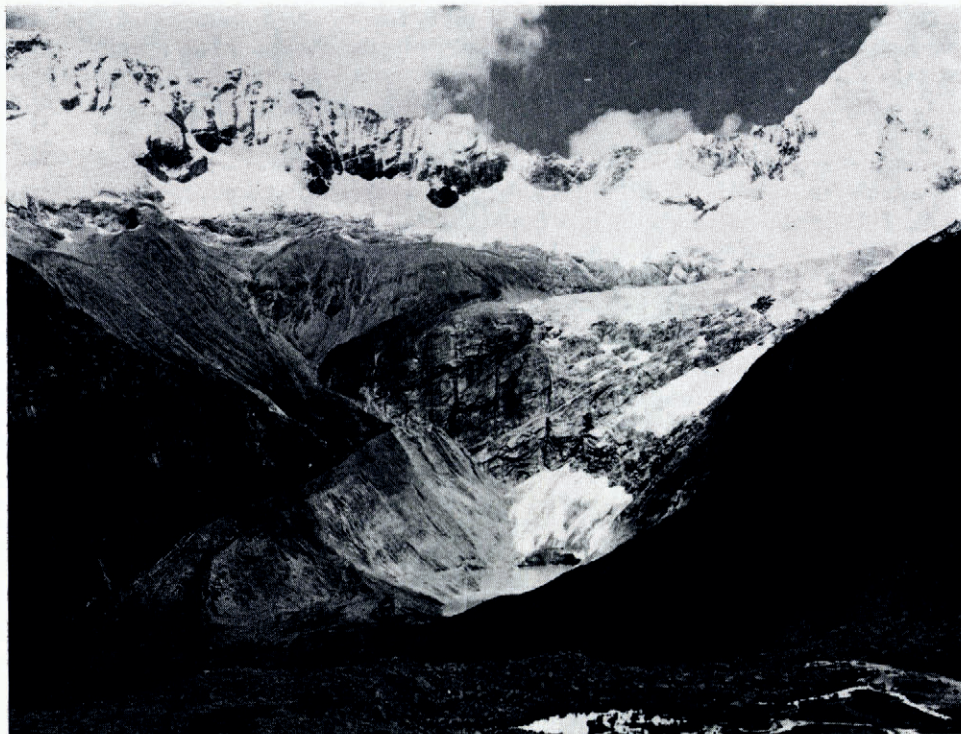
Artesoncocha (Fig. 6) which appeared between 1932 and 1940, was 500 m long, 250 m wide, and 50 m deep (Kinzel and Schneider, 1950) in 1948. It is overhung by seracs which regularly fall into the lake. The trace of the waves is clearly seen on the inner (today raised) beach at the other end. The dam has been destroyed twice, and we have a precise description of the events (CPS, unpublished). During the night between 16 and 17 July 1951, an icefall estimated at 4–5 million cubic metres produced a first leakage of the morainic dam. The level of the lake was lowered by 7 m, with the escape of 1.13 million cubic metres of water, which raised the level of Laguna Parón by 0.70 m. A waterfall, 22 m wide was formed on the external side of the dam, and regressive erosion caused its final rupture, three months later. This time 3.52 million cubic metres of water escaped, raising the level of Laguna Parón by 2.0 m. Fortunately these events happened during the dry season, when Laguna Parón (which has no open-air outlet) was at a low level. If it had happened during the rainy season, an *aluvión* would have flooded the town of Caraz.

Fig. 6. Artesoncocha on 4 February 1967, seen from lake 69. At the upper right corner, Artesomraju.

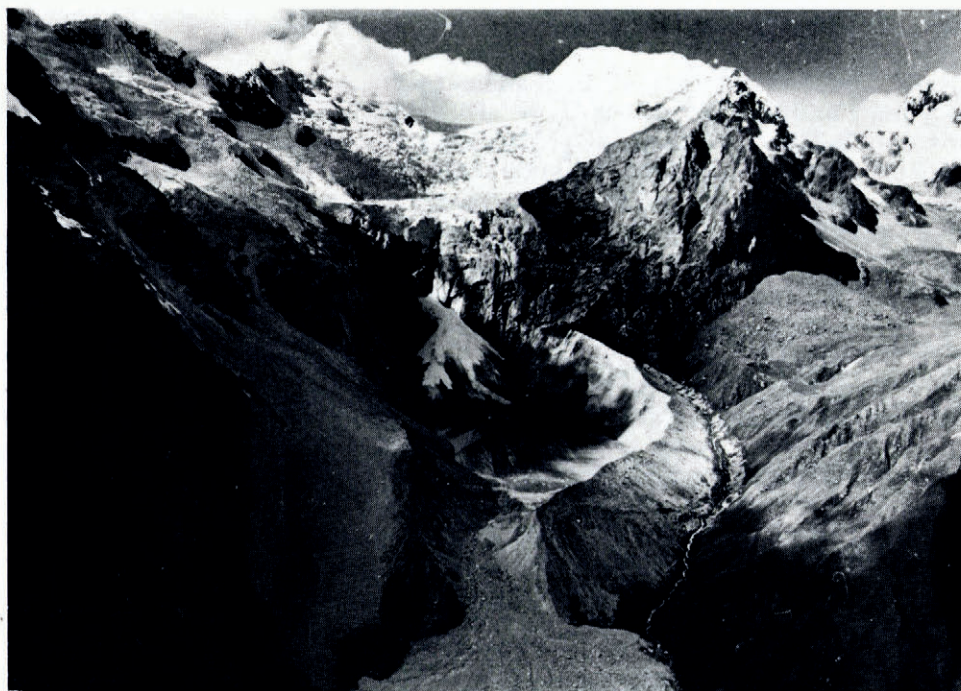
Fig. 7. Laguna Jancarwish, below Glaciar Kogan and Alpayayo. (Picture from helicopter by L. Lliboutry, May 1969.)

Laguna Jancarurish, in Quebrada Los Cedros had an underground discharge. The free-board was only 10 m in the middle of the front discharge. It seemed insufficient, since ice avalanches fall continuously into the lake from Glaciar Kogan, forming a regenerated glacier, a big ice apron at the head of the lake (Figs. 7 and 8). In 1949 the CCLCB began to lower the lake by cutting this free-board, digging a trench to lower the lake a little, then closing the mouth and digging the trench a little deeper, and so on. After two years work, the lake had been lowered 15 m. Under the precarious protection of a wooden gate 2 m high, the trench has been deepened two metres more, and a sole of cemented stones was under construction when an unexpected event happened. (In fact Dr Ali Szepessy Schaurek, in a report of 30 January 1950, has put the CPS on its guard against this hazard (Szepessy Schaurek, unpublished).

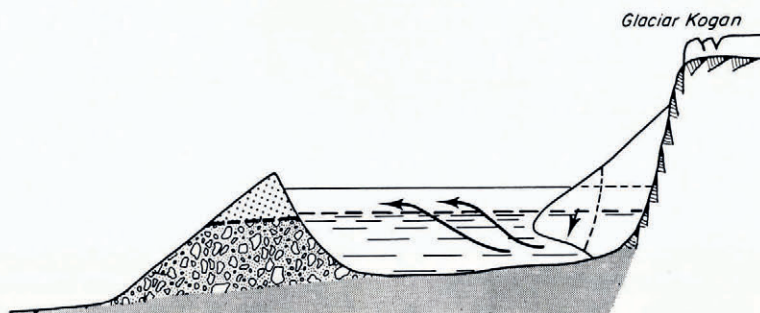
Fig. 8. Sketch of the event which produced the *aluvión* of Quebrada Los Cedros in 1949.

Nobody knew that the ice apron was calved under the lake surface: the water was probably at 4°C at depth and thus had melted the ice. The overhanging part, no longer sustained by the Archimedean force, broke and fell, producing big waves which overflowed and destroyed the gate. There was a fast regressive erosion of the moraine, formed almost exclusively of sand and pebbles. The stones of the sole were swept away, a waterfall formed, which widened while moving towards the lake. Finally the moraine around the gate failed and the big *aluvión* mentioned above took place. The level of the lake had lowered a further 21 m, and since its surface was 300 000 to 500 000 m², this gave a sudden discharge of 6 to 10 × 10⁶ m³ of water.

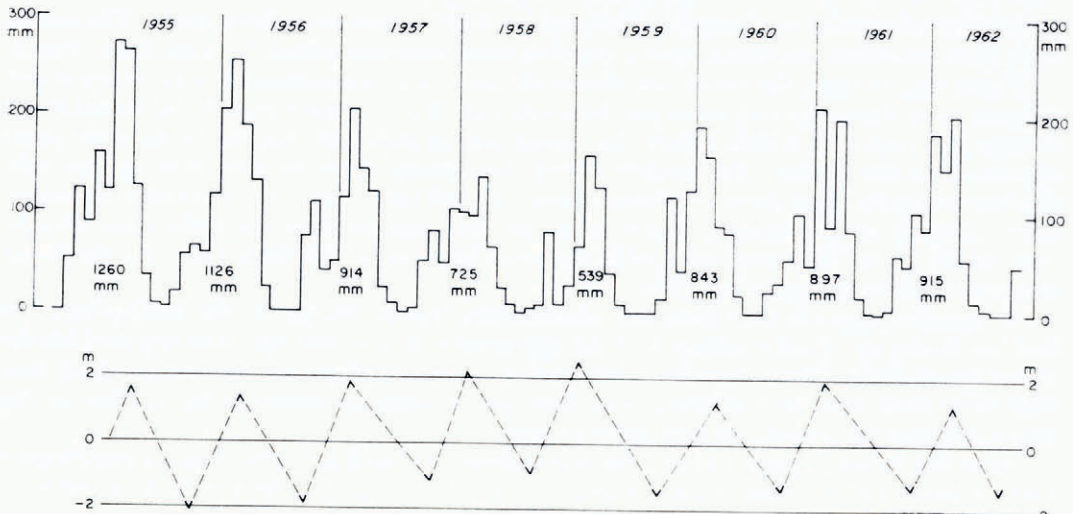
As shown in Figure 9, the water level varies annually by 3.4 ± 0.7 m, having its highest value during the most rainy months (February or March, in general), and its lowest value at the end of the dry season (September or October, in general). The relation between level and discharge when both are increasing is given in Figure 10. (With the exception of the year 1960,

Fig. 9. Above: monthly precipitations at the western tip of Laguna Parón (4 200 m a.s.l.). Below: highest and lowest levels of the lake.

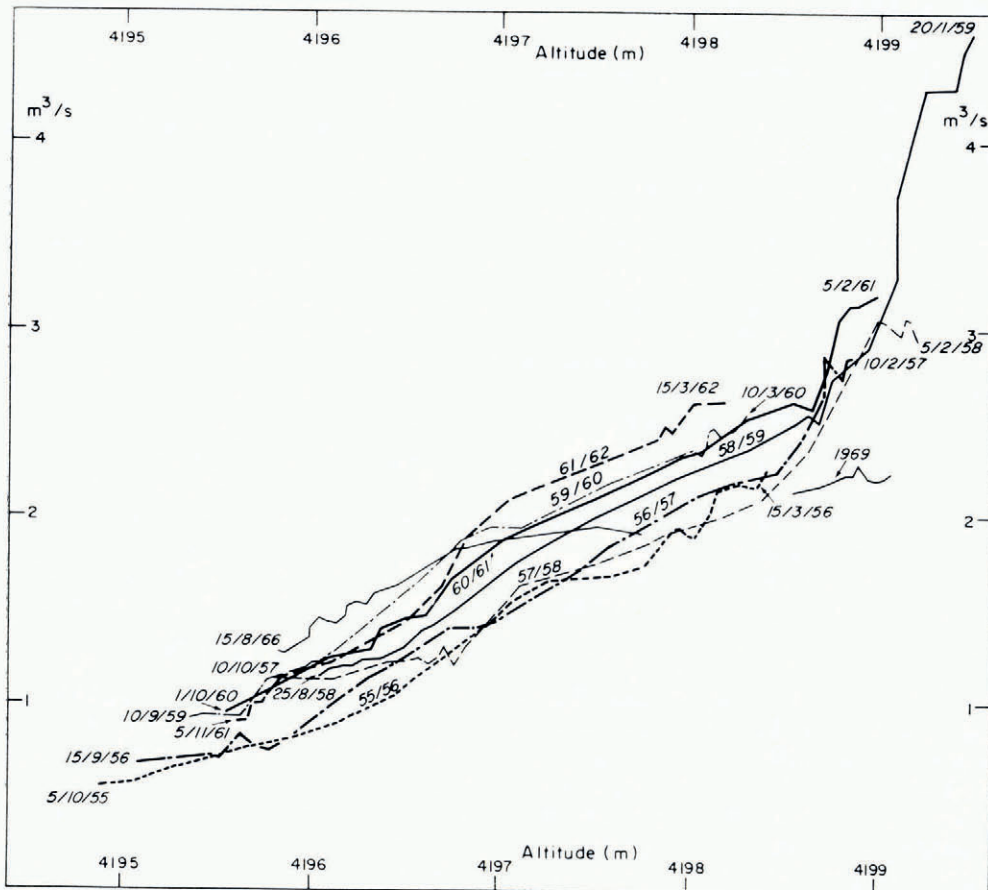
Fig. 10. Discharge of the springs from Laguna Parón versus level of the lake. Values for raising levels, smoothed by a running mean over 2 points.

during the subsequent lowering the discharge is a little higher for a given level.) The curves have been somewhat smoothed, with a running mean over two points, to make them clearer.

From 1955 to 1957, the curves are almost the same, with an increasing slope, which shows that the earth dam is getting more pervious upwards. For unknown reasons the lowest levels of 1957 and 1958 were a little higher than usual, and probably for this reason the subsequent maxima were also higher. The aquifers should then enlarge since the data from 1958 to 1966 give curves significantly above the former ones. In 1966 there must have been some unknown event (possibly an earthquake) which made the dam less pervious, since the slope became very small. So in February 1969, with the same level as in February 1961, the discharge was only 2.2 m³/s instead of 3.2 m³/s.

It therefore appears that there are continuously erratic changes in the infiltrations. In fact the drying up of some springs and the appearance of new ones has been reported by the observers of CPS. These variations may end in a catastrophic way, either by piping (the Hell Hole earth dam, in California, was destroyed by such an event), or by overflow of the free-board and the subsequent regressive erosion.
