Abnormal Oxidation of TiSi_2 in Gate Stacks Found at 750–850°C

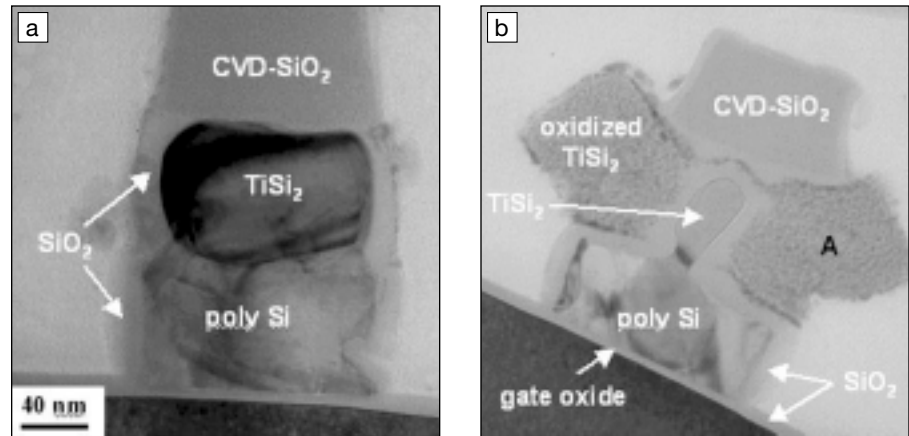
Figure 1. Transmission electron microscopy images of samples oxidized at (a) 750°C and (b) 850°C.

The group carried out transmission electron microscopy (TEM) studies to gain a detailed understanding of the oxidation process. While the films annealed at low temperatures showed two adjacent layers of polysilicon and TiSi_2 surrounded by a layer of SiO_2 (see Figure 1a), four different regions were observed for the high-temperature samples. The TiSi_2 film appeared to have shrunk considerably and was surrounded and separated from the polysilicon by SiO_2 . Furthermore, regions of a composite were found to

extrude from the original sidewall positions (see Figure 1b). This composite, marked “A” in Figure 1b, consisted of nanocrystalline TiO_2 in an amorphous SiO_2 matrix, which was identified from a high-resolution TEM study.
