## Imaging Fungal Contamination of Protective Organic Coatings

Naval Research Laboratory, Stennis Space Center, Mississippi, United States

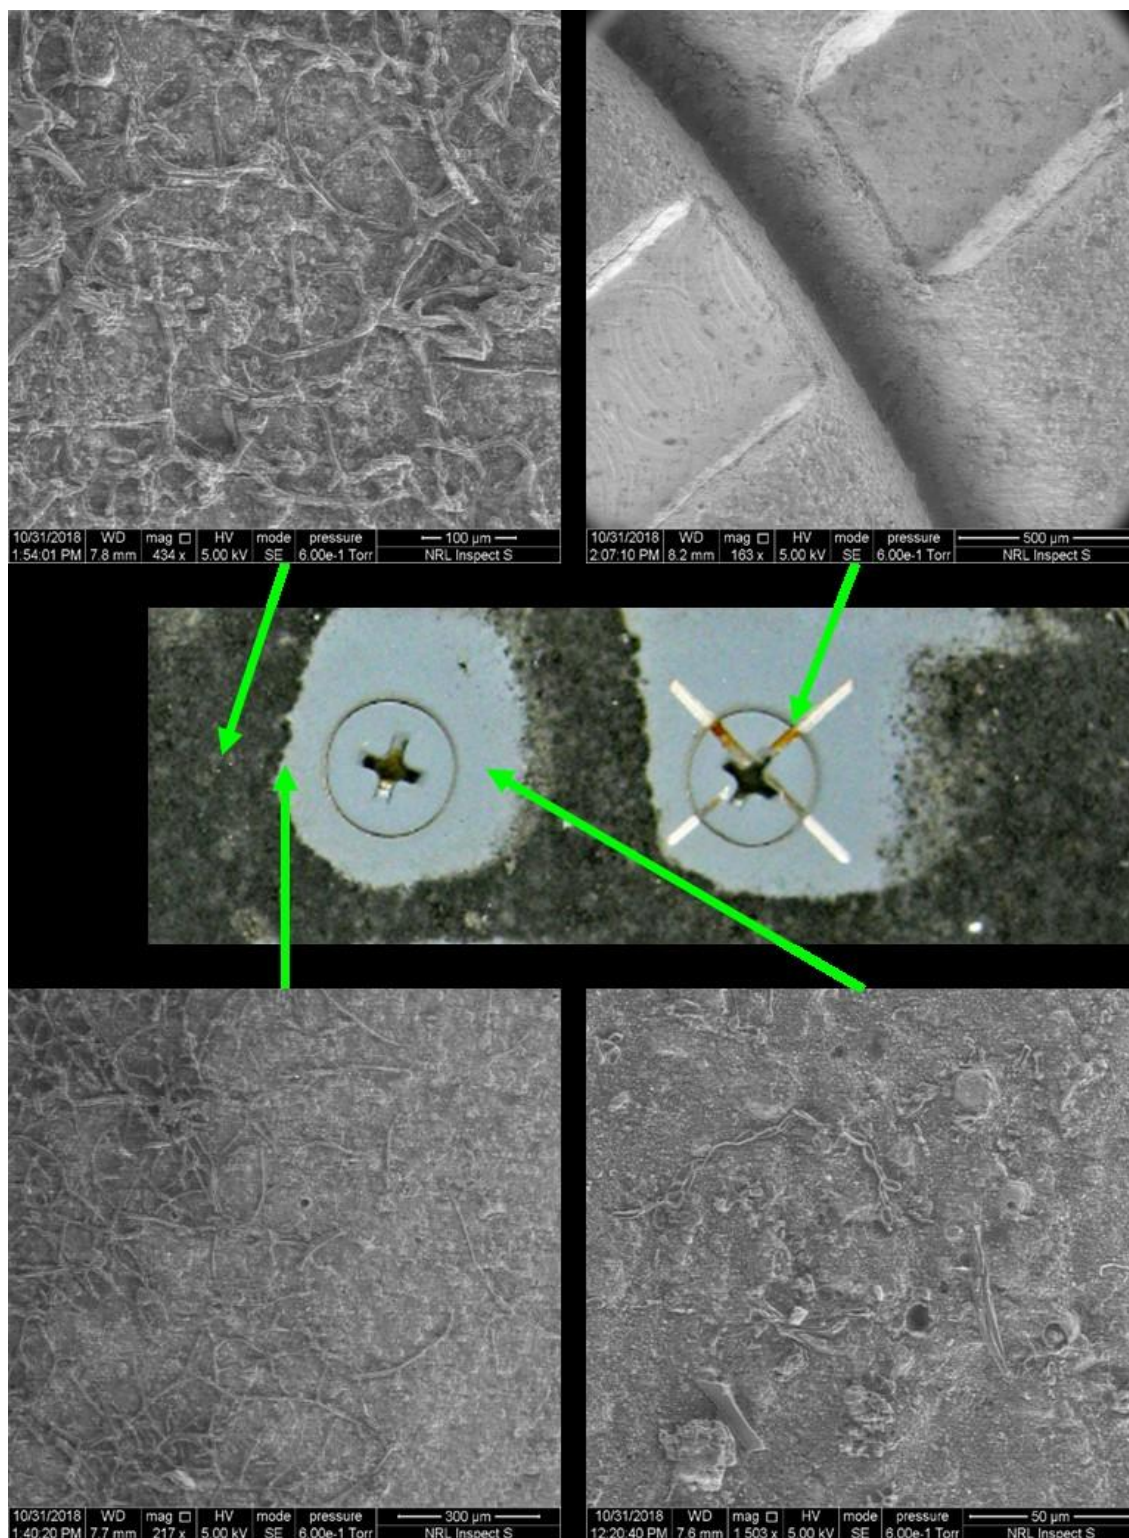
**Figure 1.** Localized images of a coated aluminum 7075-T6 substrate illustrating the different fungal growth patterns as a function of distance from the Cd/steel fasteners. Regions close to Cd/steel are free of fungal growth as are the bare metal scribes.

Organic coating systems were applied to aluminum 2024-T3 and 7075-T6 panels with cadmium plated steel and titanium fasteners. The panels were exposed for 2+ years outdoors in the deep tropics of South American. Fungal growth, as exhibited by a black biofilm, was observed on all organic coatings to differing degrees. Significant fungal growth was not observed on bare metal surfaces. Coating systems with metallic magnesium pigmented primers (magnesium rich primers) suppressed fungal growth regardless of the overlying top coat type. Oxidized magnesium primers did not afford the same fungal inhibition. Fungal growth was significantly de-pressed around fasteners coated with cadmium. Fungal growth was most severe on panels with aluminum rich primer.
