The episcopal palace of Parnassos in Cappadocia and its Early Byzantine floor mosaics

Melih Arslan,¹ Philipp Niewöhner² and Yavuz Yeğin³

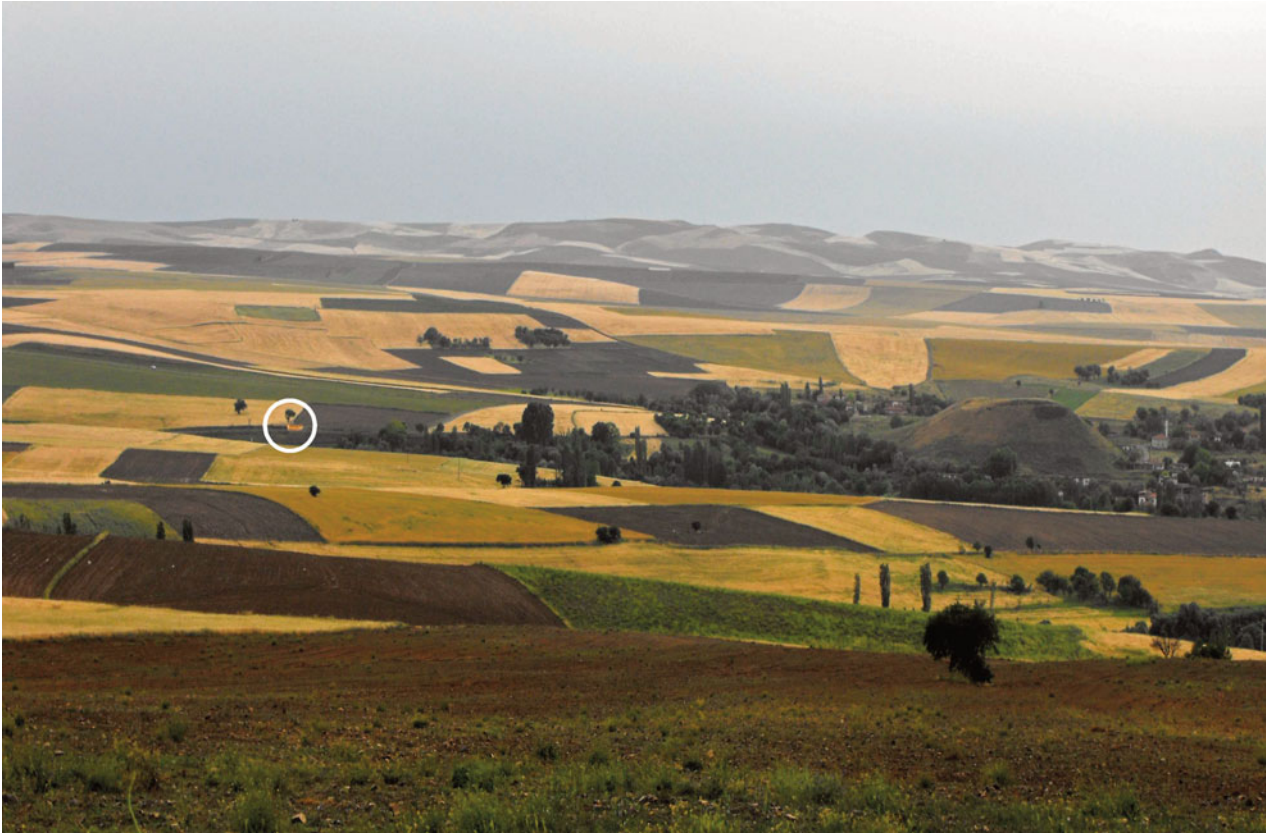
Fig. 2. Parnassos/Parlasan, view of the Turkish village, from the east (photograph © M. Arslan). The village is centred on an ancient hüyük or settlement mound, to the right or north of which the mosque may be recognised by its minaret. The location of the excavation site and bishop's palace beyond the southern outskirts of the village is marked by a white circle.

35–41, route A1; Cassia 2004: 107–8; Métivier 2005: 63). Parnassos/Parlasan is located at the bottom of a shallow valley that provides some protection from the wind and ample water (fig. 2). Several springs combine to form a substantial stream that is flanked by meadows and trees. The village occupies a rocky plateau to the west of the stream and is centred on a steep hüyük, or mound, that attests to an ancient settlement tradition. Sherds are widely scattered on the west side of the stream (but not on the east side), a few surviving old village houses re-use ancient ashlar, and the new mosque employs two column shafts and two mullions, the old mosque some more, unspecific marbles (Ersay Yüksel 2012). Otherwise, Parlasan used to be void of antiquities, and J. G. C. Anderson, who visited the village in the 19th century, explained this by a movement to the more prosperous town of Şereflikoçhisar, about 10 km to the south (Anderson 1899: 107–9).

It came as a surprise when a salvage excavation of the Museum for Anatolian Civilisations at Ankara unearthed a large building with sumptuous Early Byzantine floor mosaics beyond the southern outskirts of the village (fig. 2). The find spot suggests that Early Byzantine Parnassos was larger than the Turkish village, and the size, quality and decoration of the building, which was centred on an apsed hall and may, as we shall see, be identified as the episcopal palace, indicate that the bishopric of Parnassos was a substantial institution. The floor mosaics show that a provincial Anatolian bishop could aspire to some of the same standards otherwise associated with metropoleis such as Constantinople or Antioch. More recent discoveries of a Late Roman sarcophagus and three Early Christian gravestones confirm this impression and are presented in the online supplementary material: Appendix 1.

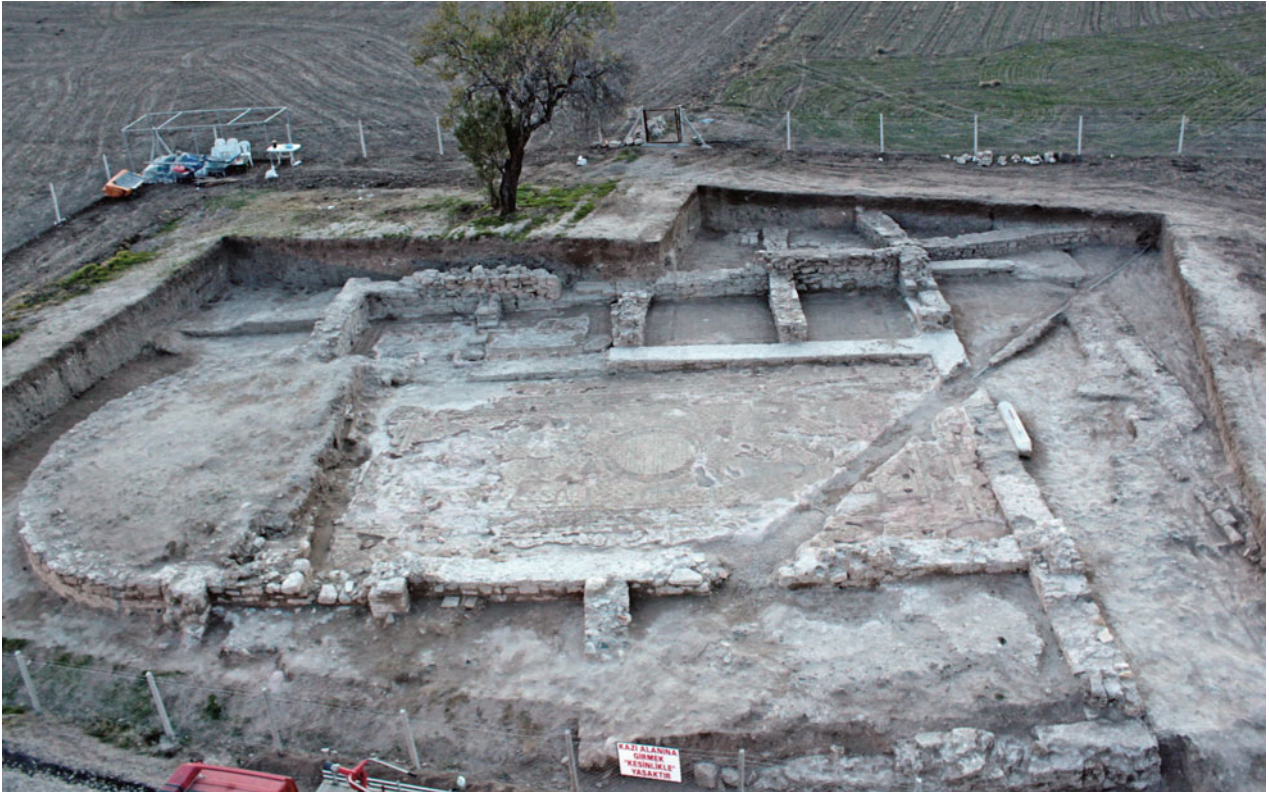
Fig. 3. Excavation site at the end of the first season in 2010, from the northeast (photograph © M. Arslan).

The brick buttress is located halfway between the southeast wall of the northeast room and the wall – now mostly destroyed – to the east of the apse (figs 3, 5 and 6). All three structures would have combined to support the southeast wall of the hall where it required extra strength. For comparable buttressing, see the north wall of an Early Byzantine basilica at Örencik in the vicinity of Kadoi/Gediz in Phrygia (Altunkaynak Duğan, Ünan 2019: 38, fig. 1). At Parnassos, the sloping terrain necessitated deeper foundations that, like a terrace wall, had to withstand sideways pressure down the slope to the east.

The location of the doors opposite and flanking the apse underscores the hall's focus on the apse. The apse itself was elevated 90cm above the mosaic floor of the hall (figs 3 and 4). The flooring of the apse has not survived;

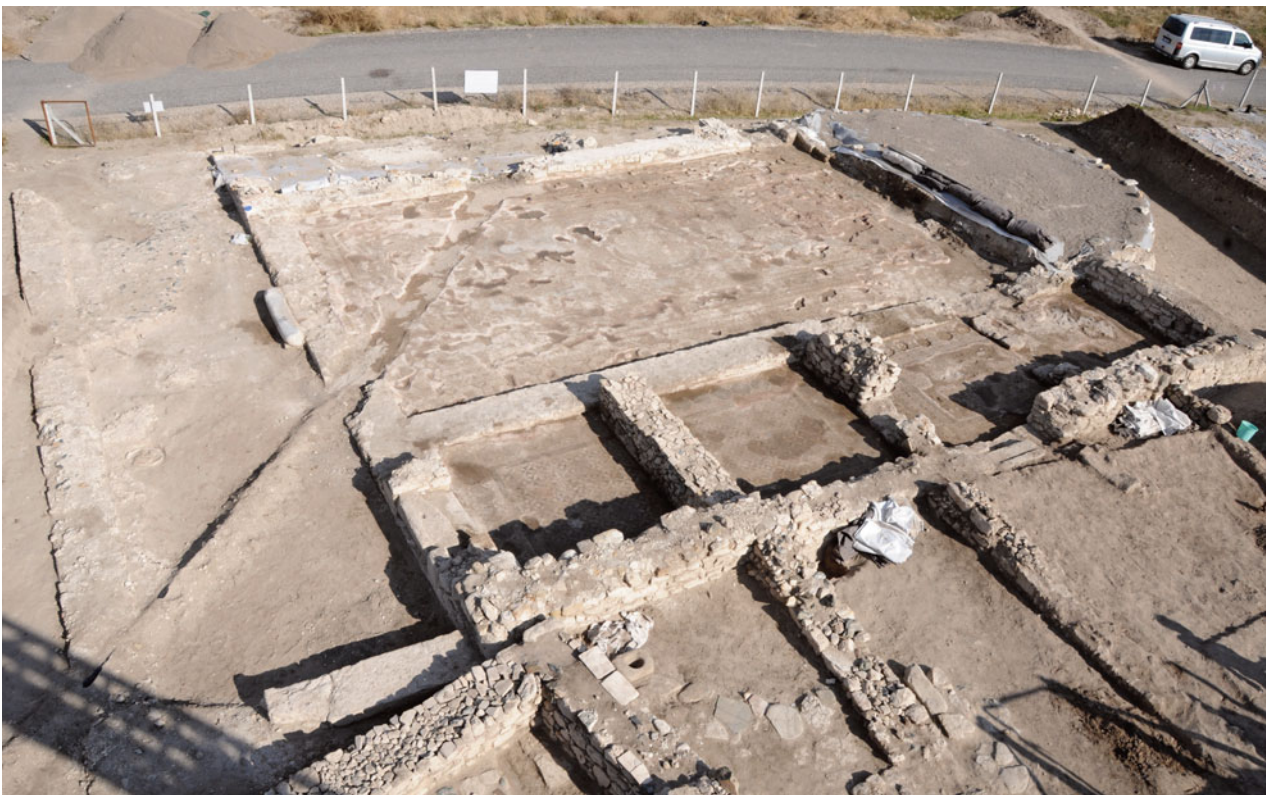
Fig. 4. Excavation site at the end of the second season in 2011, from the west (photograph © M. Arslan). In the foreground, the secondary room I that partly preserves a mixed stone floor and contains a drain. The trench that starts at the bottom left corner of the photograph and cuts diagonally across the palace was dug in 2007. The road in the background was built in 1991.

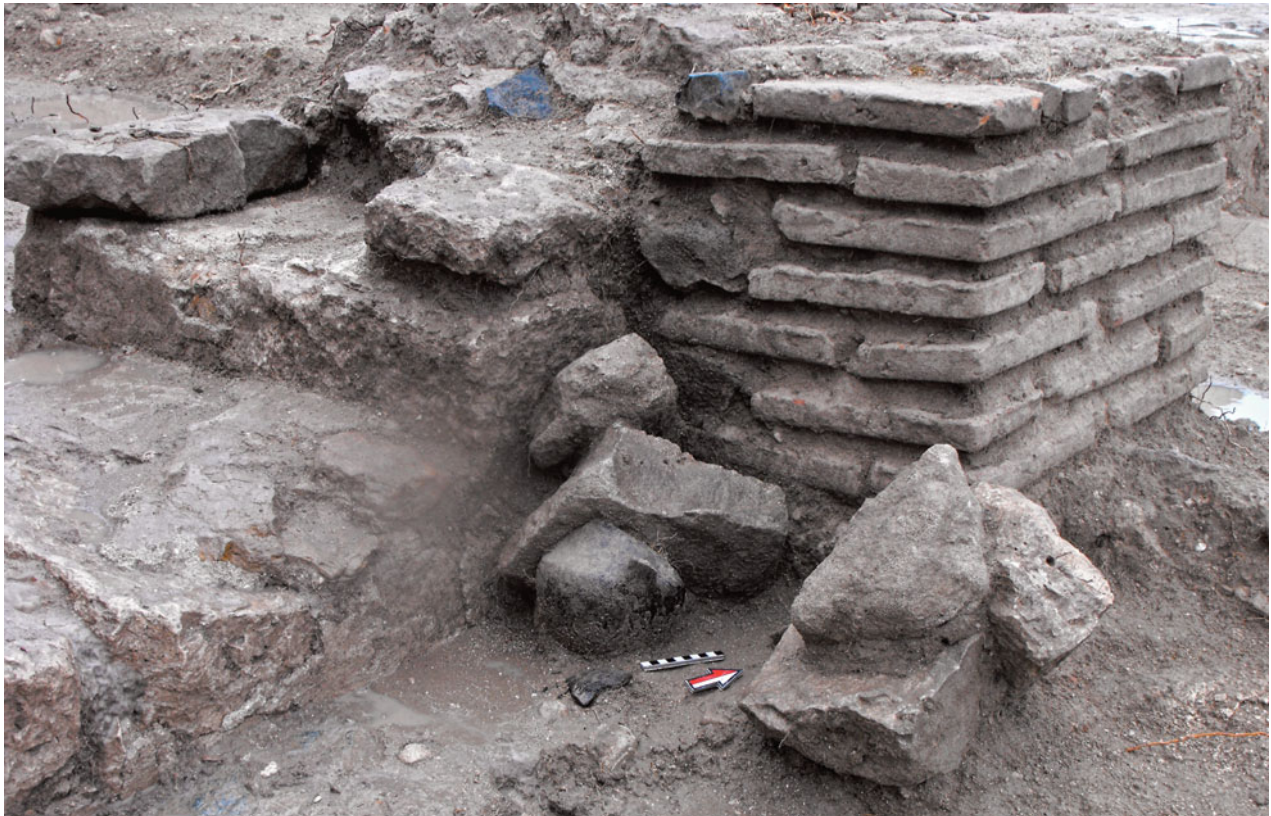
Fig. 6. Brick buttress on the east side of the apsed hall's east wall, from the southeast (photograph © M. Arslan). To the left, what appears to be the northern door jamb of the apsed hall's southeast door.

The brick buttress would have tied in with the horizontal brick band and formed its vertical equivalent. The buttress is also the only remaining part of original brick masonry in the building. The horizontal brick band appears to have been robbed, as described above, leaving behind perfectly level socle walls on the southwest, northwest and northeast sides of the hall. All walls are roughly 90cm wide and formed by two faces of irregular, coursed ashlars and a rubble core, held together by lime mortar that also served to close the joints (fig. 7). The additional brick band helped to reinforce the walls of the hall, because it was the tallest structure and most vulnerable to damage by earthquakes or any other movement, for example, of the foundations.

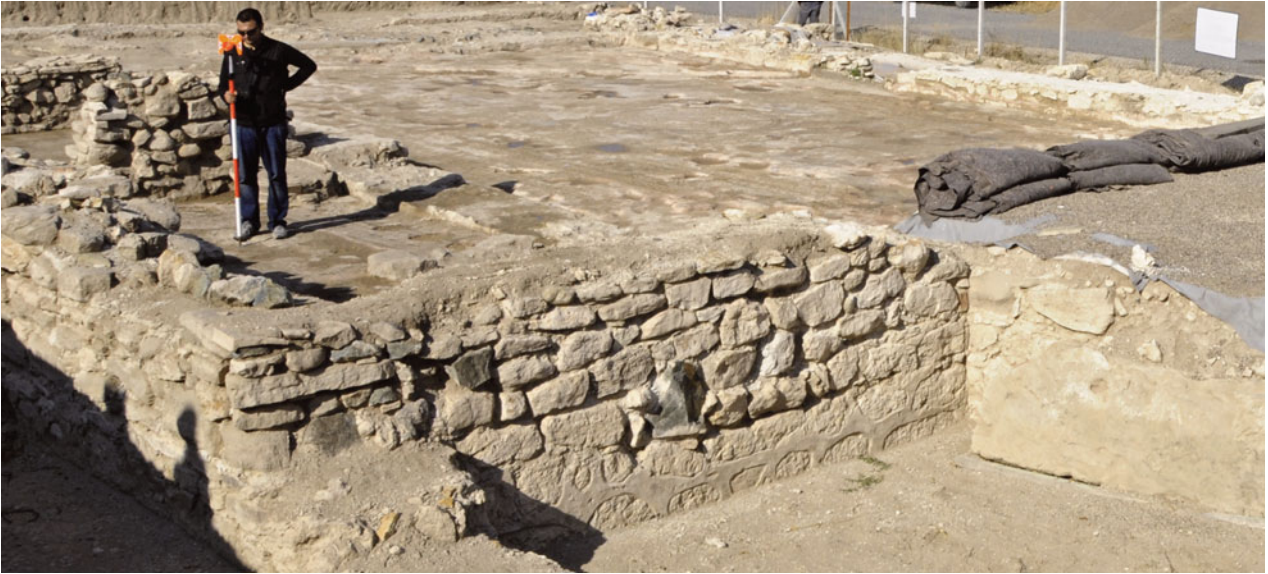
Fig. 7. South wall of the southwest room, from the south (photograph © M. Arslan). The lower part, which used to be buried under later floor levels and was thus protected from the elements, has preserved the original, early treatment of the outer façade: stones remained visible, but joints were closed flush with mortar.

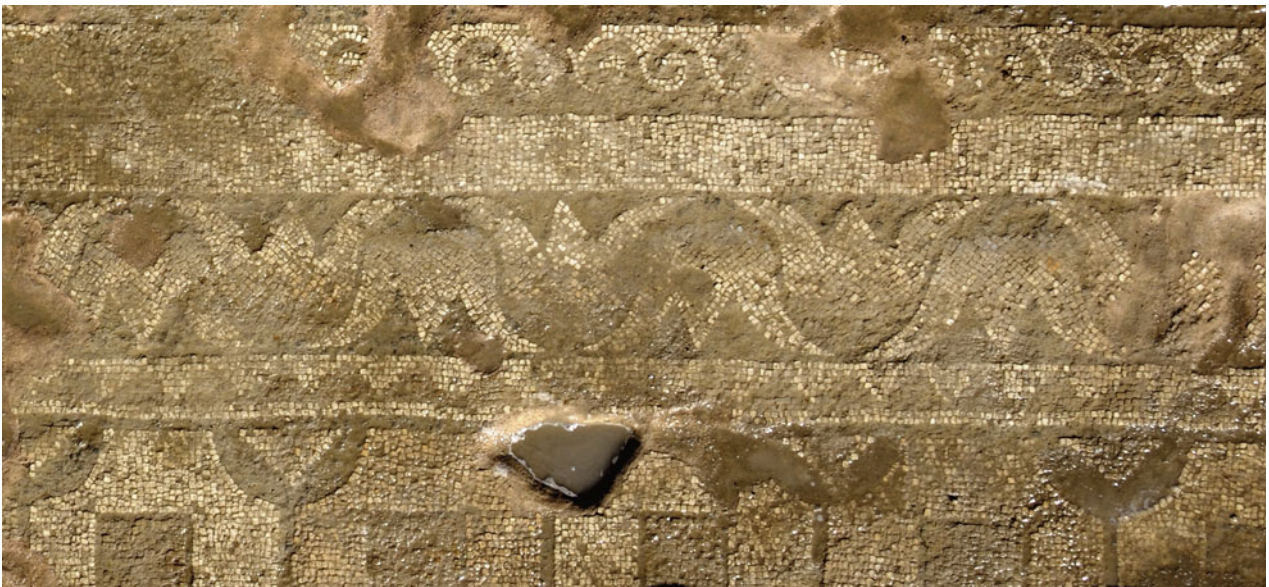
Fig. 10. Western border of the animal mosaic, middle section with a well-preserved middle border in the shape of alternately hanging and standing calices with a dogtooth-pattern below and a white band above, from the southwest (photograph © M. Arslan).

but not on the southeast. It is made up of alternately hanging and standing calices, each with a black bottom, a turquoise centre and white leaf tips (figs 8 and 10). The next spacer is a plain white band, after which follows the third and innermost border that continues around all four sides of the animal scene. It consists of two narrow, red and white wave bands that enclose a wide, blueish-grey acanthus scroll on a black ground (figs 8, 11 and 12).

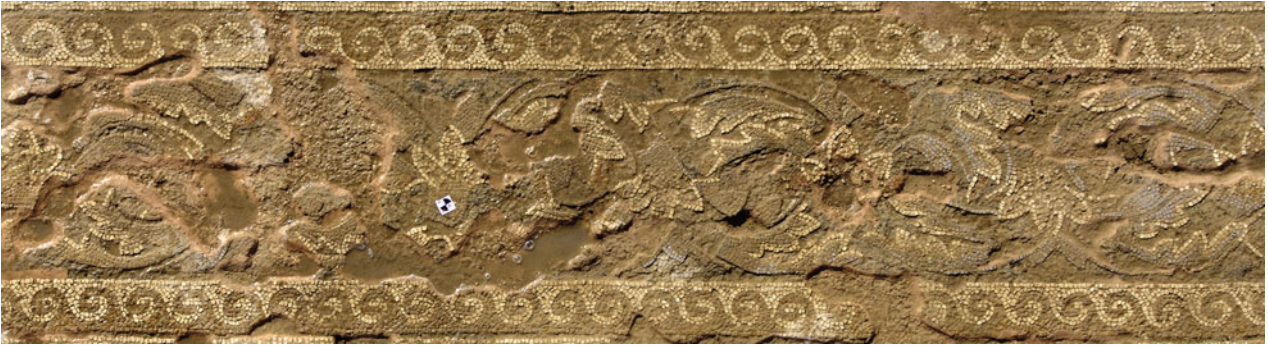
Fig. 11. Eastern border of the animal mosaic, middle section with a well-preserved inner border in the shape of a scroll between wave bands, from the northeast (photograph © M. Arslan).

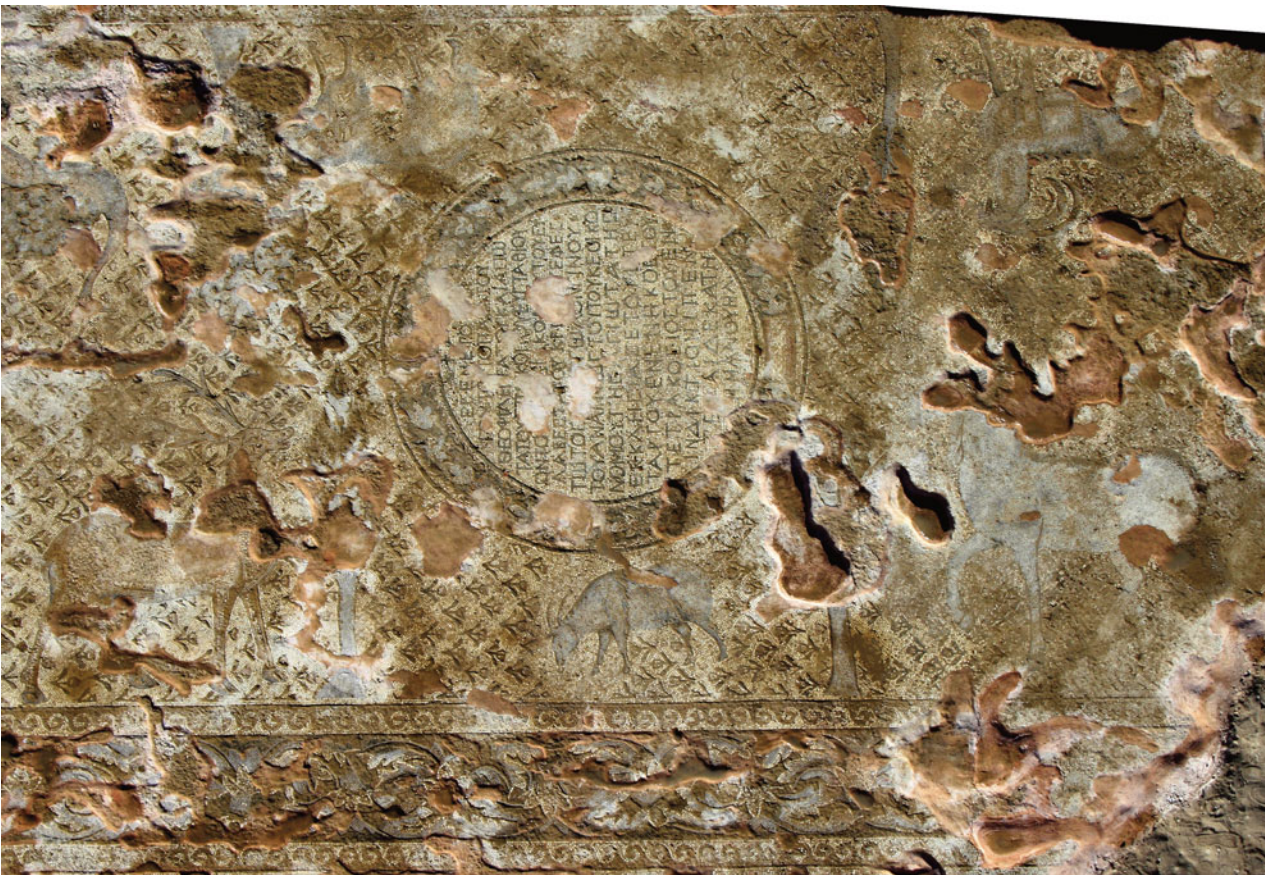
Fig. 12. Central part of the animal mosaic, from the northeast (photograph © M. Arslan). On the bottom side, from left to right, a stag, a cypress tree, a goat, a tree and a horse; on the top side, and thus upside down, from right to left, a mountain goat, a cypress tree, a rabbit, a sheep(?), a deciduous tree and an ostrich.

At Parnassos, the animals are arranged individually or in pairs, and grouped as well as separated by the trees (figs 8 and 12). The animals are mostly black, blueish-grey and brown in colour, but each individual is carefully differentiated from its neighbours on right and left as well as across the width of the mosaic so as to lend variety to the composition. The northern part of the mosaic contains two pairs of animals, each of which is framed by two trees. On the west side, a mountain goat (supplementary fig. 5) and what may be a doe and his spouse (supplementary fig. 6) are standing back to back. Their colours gradually change from black croups to white bellies. Only the right, or southern, tree is preserved well enough to be identified as a cypress (figs 8 and 12). On the southeast side, a large, blueish-grey horse turns its head (supplementary fig. 7) towards what appears to be a smaller, brown horse that follows behind (supplementary fig. 8); the two horses could represent a mare and a colt or possibly a stallion and a much smaller mare. Above the croup of the large blueish-grey horse, the hind part of a black bird can be made out, but its head is lost (supplementary fig. 9).

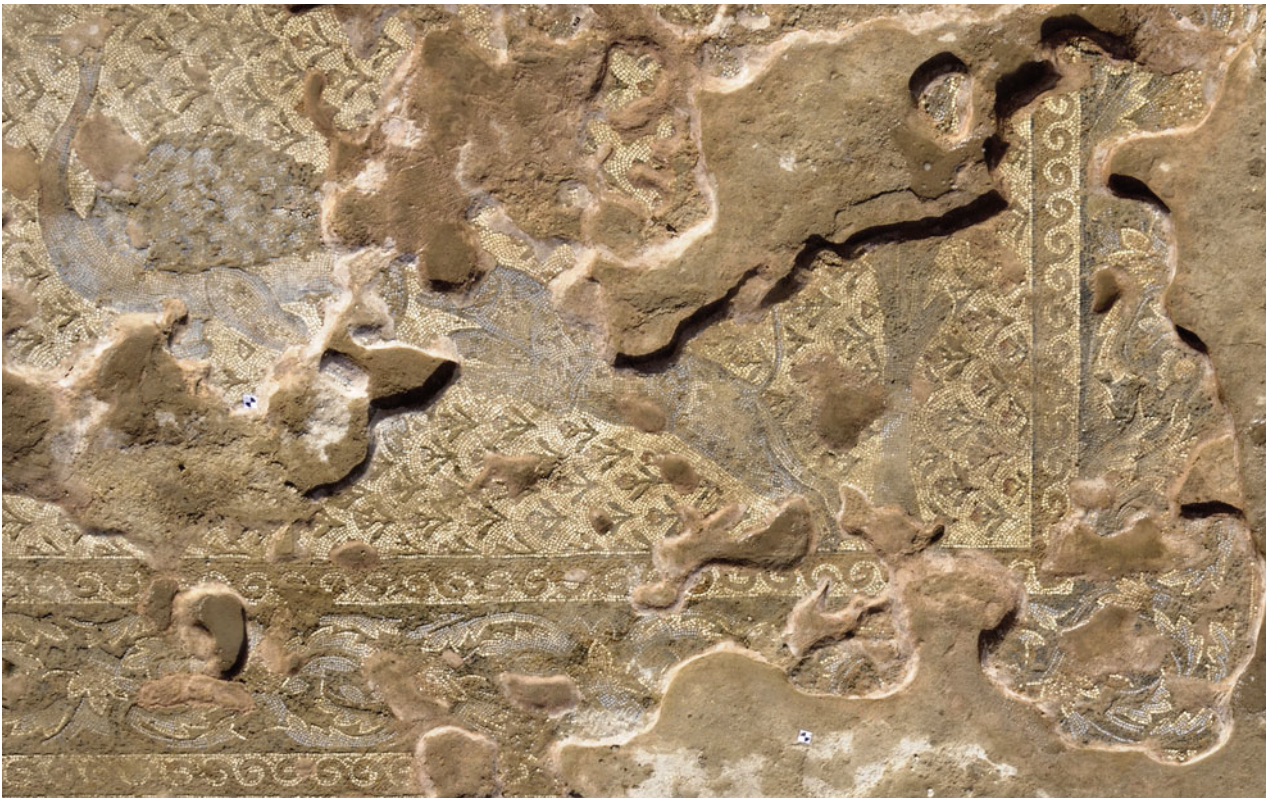
Fig. 13. Southwest corner of the animal mosaic, from the northwest, including a leopard attacking an ostrich (photograph © M. Arslan).

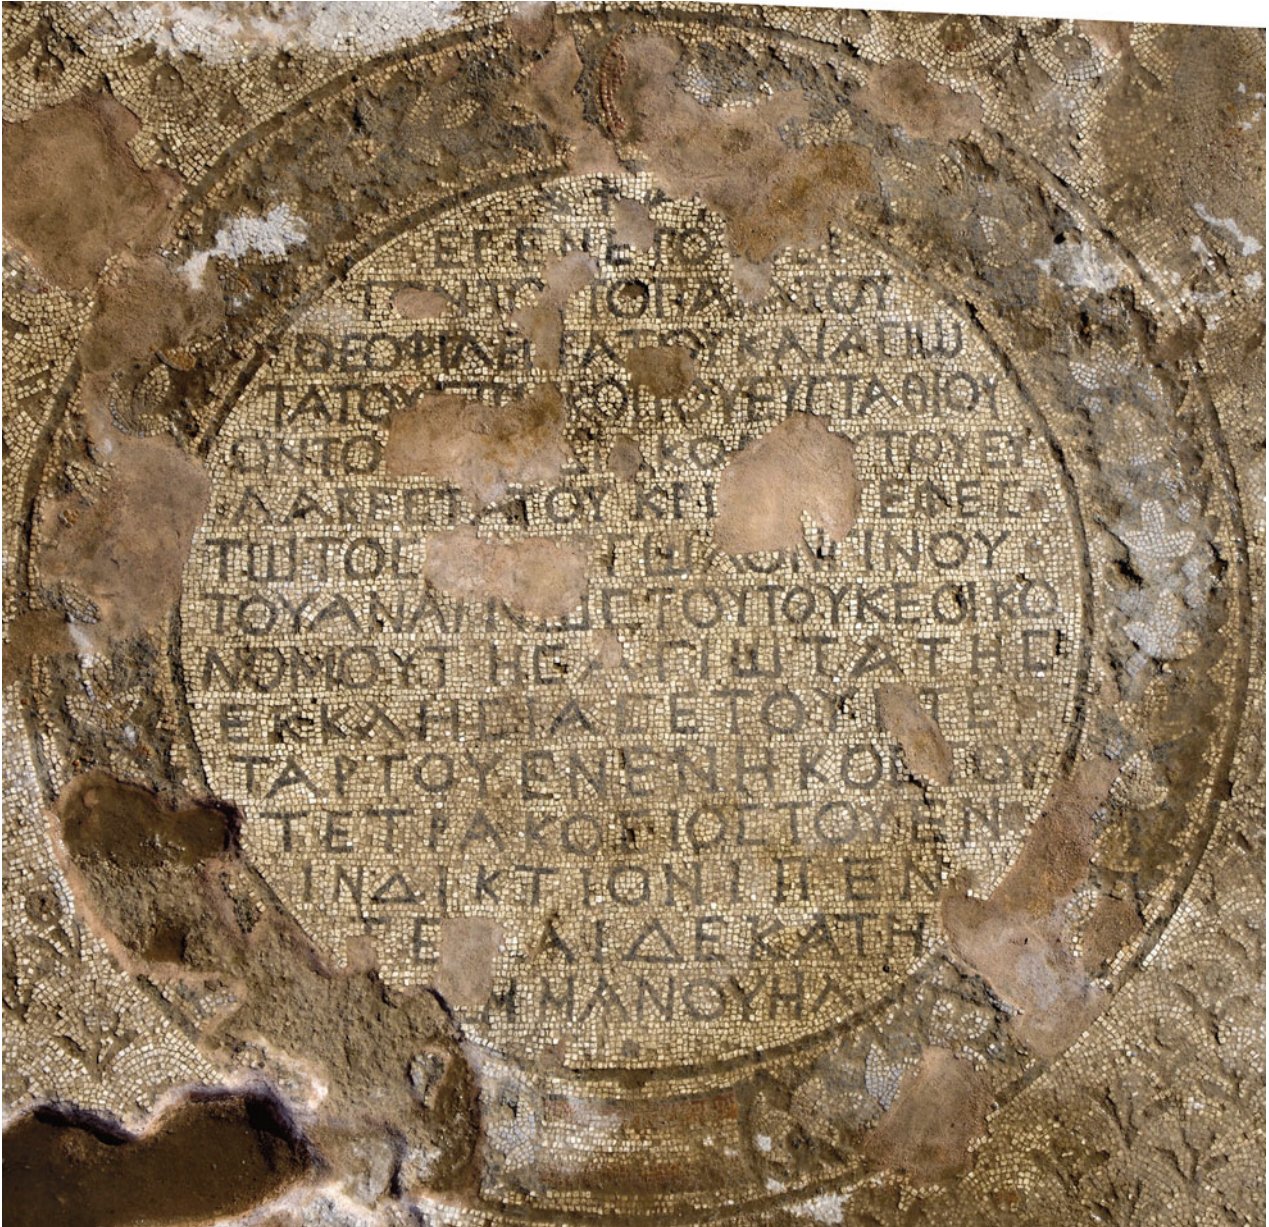
Fig. 14. The medallion with wreath and inscription in the centre of the animal mosaic, from the northwest (photograph © M. Arslan).

The medallion in the centre of the hall mosaic contains an inscription that is to be read from the north; that is, by an approaching visitor on the way from the main northern door to the southern apse (figs 8 and 12). The medallion has an overall diameter of about 2.4m, including a laurel wreath that is 30cm wide and leaves an inner circle 1.8m in diameter for the inscription. The wreath is green, with additional grey tri-lobes, and has a binding of light tesserae that marks the northern side as the ‘bottom’ (fig. 14). The inscription forms 15 lines of black letters on a white ground, with a cross and two flanking ivy leaves on top. It reads (*SEG LXIV*, 1502; Arslan et al. 2021: 9–10):

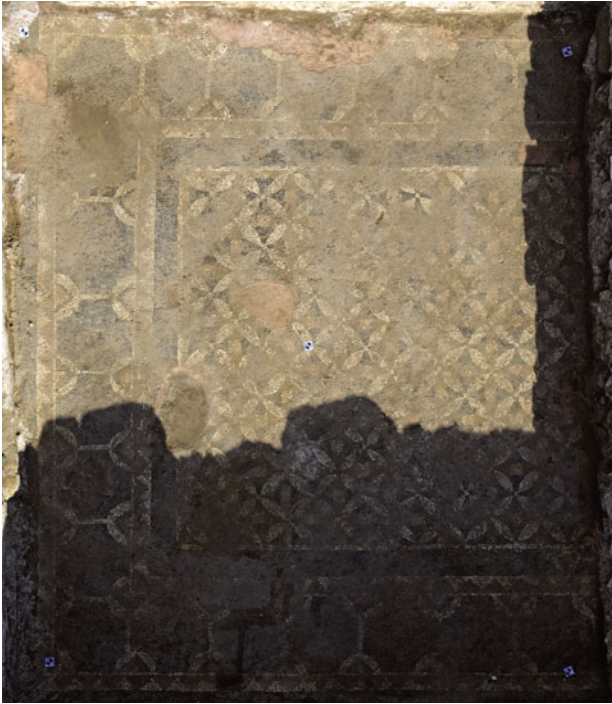
Fig. 15. Northwest room with geometric floor mosaic; northern half, which was later partitioned off as room B, from the southwest (photograph © M. Arslan).

The northwest room employs almost the same outer border as the hall but with flipped colours (figs 15 and 16; cf. fig. 9). The border consists of a series of black squares, the corners of which are cut by small white semi-circles that each contain a red semi-rhomb with a black contour. Again, as in the hall, the border is framed by a red and white dogtooth pattern, but this time it is not only on the inside, but also on the outside. Next follow, again on both sides, thick black bands, but some of the outside bands are cut down to thin lines by the southwest and northeast walls of the narrow room. Inside this border, the northwest room has a repeat pattern of overlapping white compass flowers that, on a black ground, alternate with small off-white squares.

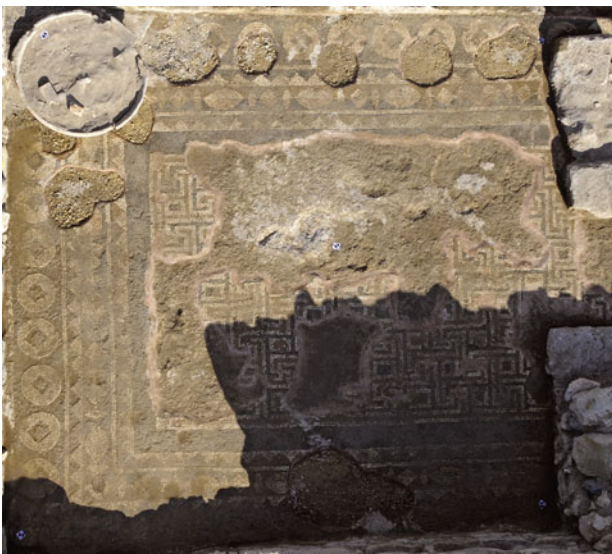
Fig. 17. Southwest room with geometric floor mosaic; northern half, which was later partitioned off as room D, from the southwest (photograph © M. Arslan). The upper left corner contains the bottom part of a pithos, and numerous round holes indicate where more pithoi used to stand during the second phase.

The southwest room, like the hall, has an additional outer border on some sides but not on others (figs 8, 17 and 18). In the hall, this may have been intentional, in order to provide additional space for viewing the animals on the one hand and depicting as many animals as possible on the other, but in the southwest room no such reason comes to mind. The extra border occurs on the northwest and northeast sides and could have been avoided by adding to the repeat patterns of the main border and the central panel. Such additions would seem to be a simple task, and it is not obvious why the mosaicists preferred the addition of an outer border that compromised the symmetry of the floor.

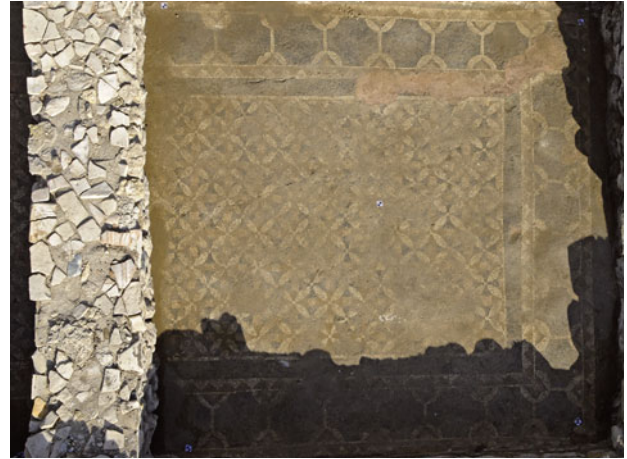
Fig. 16. Northwest room with geometric floor mosaic; southern half, which was later partitioned off as room C, from the southwest (photograph © M. Arslan). The top of the secondary partition wall on the left is formed by a level band of re-used brick fragments (see fig. 20).

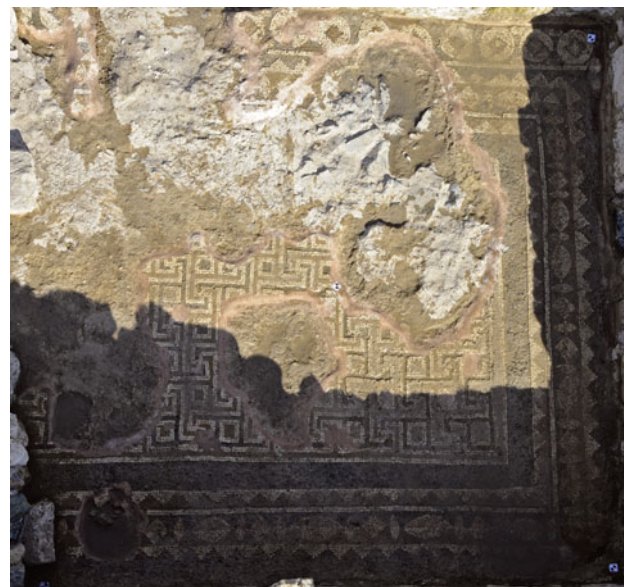
Fig. 18. Southwest room with geometric floor mosaic; southern half, which was later partitioned off as room E, from the southwest (photograph © M. Arslan).

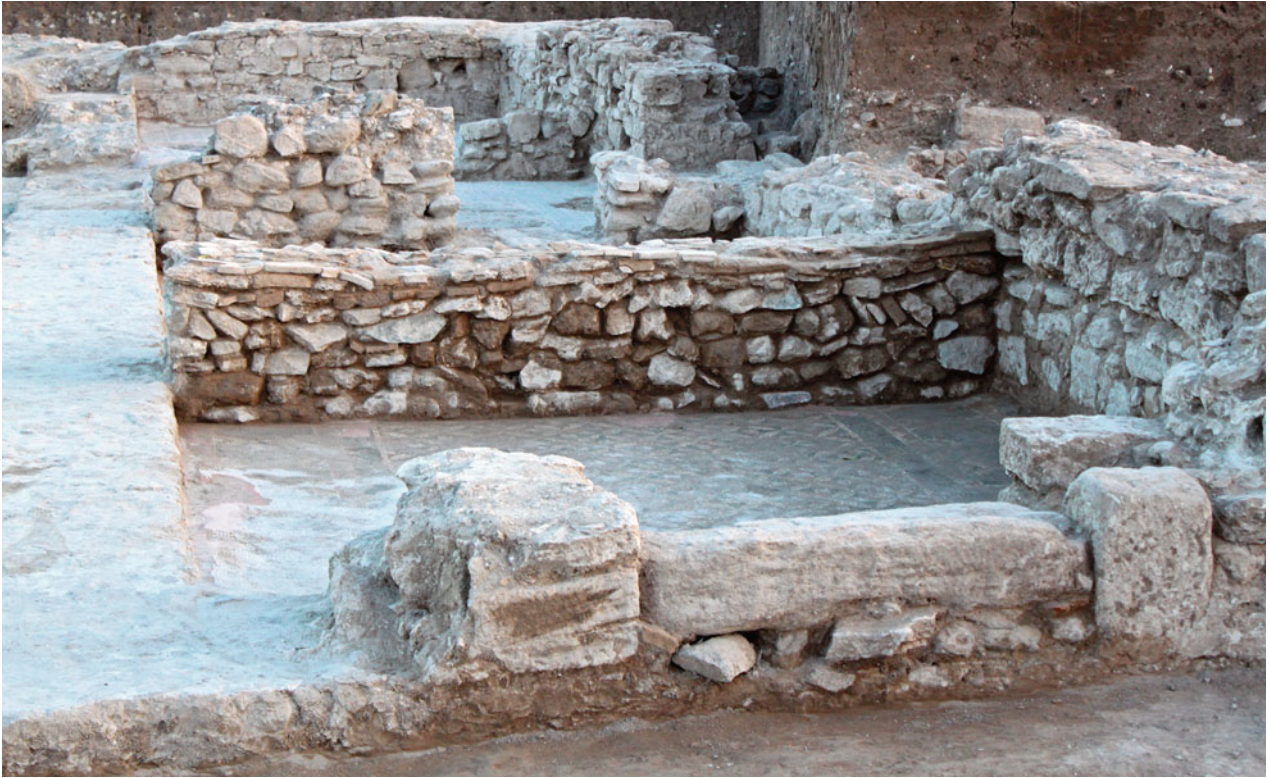
Fig. 20. Northwest room with geometric mosaic floor, the northern part of which was later partitioned off as room B, from the northwest (photograph © M. Arslan). The secondary partition wall in the middle ground stands on the Early Byzantine mosaic, is built without lime mortar, and employs mixed masonry with a level band of re-used bricks (see fig. 16). The elevated door sill in the foreground also relates to the second phase, when the uneven filling underneath would have been hidden by a higher floor level. On the left, the west wall of the apsidal hall forms a level horizon, apparently for a band of bricks, which could also explain the low level of preservation, because bricks were much sought after and would have been robbed for re-use.

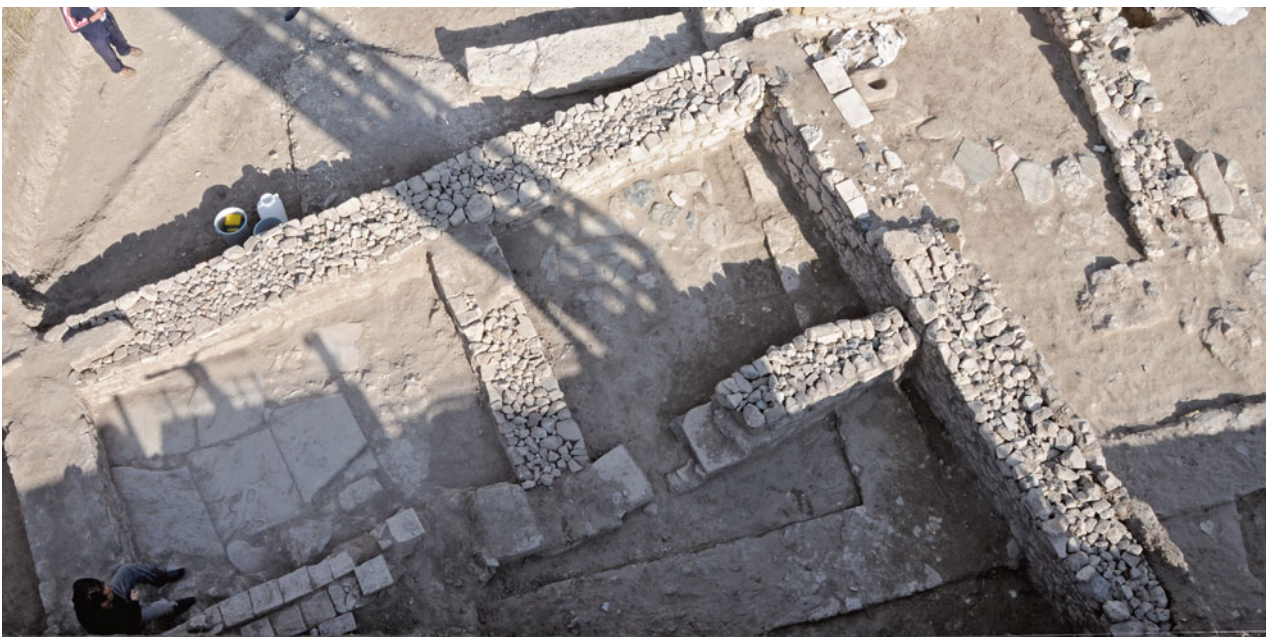
Fig. 21. Northeastern corner of the excavation, from the west (photograph © M. Arslan). The secondary rooms M, on the left, with flagstone-floor, and L, on the right, with a mixed stone floor, diverge from the orientation of the Early Byzantine palace below.

The southernmost west room F was over 2m wide and 6–7m long, thus extending further west than the western yard used to. An additional room J to the southwest of room F confirms that whatever used to follow to the west of the western yard in the Early Byzantine period was now overbuilt. The secondary walls are ill preserved, and the excavation did not establish the location of doors. Two more rooms, G and H, to the northwest of F appear to have had similar proportions, but their southwest walls remain elusive. The fourth and northwesternmost room I, to the southwest of B, was up to 2.5m wide but only about 3.5m long, with a single door on the southwest side that opened onto a narrow room K. Room I has preserved remnants of a floor made from various stones in a random arrangement, as well as, in the northern corner, a drain (figs 4, 19 and 21). It may
