Characterization of Defects in III-V Semiconductor Materials (InP, GaAs and InGaAs/ InP on Si) in Nano-sized Patterns by Transmission Electron Microscopy

J.H. Lee¹, Y.D. Cho¹, I.G. Lee¹, C.S. Shin², W.K. Park², D.H. Kim³, D.H. Ko¹

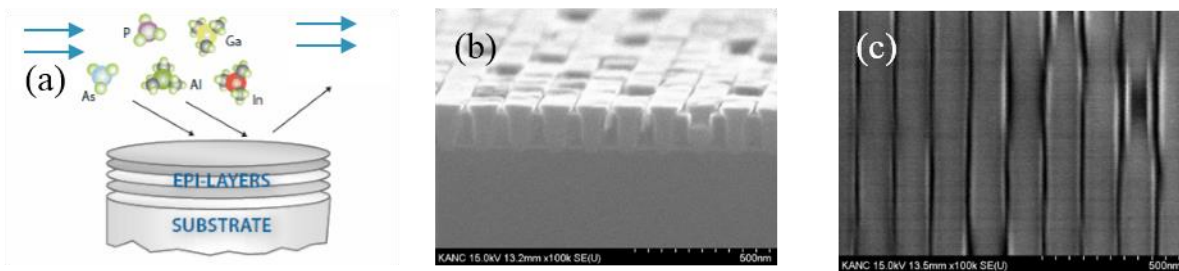
Figure 1. Shows (a) III-V compound process, (b) results of SEM cross section image and (c) Top view image.

In this investigation, we studied the defect generation in the case of III-V compounds of InP, GaAs, and InGaAs/ InP on Si substrate with nano-sized trench structures. Also, few additional blanket samples prepared on various Si substrates was analyzed to compare with effects of patterning by transmission electron microscopy. The TEM samples were prepared by Focused Ion Beam because the pattern size of region of interesting was too narrow, moreover, a specific plane view specimen was required of three dimensional analysis. III-V compounds such as InP and GaAs were grown in the trench patterns by metalorganic chemical vapor deposition.

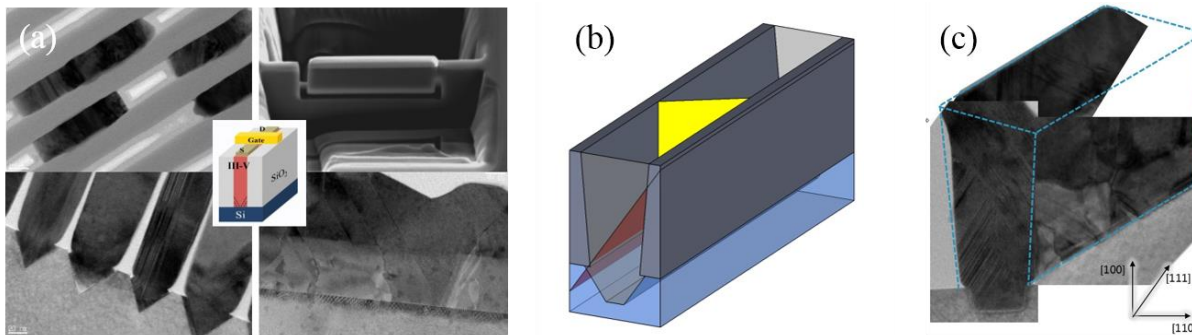
Figure 2. Shows (a) X,Y, and Z axis TEM images. (b) 3D reconstruction of [-111] twin boundary. (c) TEM 3D images of X, Y axis and plane view.

Plain-view (z axis) samples as well as cross-sectional TEM samples were made to confirm that the defects grew along the directions parallel and perpendicular to the trenches. Plan view images show defects of different angles of stacking faults and twin boundaries. Such defects are formed mostly along the (111) plane and observed along the directions parallel or vertical to the [110]. The various angles of the defects appeared in the TEM images are due to the structural formation of the multiple twin boundaries or pyramidal defects. Multiple twin boundaries are formed by the several twin defects along (111) twin boundaries. [4]

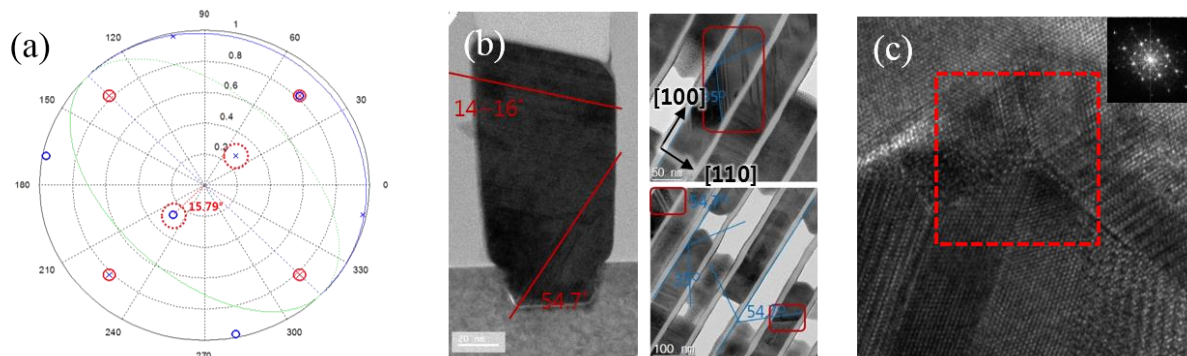
Figure 3. shows (a) Stereograph of 2nd twin boundary. (b) Defect analysis of TEM images (c) The HR-TEM and SACD image of 5 folds twin boundary.
