Diffusion Brazing of Ti6Al4V and γ-TiAl alloy with Al/Cu multifoils fillers

F. Costa*, A. Vieira*, A. Guedes*, S. Simões** and F. Viana**

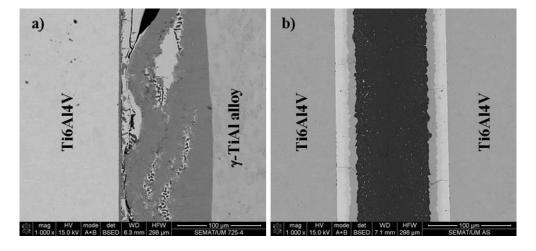
Figure 1. SEM images of the interfaces for joining with Cu/Al/Cu filler. a) Ti6Al4V/ γ -TiAl alloy joint, processed at 725 °C; b) Ti6Al4V/Ti6Al4V joint, processed at 625 °C.

Several defects, such as cracks and unbounded zones, were observed at the interfaces of Ti6Al4V/γ-TiAl and Ti6Al4V/Ti6Al4V joints when Cu/Al/Cu (34.5 Cu, wt.%) stacking sequence was used as filler, regardless of the processing temperature. As it can be observed in Figure 1a, Ti6Al4V/γ-TiAl interfaces present cracks that are parallel to the surface of the Ti6Al4V alloy along with large unbounded zones. Concerning Ti6Al4V/Ti6Al4V interfaces, cracks that are developed perpendicularly to the base materials surfaces are a characteristic feature (Fig. 1b). The detection of such defects at the interfaces clearly indicates that the mechanical properties of joints produced under the set of processing conditions tested when Cu/Al/Cu multifoil was used as filler would be inadequate for practical applications.

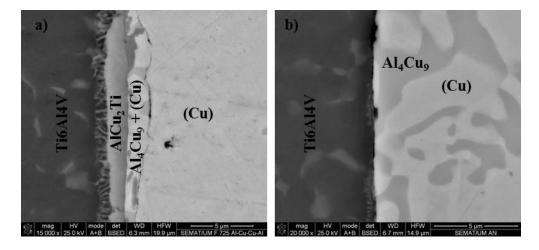
Figure 2. SEM images of the interfaces near the base materials for joining with Al/Cu/Cu/Al filler at 725°C. a) Ti6Al4V side of a Ti6Al4V/ γ -TiAl joint; b) Ti6Al4V/Ti6Al4V joint.

Changing the chemistry of the filler, by using a Al/Cu/Cu/Al (93 Cu, wt.%) foil stacking sequence, allowed reducing substantially the defects detected at the interfaces, after joining at 725 °C, as it can be observed in Figure 2. For Ti6Al4V/ γ -TiAl joints, EDS analysis indicate that bonding to both base materials is promoted by the formation of a reaction layer (23Al-27.9Ti-49.1Cu, at.%) essentially composed of AlCu₂Ti. Between the AlCu₂Ti layer and the central zone of the interface, which consists in (Cu), a layer (22.9Al-5.4Ti-71.7Cu, at.%) composed of a mixture of phases that should comprise mainly Al₄Cu₉ and (Cu) was detected. Only some zones of the interfaces, located near the Ti6Al4V alloy surface, display pores or microcracks. Figure 2a shows a microcrack running along the interface between the Al₄Cu₉ + (Cu) layer and (Cu). In the case of Ti6Al4V/Ti6Al4V joints (Fig. 2b), bonding is ensured by a reaction layer mainly composed of Al₄Cu₉ (31.9Al-1.9Ti-66.2Cu, at.%) and (Cu); scarce microcracks may be observed at this layer. The remaining interface is apparently defect free and consists in (Cu).
