## Hydrogen Embrittlement of Pre-Cathodically Hydrogen Charged Inconel 718 Fabricated via Selective Laser Melting: Fracture and Crack Propagation via 3D EBSD

In this work, new experimental techniques to measure the hydrogen diffusivity of AM Ni-based alloys and the understanding of the hydrogen embrittlement mechanisms of AM Inconel 718 is investigated. The work paid particular emphasis in the HE susceptibility for different scanning strategies and anisotropy. Solidification structures were analyzed using Scanning Electron Microscopy (SEM) and Transmission Electron Microscopy (TEM). Crystallographic texture was analyzed via Electron-backscattered Secondary Diffraction (EBSD) before H-charging. Specimens were electrochemically pre-charged in a 3 wt.% NaCl electrolyte at 90°C – to facilitate the diffusivity- at different charging times. Slow strain rate tensile test was performed at a strain of 0.01mm/min (strain rate:  $10^{-6}$  s<sup>-1</sup>) for both non-charge and H-charged samples. Fractography analysis via SEM and EBSD was followed to examine the microstructure evolution after deformation (Fig.1), as well as the reduction of area and the change in fracture mode (ductile-to-b

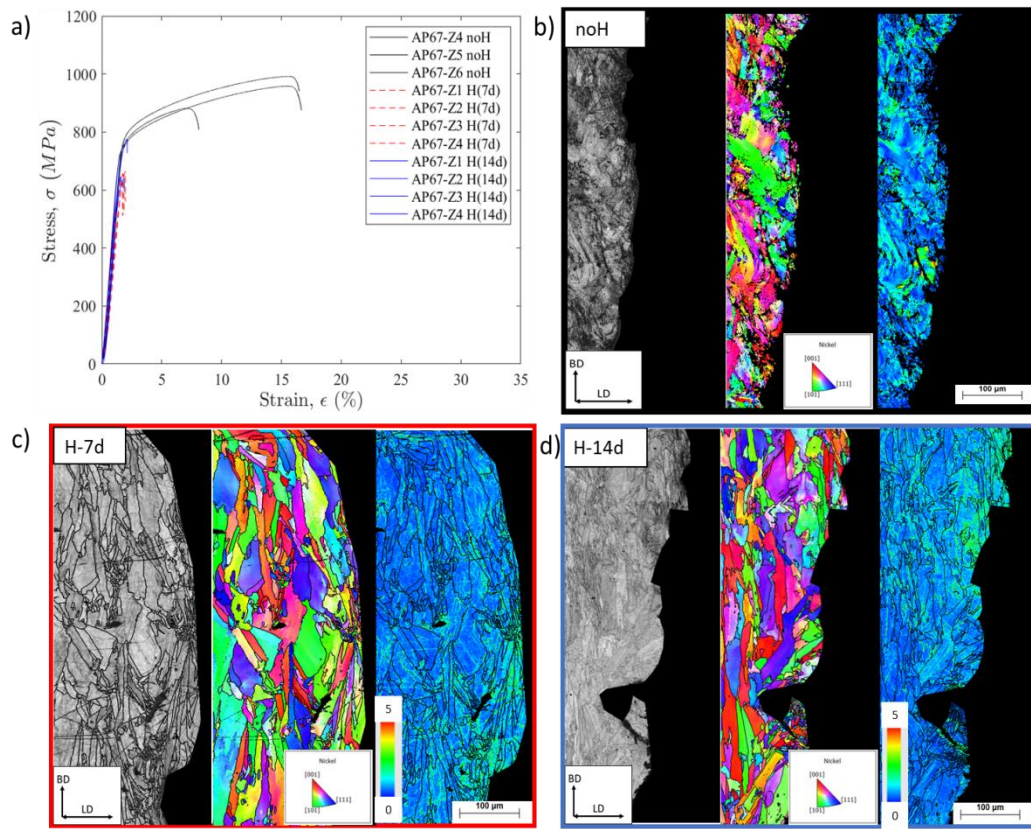
**Figure 1.** stress-strain results for AM Inconel 718 with scanning strategy meander  $67^\circ$  (a), fracture analysis of same material showing IQ map, IPF-Z map and Kernel map from EBSD results for non H-charged (b), H-charged for 7 days (c) and H-charged for 14 days (d)

Results show a significant reduction of the ductility and strength of the high hydrogen absorption samples – considered as the fully charged condition. Fracture was changed from intragranular to intergranular due to the hydrogen enhanced decohesion (HEDE) mechanism in conventional Inconel 718 (control sample) and cleavage-like fracture in AM Inconel 718 with diffusion of hydrogen into the cell dendrites (Fig.2). From the TDS results and diffusivity studies the most optimal charging condition were chosen, and electrolyte was changed to deuterium for characterization in Atom Probe Tomography (APT) to allow the mapping imaging and distribution of hydrogen in the sample. Complimentary, fracture and crack propagation was analyzed via 3D EBSD.
