MICROSTRUCTURE OF GaN GROWN ON (111) Si BY MOCVD

D. M. Follstaedt, J. Han, P. Provencio and J. G. Fleming

Sandia National Laboratories, Albuquerque, NM 87185-1056

Cite this article as: MRS Internet J. Nitride Semicond. Res. 4S1, G3.72 (1999)

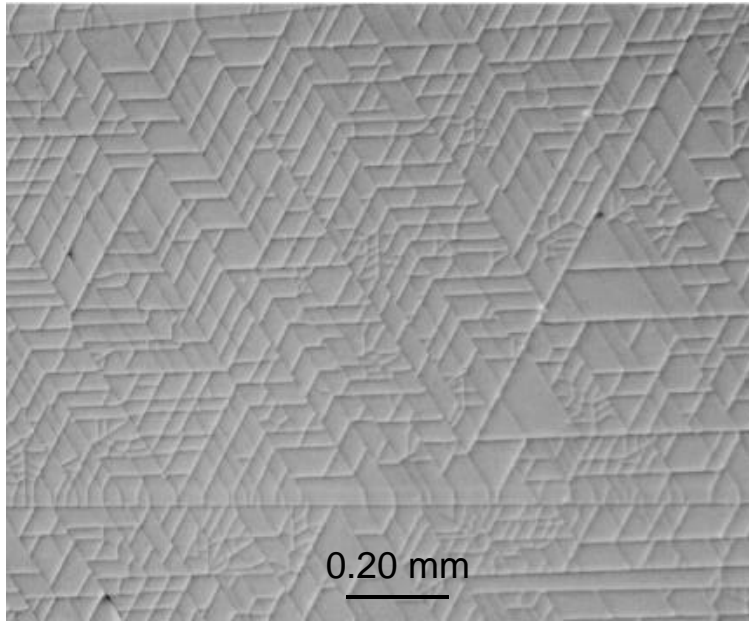
Figure 1. Nomarski optical micrograph showing cracking of GaN on (111) Si along {1-100} planes.

In situ reflectivity indicated that the GaN surface was smooth immediately after growth at 1060°C. However, upon cooling to room temperature, a dense set of cracks with separations

from 20 to 100 μm was found along {1-100} planes, as seen in Figure 1. The layer is expected to have relaxed fully at the growth temperature, as found for GaN grown on Al_2O_3 using in situ stress monitoring techniques [4]. The greater thermal expansion coefficient of GaN as compared to that of Si ($5.6 \times 10^{-6}/\text{K}$ vs. $2.6 \times 10^{-6}/\text{K}$, respectively) then explains cracking since the GaN layer would be put into tension upon cooling. In spite of cracking, the GaN layer adhered to the substrate. X-ray diffraction of such layers gives (0002) GaN reflections with FWHM of 900 arcsec, similar to those found previously [2].

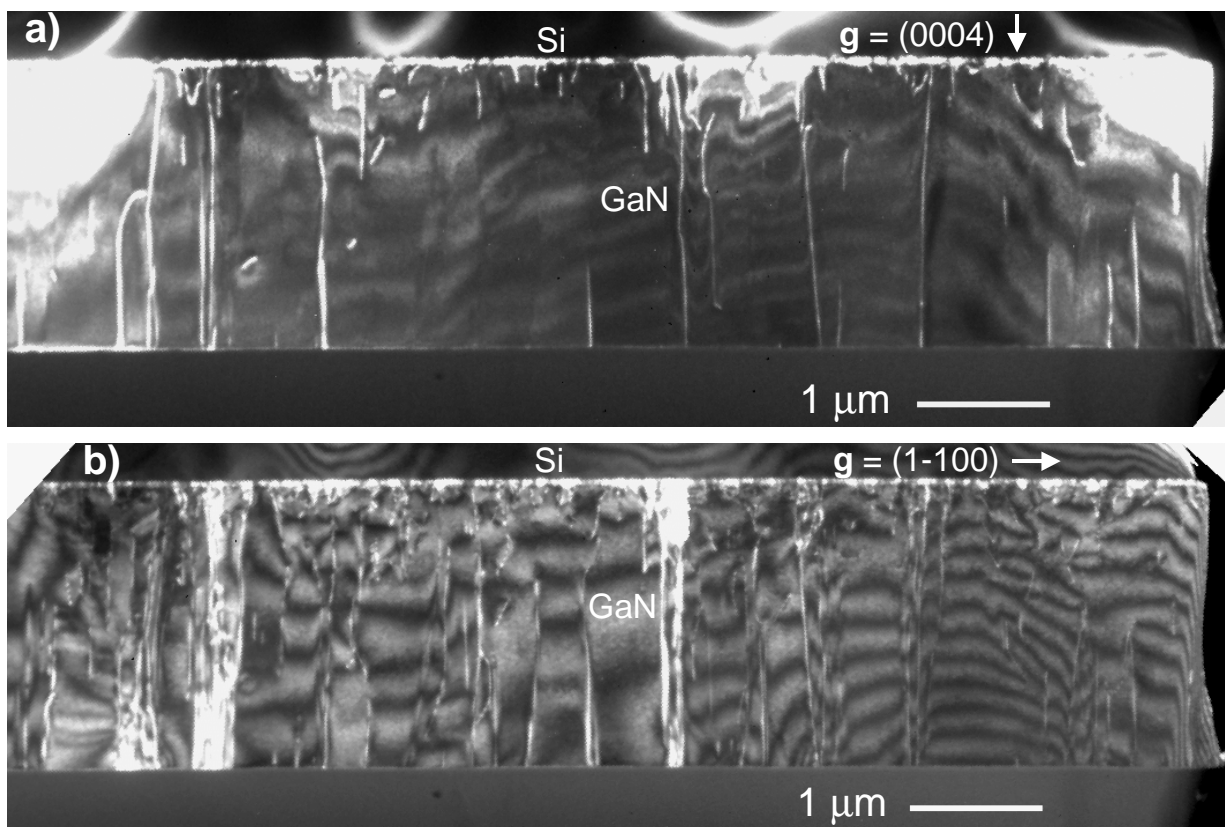
Figure 2. Weak-beam TEM images obtained near $[11\text{-}20]$ orientation. a) $g = (0004)$, with cores of dislocations having $\mathbf{b} = \mathbf{a} + \mathbf{c}$ illuminated. b) $g = (1\text{-}100)$, with cores of all dislocations illuminated. A crack running through the layer and into the Si substrate is seen at far right.

Dislocations thread from the buffer layer to the surface of the GaN layer along the c-axis, growth direction. Examination in cross-section with different diffracting beams can be used to determine the Burger's vectors of individual dislocations, which for hexagonal close-packed lattices are [6]: \mathbf{a} (or $1/3\langle 11-20 \rangle$, in the basal lattice plane), \mathbf{c} ($\langle 0001 \rangle$, along the hexagonal axis), or $\mathbf{a}+\mathbf{c}$ ($1/3\langle 11-23 \rangle$, mixed character). In Figure 2, image (a) uses the (0004) reflection to illuminate the cores of dislocations with Burger's vectors having a c-axis component. Image (b) uses (1-100) to image those with a basal plane component. Detailed examinations with several reflections indicate that almost all dislocations are detected in Figure 2b) and have a basal-plane component. Those with a c-axis component seen in Fig. 2a ($\sim 1/3$ of the total) are almost all of mixed character. The additional ones in Fig. 2b ($\sim 2/3$ of the total) have purely basal-plane Burger's vectors, $\mathbf{b} = \mathbf{a}$; since the dislocation lines are fairly straight along the c-axis, these are edge dislocations. Very few dislocations have $\mathbf{b} = \mathbf{c}$ corresponding to pure screw character. This distribution of Burger's vectors is like that found by us [7] and others [8] in GaN on sapphire.

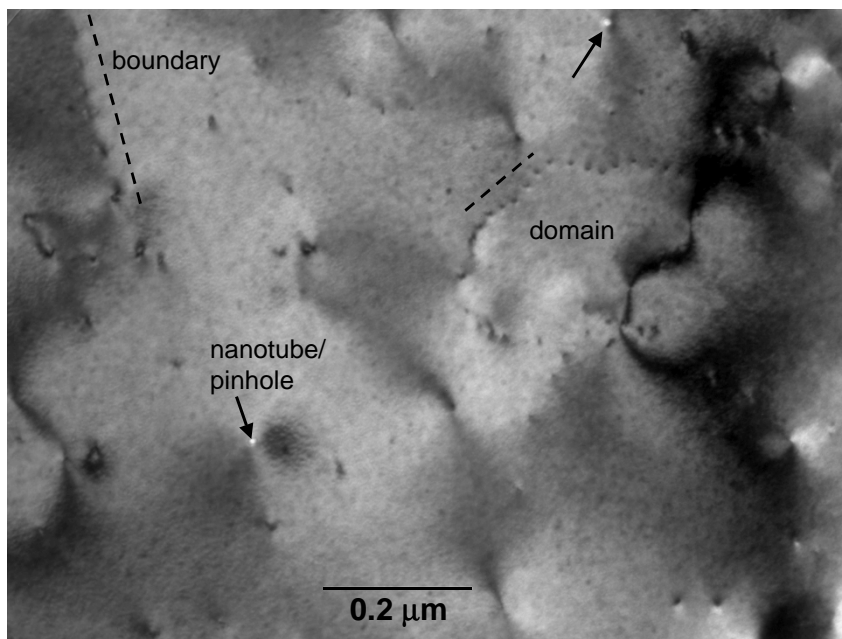
Figure 3. Plan-view TEM image of the surface of the GaN layer, obtained near $[0001]$ orientation using $g = (1-100)$ two-beam conditions in bright-field. Dislocations appear as short black-white lines, and often form continuous curves at boundaries between domains of material with slightly differing orientations; two are noted with nearby dashed lines. Two void-like defects (nanotubes or pinholes) are also noted with arrows.

Plan-view TEM gives additional insight into the dislocation arrangement. A specimen was prepared by placing thinned epoxy on the specimen surface to penetrate into cracks, removing excess epoxy from the surface, and carefully backthinning with the specimen attached to a grid for structural support. The thinned area is at the surface of the GaN layer and allows defects threading to it to be detected. In Figure 3, the dislocations are viewed nearly end-on and appear as short black-white segments. They often lie along continuous curves that form boundaries between domains of material with slightly differing orientations. A similar arrangement is found for threading dislocations in GaN grown on sapphire [9]. Plan-view images allow more surface area to be examined than in cross-section and give the most accurate determination of dislocation density at the surface: 8×10^9 disl/cm² for this specimen. This density is like that found for GaN grown on sapphire [7], although lower values have been achieved [8].

By examining this greater surface area, an additional defect with a low density is found. Two void-like defects were identified in Figure 3 (small white spots, arrowed) by examining their contrast with changes in TEM objective lens focus. Such defects have been termed “nanotubes” if they have extended length into the GaN, or “pinholes” if they are pits located at surface [10]. Since we do not have depth information, we cannot determine which of the two classifications apply. Other images taken under high resolution conditions show that the $\{1\text{-}100\}$ lattice planes form facets around the voids. Their areal density is $\sim 1 \times 10^8$ /cm², again comparable to that found in GaN grown on sapphire [10].

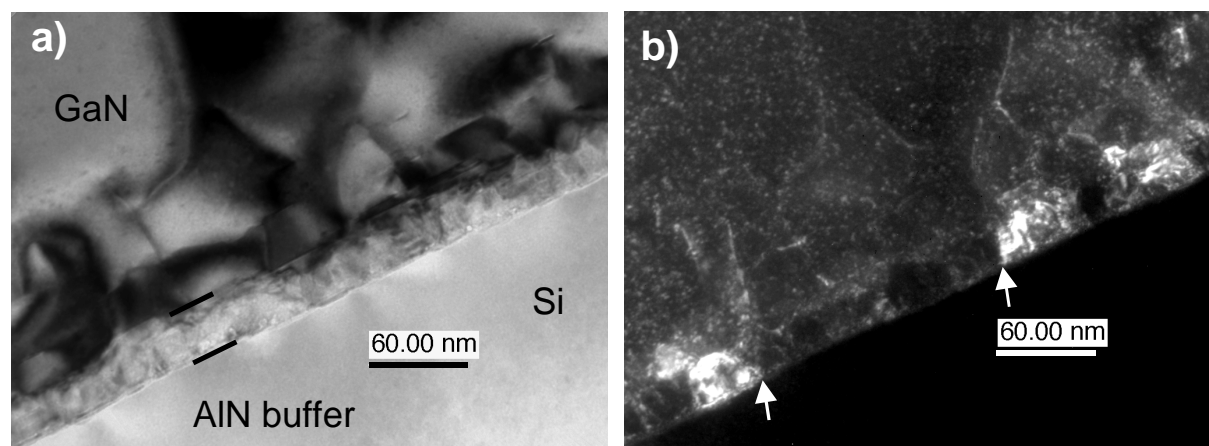
Figure 4. a) Bright-field, $(3-300)$ two-beam image of AlN buffer on Si near $[11-20]$ cross-section orientation with dislocations extending into GaN layer. b) Corresponding weak-beam image showing 20-40 nm grains in the buffer with contrast between them indicating slight orientation differences. Two dislocations appear to originate at grain boundaries in the buffer (arrowed).

The buffer layer was found to be continuous over extended distances in cross-section images. Its thickness varies somewhat as seen in Figure 4a, but it is readily identified from the GaN overlayer. By tilting the specimen slightly to vary the contrast in bright field, or by weak-beam examinations like Figure 4b, the layer is seen to be composed of grains that are 20-40 nm across and slightly misoriented with respect to each other.

Dislocations in the GaN just above the buffer interact with each other, as seen in Figure 4. The dislocations extend into the AlN buffer at near-normal incidence. In some cases, they appear to coincide with grain boundaries in the buffer; two instances are arrowed in Figure 4b. This suggests that the misorientations between AlN buffer grains may directly produce some of the dislocations threading through the GaN. Perhaps if a buffer layer with larger grains were formed, the GaN would have fewer defects.

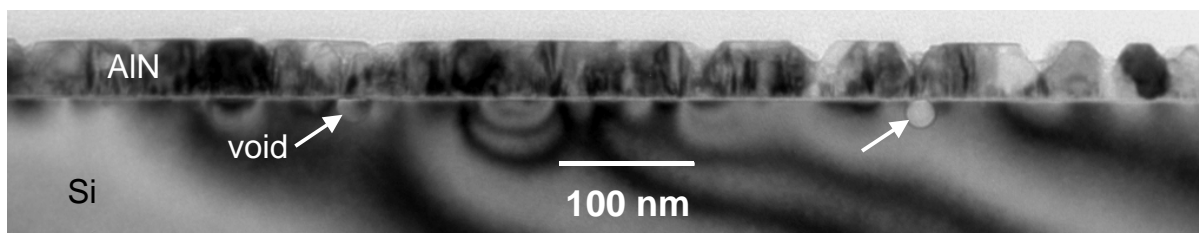
Figure 5. Cross-section TEM image of 40 nm AlN buffer grown on (111) Si, seen in [11-20] orientation with $g = (0002)$ two-beam conditions. Grains in the AlN buffer are faceted at the top surface, and two voids (arrowed) can be seen just below the interface in the Si.

A cross-section TEM specimen was also made of a 40 nm-thick AlN buffer layer grown alone on (111) Si at 1100°C. The layer was again found to be continuous with slight misorientations between grains, as seen in Figure 5. Our examinations indicated two other features of this layer. First the individual grains composing the buffer exhibit faceting on the growth surface; the facets appear to be $\{1-101\}$ lattice planes. Secondly, a few voids were found in the Si immediately beneath the interface, which suggests that Si may be diffusing into the AlN.
