Crack Characterization Using Image Analysis

James Grande

GE Global Research Center, Niskayuna, NY 12309

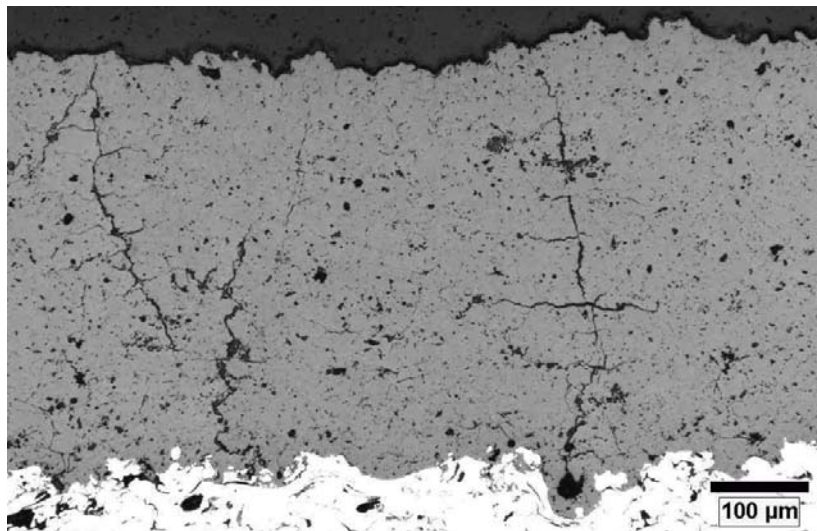
Figure 1.) TBC with various cracks depicting vertical cracks with branching and tortuosity.

The advantage of this technique is that it provides a more complete picture of the cracks and accounts for cracks that may go off in various directions as well as ones that have significant branching (Figure 1). In addition, the X and Y projections can be used in conjunction with other shape parameters to ascertain the degree of branching and the tortuosity of the crack.

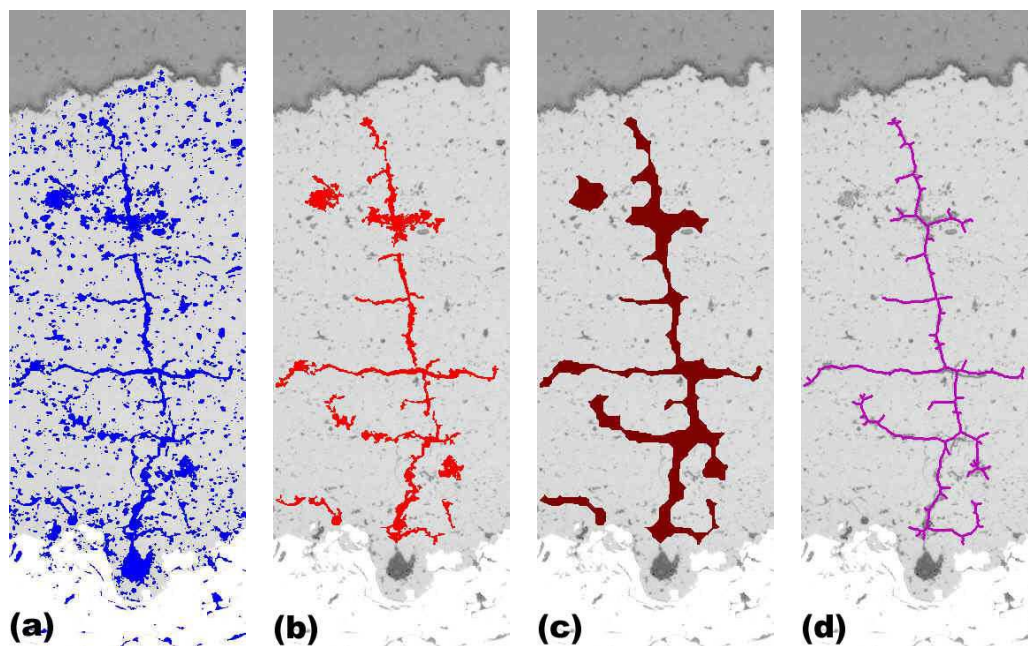
Figure 2.) Image processing steps for reconstructing large vertical cracks.

The processing steps involved require excellent metallographic preparation in order to minimize edge rounding and to image fine cracks that often emanate from larger ones. Once the image has been segmented to a binary image (Figure 2a), image processing can be performed in order to filter out pores (Figure 2b), connect smaller cracks to larger cracks which are in close proximity but not connected due to the 3-dimensional nature of cracks (Figure 2c), and finally thin the crack to approximate its original thickness (Figure 2d) while retaining only $>100\mu\text{m}$ cracks.
