REGULAR PAPER

Fretting wear behaviour in 6061-T6 aluminium alloy

Keywords: fretting wear; fatigue; riveted lap joint

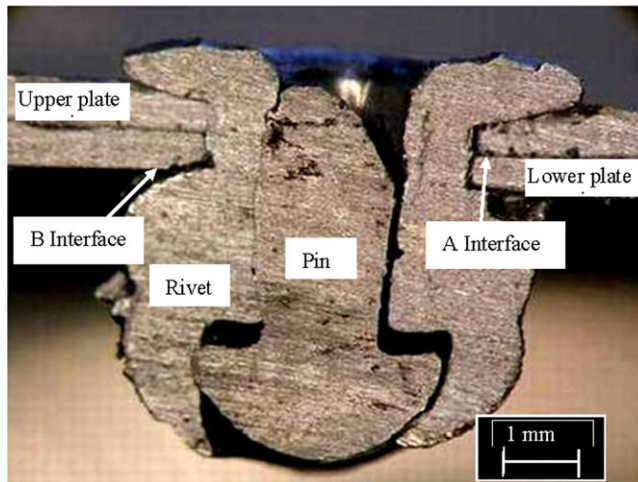
Figure 1. Cross-section of unloaded A4 blind rivet joint.

The macroscopic cross-sectional view of the rivet joint after riveting is shown in Fig. 1. The cross-sectional view of the joint area is taken perpendicular to the load to be applied. In this study, two interfaces A and B, which are exposed to friction, were investigated in the blind rivet joint indicated in the cross-sectional image. Surface A of the bottom plate contacting the top plate, surface B of the bottom plate contacting the rivet head [19].

In this examination, it was determined that there was wear damage on the contact surfaces of A and B in the blind rivet connection (Fig. 1).

The roughness values of the plate surfaces in the joint areas were measured using the Mitutoyo Surftest 201 device. The average surface roughness Ra was tested using Mitutoyo 201 portable surface roughness tester. Measurements were made from the rivet head contact surface of the upper plate, the contact surface of the upper plate with the lower plate, the contact surface of the lower plate with the upper plate, and the rivet head contact surface of the lower plate. These surfaces are the parts shown in Fig. 1 as interface A, and interface B, respectively.

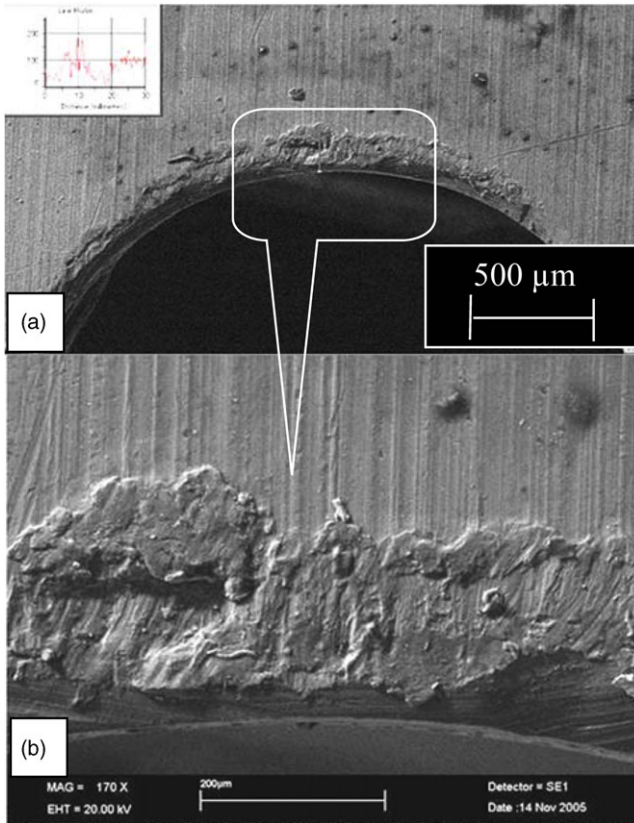
Figure 2. Image of lower plate contact surface with rivet head (load: 480 N, cycle: 6×10^4).

The fretting zones formed on the B contact surface at 480 N in the joints in 6×10^4 cycles are shown in Fig. 2. The figure shows three body fretting zones at the edge of the hole. These visible fretting zones are eroded oxidised black zones, so the boundary between fretting and non-fretting zones can be clearly distinguished. The width of these particles is up to 0.3 mm from the edge of the hole. Particles concentrated most against the load direction, and three-body fretting occurred in the fretting areas of the plate. Three-body fretting zones appear in black and contain deposits. Three-body fretting occurred at 480 N at 6×10^4 cycles. B contact surface wear scar width can be seen in Fig. 3. The wear scar width increased with cycle at 480 N.

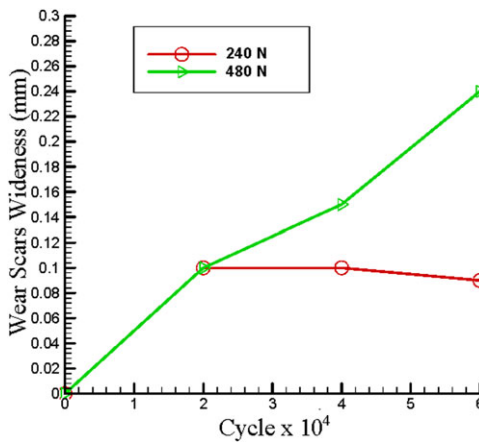
Figure 3. Variation of wear scar width with cycle.

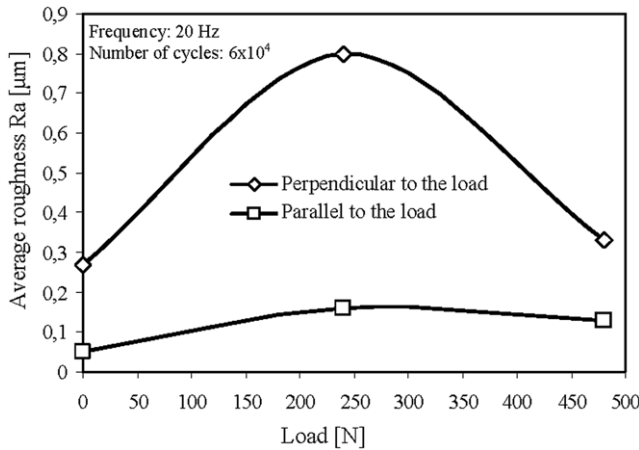
Figure 4. Variation of rivet head contact surface roughness of upper plate with load.

The variation of the mean roughness values measured on the upper plate in 6×10^4 cycles with the load is shown in Fig. 4. The roughness values measured perpendicular to the load were higher at 240 N.

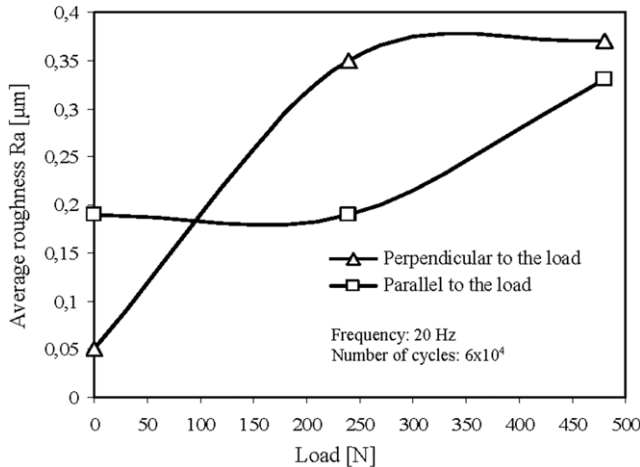
Figure 5. Variation of the contact surface roughness of the upper plate with the lower plate with load.

The average roughness values in 4×10^4 cycles was observed that the roughness decreased at 240 N and the roughness values increased at 480 N. Fretting scars began to appear when the cycle increased at 480 N, and the roughness values increased at 480 N due to increasing fretting scars. This is the transition phase from two-body fretting to three-body fretting. This is the stage where small residues begin to form. The variation of the mean roughness values measured at the interface between the upper plate and the lower plate in 6×10^4 cycles with the load is shown in Fig. 5. Since the cycle is high, it is seen that the roughness values increase at 240 N and 480 N (Fig. 5).

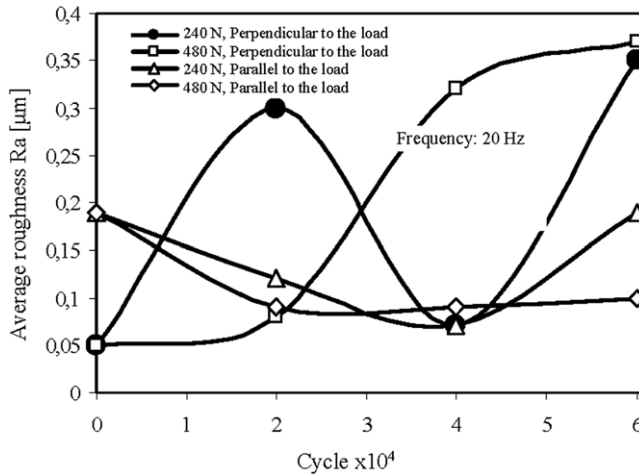
Figure 6. Variation of the contact surface roughness of the upper plate with the lower plate with cycling.

The variation of the roughness of the contact surface of the upper plate and the lower plate with the cycle is given in Fig. 6. When Fig. 6 is examined, it is seen that the roughness decreases slightly as the cycle increases due to the friction of the two plates in the measurements made parallel to the load. In the direction perpendicular to the load, the roughness first decreased due to the reduction in manufacturing traces with the effect of friction, and when the cycle was increased, the roughness increased due to the fretting residues formed on the surface, especially at 480 N.

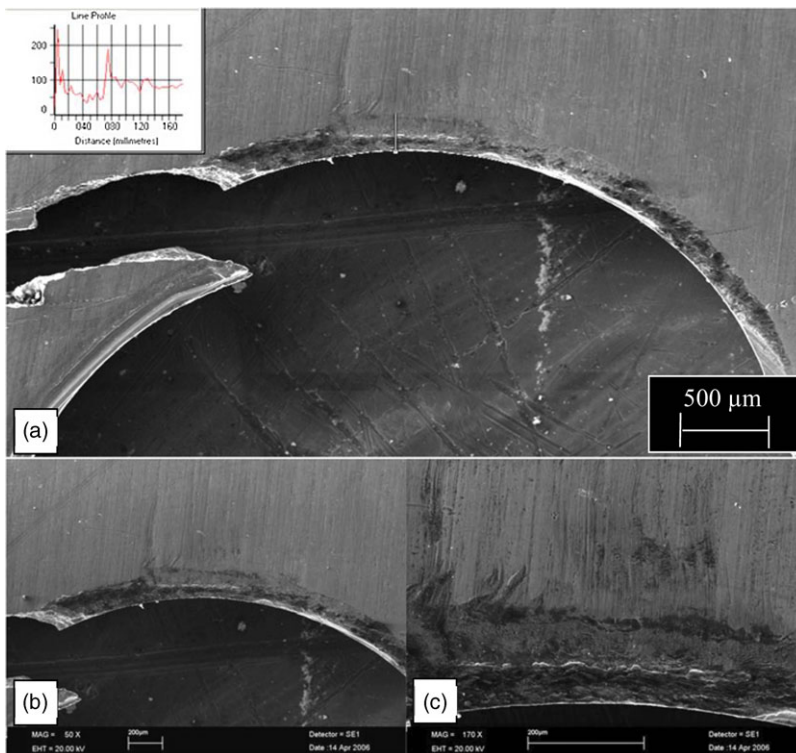
Figure 7. Lower plate contact surface with rivet head (load: 480 N, cycle: 866,920).

Small residual particles were seen at the hole edge of the contact surface of the lower plate with the upper plate. These visible wear areas are worn oxidised black areas. Residues generally occurred in the cracked part of the bottom plate. First, cracks in the bottom plate were seen at 476,711 cycles (Fig. 7).

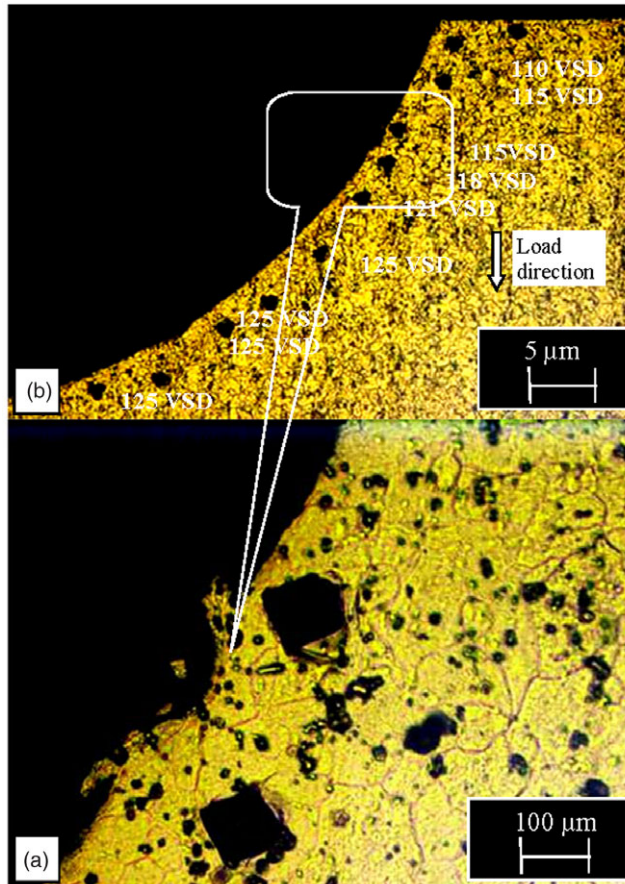
Figure 8. a) Microhardness distribution of upper plate a contact surface with lower plate b) detail view (load: 480 N, number of cycles: 6×10^4).

In the rivet joint with 480 N and 6×10^4 cycles, it was determined that the microhardness of the contact surface of the upper plate with the lower plate A increased with fretting wear and reached an average of 122 VSD (Fig. 8).

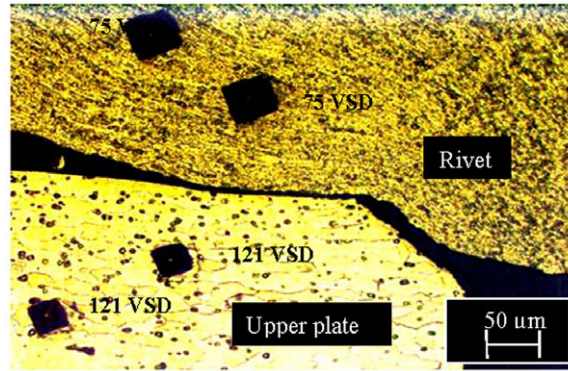
Figure 9. Microhardness distribution of upper plate contact surface with rivet head (load: 480 N, number of cycles: 6×10^4).

It is seen in Fig. 9 that the rivet body is softer than the plate, according to the hardness distribution of the rivet and upper plate, which is not subjected to load testing.

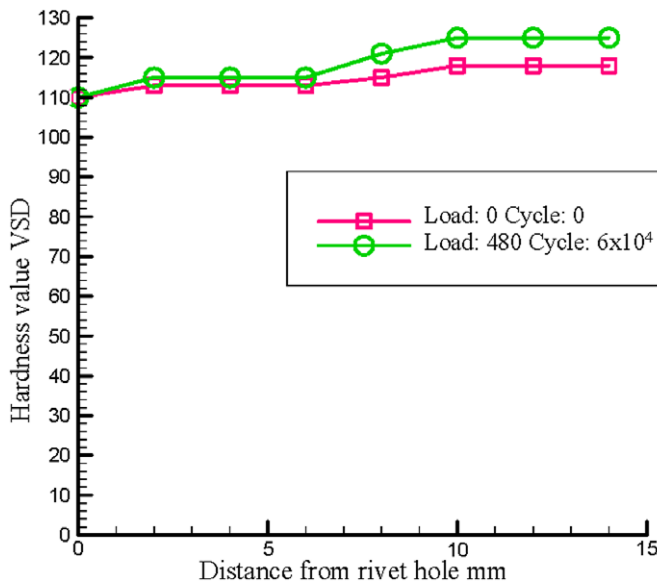
Figure 10. Comparison of microhardness values of loaded and unloaded plates.

The change graph of the hardness value scanned from the part of the rivet hole perpendicular to the load to the part parallel to the load is given in Fig. 10. The stiffness increased slightly as we approached the part of the hole perpendicular to the load. The hardness has increased since the load is forging in the part where the load comes vertically.

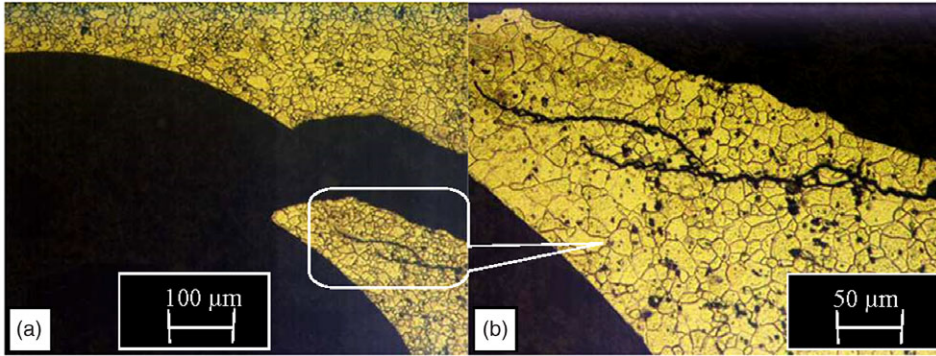
Figure 11. a) Image of lower plate with upper plate contact surface crack. b) Detail image (load: 480 n, cycle: 866,920).

Metallographic examination was carried out in the joint areas of the samples. The joints were mounted to sand off the residue on the samples. It was then sanded with P1200 water sander. Polished surfaces are etched with keller etching. Thus, the grain structures were made visible. There was a change in the grain structures on the contact surfaces. Figures 11 and 12 show the grain structures of the cracked joint. Crack progression is clearly seen in the detail picture in Fig. 12. The crack propagates both from the grain boundary and over the grain.

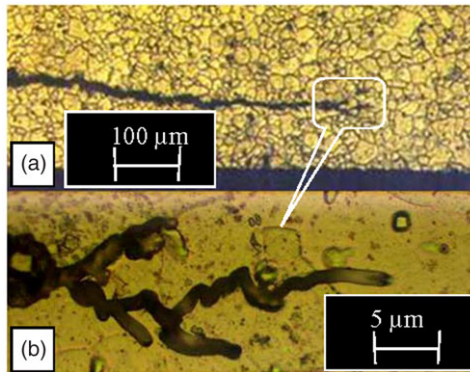
Figure 12. a) Image of lower plate with upper plate contact surface crack. b) Detail image (load: 480 n, cycle: 866,920).
