The Immense Cost of Japanese Dams and Dam-Related Landslides and Earthquakes [Chinese text available] ダムと地すべりに浪費される巨費 まさのあつこ

Masano Atsuko

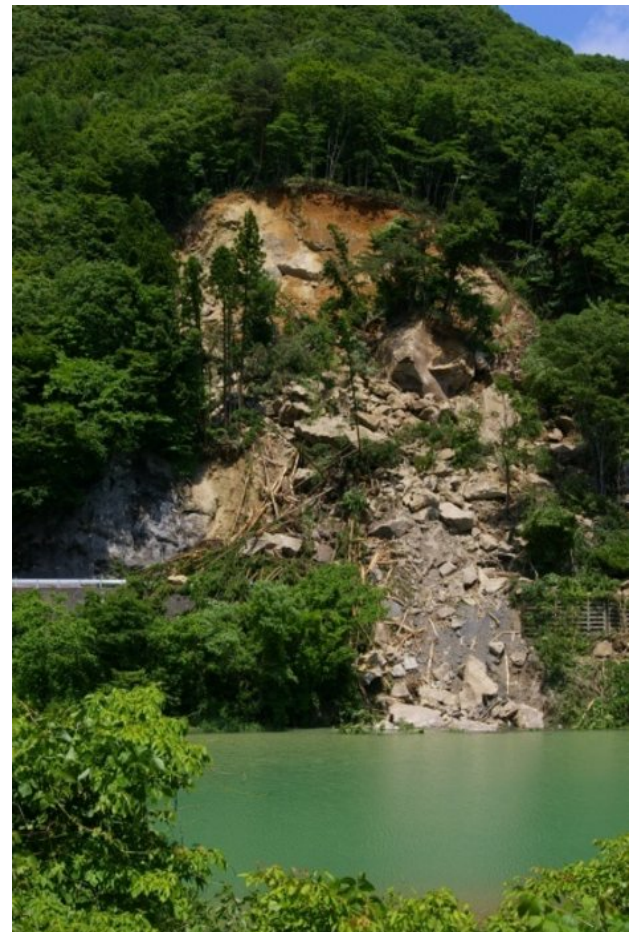
The Iwate-Miyagi Nairiku Earthquake

It had been three months since the Iwate-Miyagi Nairiku Earthquake struck northern Honshu on 14 June 2008, triggering a huge landslide above Aratozawa Dam. The area hit by a landslide has been further carved by snow and rain, and trees and other vegetation are in disarray. The site looks like the day after a wretched barber had just given it a bad haircut. For the earth, this must be an embarrassing appearance.

In this landscape carved by rivers, a landslide with an average depth of 55 meters, a width of 810 meters, and a length of 1400 meters slid as far as 140 meters off the side of the mastiff and into the back of the lake formed by the dam.

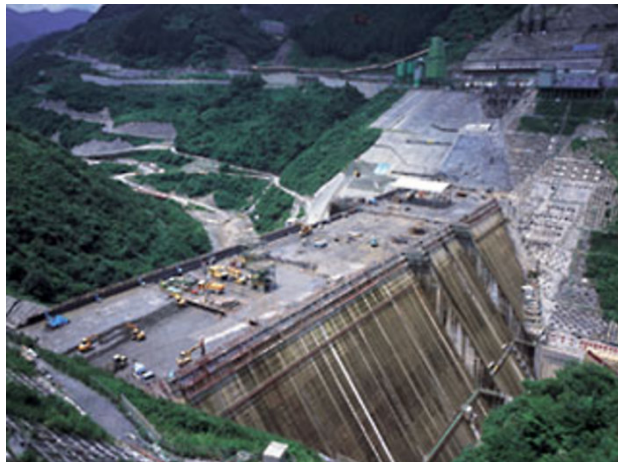
Takizawa Dam, second construction

the water level was 16 meters away from being full. A half month later, the slope—now 90 meters wide, 90 feet deep, and 15 meters long—slid further. In response, Kurihara Yoshiharu, the assistant director of the agency announced, “We knew that this was an area susceptible to landslides and while keeping the water level down, we had taken preventive measures such as constructing an embankment.” A visit to the area confirms evidence that the agency had taken all sorts of measures in no less than 40 different places. The agency had “combined the best construction techniques,” said Kurihara, yet this was insufficient.

Prevention measures continued and in August 2007 another attempt was made to fill the reservoir. This time, workers were able to fill it to capacity, but as they began to lower the water in April 2008, a crack was discovered in a city road near the reservoir bank. As the water continued to be lowered, other fissures appeared. On 7 May, a 40 centimeter diameter crack was found on Route 140 on the other side of the reservoir and six days later another was discovered in a concrete barrier. Even when the water level was maintained, the land continued to slump. On 13 June, a crack appeared in another city road as the slope dropped by .4 meters. When I visited Saitama,

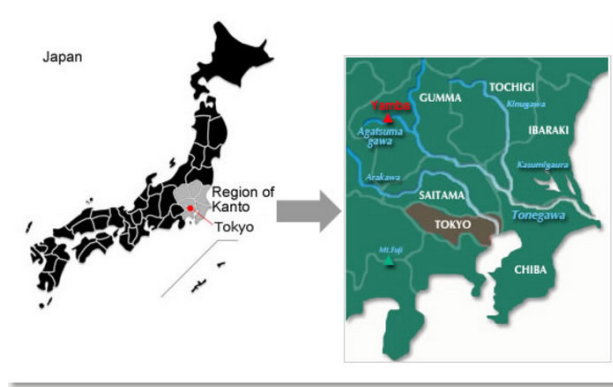
Yamba Dam map

The Transportation Ministry has designated the slopes around the reservoir site as susceptible to landslides and determined that 22 locations are likely to weaken when the reservoir is filled. In the end, however, the ministry decided to take preventive measures in just six spots “where stored water is highly likely to lead to landslides.” The region around the dam has been repeatedly subject to volcanic activity, and, as is even reported on the Transportation Ministry’s website, it is the location of a hydrothermally-altered zone. Areas that have such a zone and experience other volcanic activity are particularly vulnerable to landslides.
