## Microstructural Properties of Piezoelectric 0.95(Na<sub>0.05</sub>Bi<sub>0.05</sub>TiO<sub>3</sub>)-0.05(BaTiO<sub>3</sub>) Thin Films on SrTiO<sub>3</sub> (001) Substrates

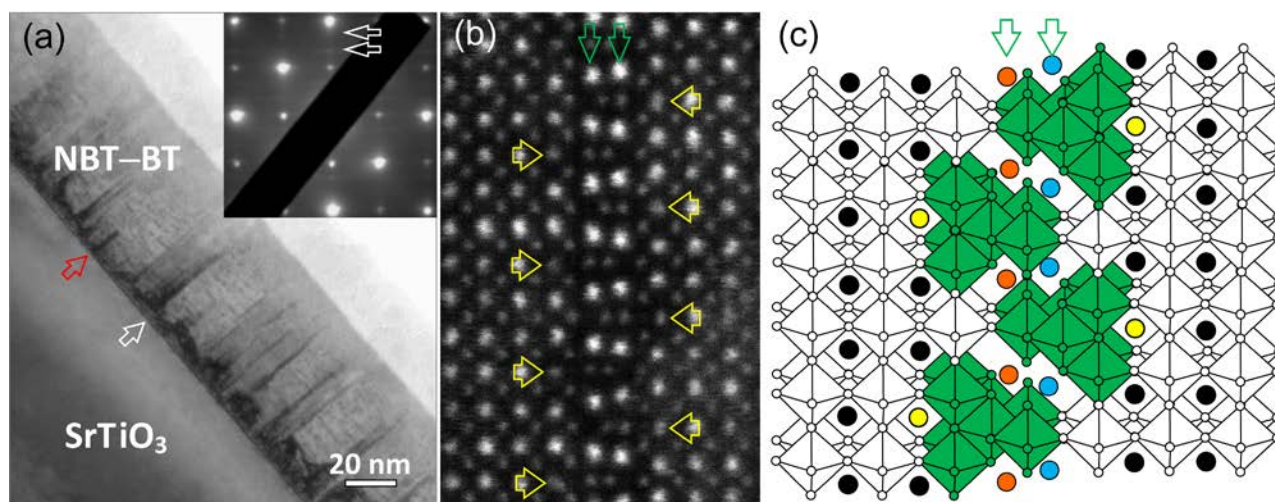
**Figure 1.** (a) A low-magnification BF-TEM image of 0.95NBT-0.05BT thin films on SrTiO<sub>3</sub> (001) substrates. The inset is the corresponding SAED pattern. (b) An atomic-resolution HAADF image of a typical planar defect projected along the [010] zone axis of 0.95NBT-0.05BT. Vertical green arrows denote the Bi-rich double planes, and horizontal yellow arrows mark the Bi-deficient Na/Bi(Ba) columns. (c) The model of the planar defects. The corner-sharing oxygen octahedra in the normal regions are displayed in white, while those with edge sharing ones in the fault area in green. Bi-atom columns in the defects with different height levels are in red and blue, respectively. The Na/Bi (Ba) columns in the normal regions are presented in black, and the Bi-deficient columns in yellow.

Figure 1(a) shows a low-magnification bright-field (BF) TEM image of 0.95NBT-0.05BT films on SrTiO<sub>3</sub> (001) substrates. The contrast difference between 0.95NBT-0.05BT and SrTiO<sub>3</sub> is visible, which allows us to determine the 0.95NBT-0.05BT/SrTiO<sub>3</sub> interface. Contrast variations can also be seen in the image, which is due to the existence of planar defects in the 0.95NBT-0.05BT films. In most cases, the planar faults show the habit plane parallel to the {100} plane of 0.95NBT-0.05BT and either terminate within films or penetrate the whole films, as indicated by a red and a white arrow, respectively. A selected-area electron diffraction (SAED) pattern is inserted in Figure 1(a), which was recorded from the films and part of the SrTiO<sub>3</sub> substrate. Based on the zone axis SAED pattern, the crystallographic orientation relationship can be determined as [010]<sub>NBT-BT</sub>//[010]<sub>SrTiO<sub>3</sub></sub> and (001)<sub>NBT-BT</sub>//(001)<sub>SrTiO<sub>3</sub></sub>. In addition, we noted that diffuse scattering streaks around reflection spots from the 0.95NBT-0.05BT films appear in the SAED pattern, as indicated by a pair of horizontal arrows. The presence of these diffuse streaks results from a high density of planar defects parallel to the film growth direction.

An atomic-resolution HAADF-STEM image of a typical planar fault in the 0.95NBT-0.05BT films is displayed in Figure 1(b), which is recorded along the [010] zone axis of 0.95NBT-0.05BT. The planar defect consists of edge-sharing oxygen octahedra with Bi atoms at the center of the space formed by

octahedral network. In Figure 1(b), the structure of the planar defect has a repeat period three times as large as that of 0.95NBT-0.05BT along the film growth direction. This is consistent with the diffuse streaks appeared in the SAED pattern. It should be mentioned that this planar defect is identical to one of planar defects observed in the 0.95NBT-0.05BT films grown on Ni substrates buffered by a NiO layer [6]. The structural model of the planar defect is displayed in Figure 1(c). In fact, an ordered intergrowth of the planar defect and perovskite-type 0.95NBT-0.05BT phase has been observed in the 0.95NBT-0.05BT/SrTiO<sub>3</sub> system. Regarding the thickness of 0.95NBT-0.05BT between two adjacent planar defects and relative displacement of adjacent planar defects along the film growth direction, a number of ordered sequences characteristic of new structures could be locally obtained. The formation of the planar defect in the films occurs during the film growth since no planar defects have been observed in the 0.95NBT-0.05BT bulk materials [6]. Considering the difference in properties between thin films and bulk materials, the observed planar defect in the films can play an important role in modifying the film properties [7].
